MWRA Pipeline Maintenance

Massachusetts Water Resources Authority
Leakage Control Report
Inspection Branch

Leak No.: FY17-22
 Date: 5/15/2017
 Leak Indication Classification:
 I II **III** (Circle One)
 Service Area: Northern High

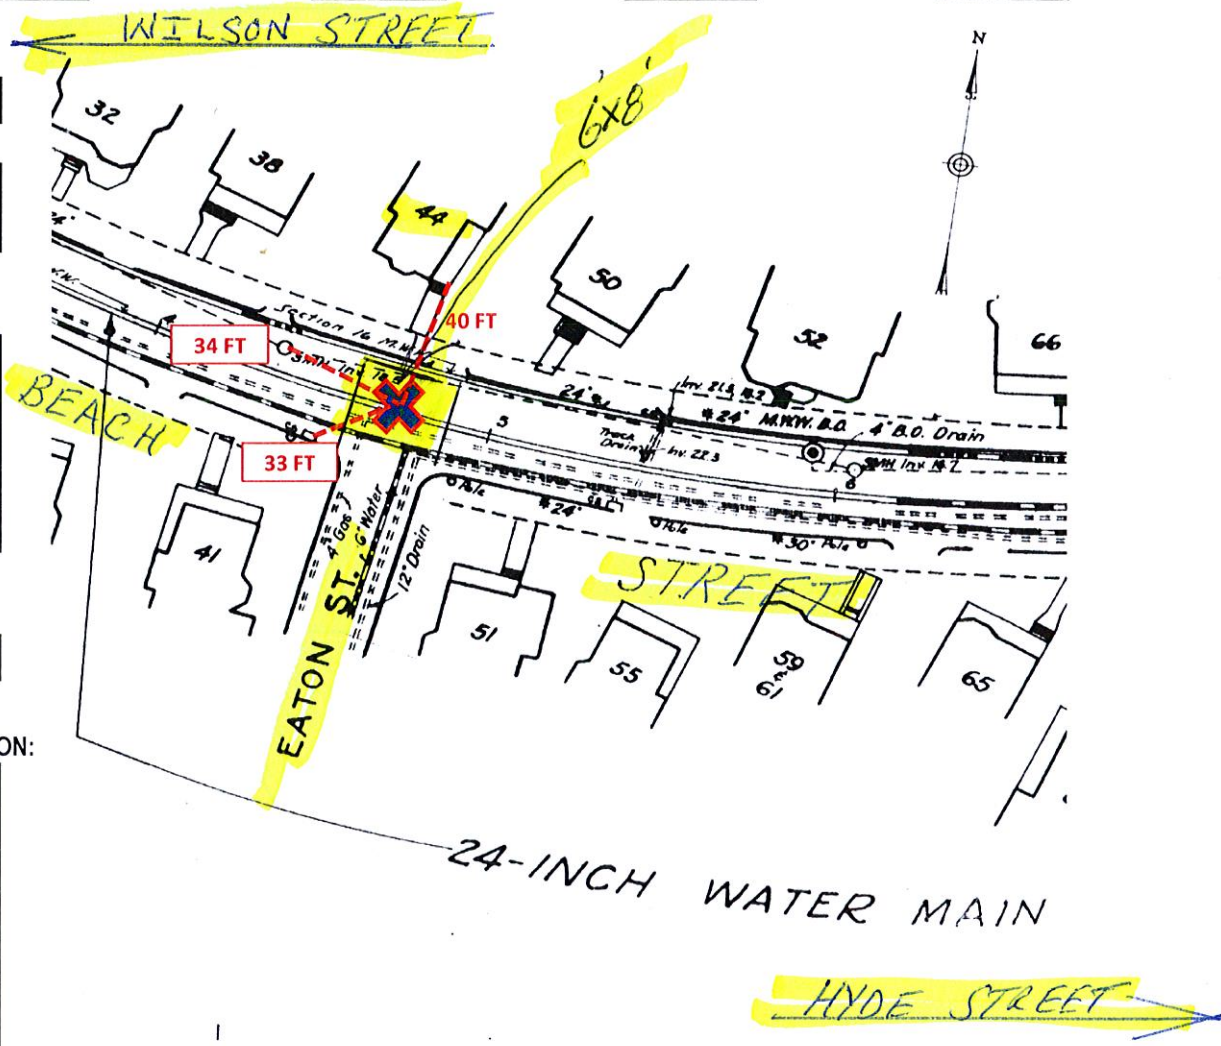
Remarks: Water in road is due to a sump pump which is unrelated to this leak.
