**Sliplining of the Wellesley Extension  
Relief Sewer, Re-construction of the  
New Haven Street Drop Chamber  
and the Restoration of West Roxbury Tunnel**

## New Haven Street Drop Chamber

Wellesley Extension Relief Sewer

West Roxbury Tunnel

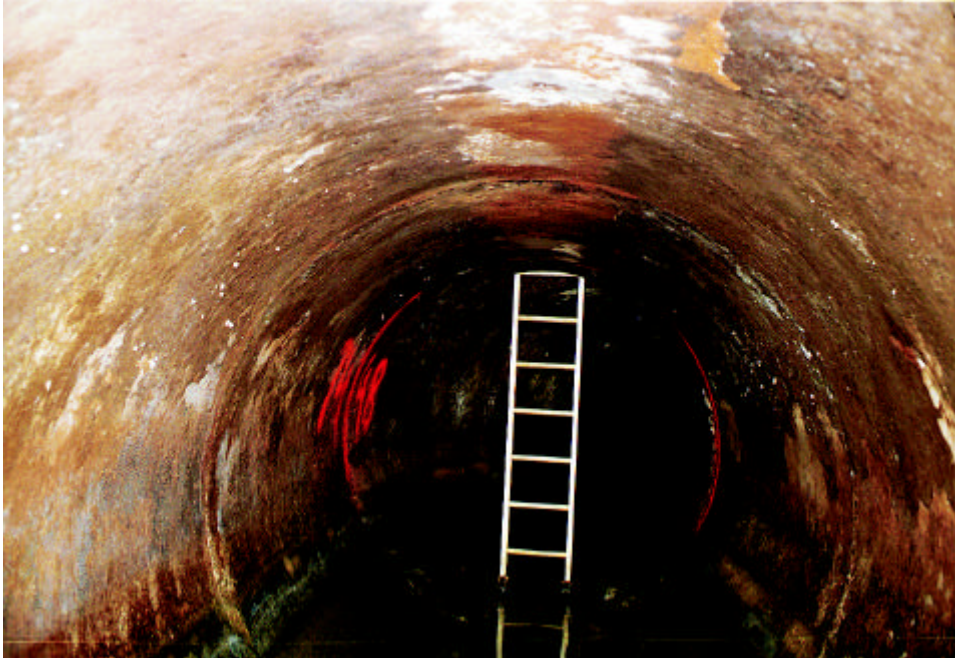
Photo #106:  
**Section 137A, station 66+60, 7-foot diameter sewer, West Roxbury-East end of "West Roxbury Tunnel" Looking east toward Grew Avenue. Top of Pipe 17 feet below ground. Very good condition. No significant corrosion present.**

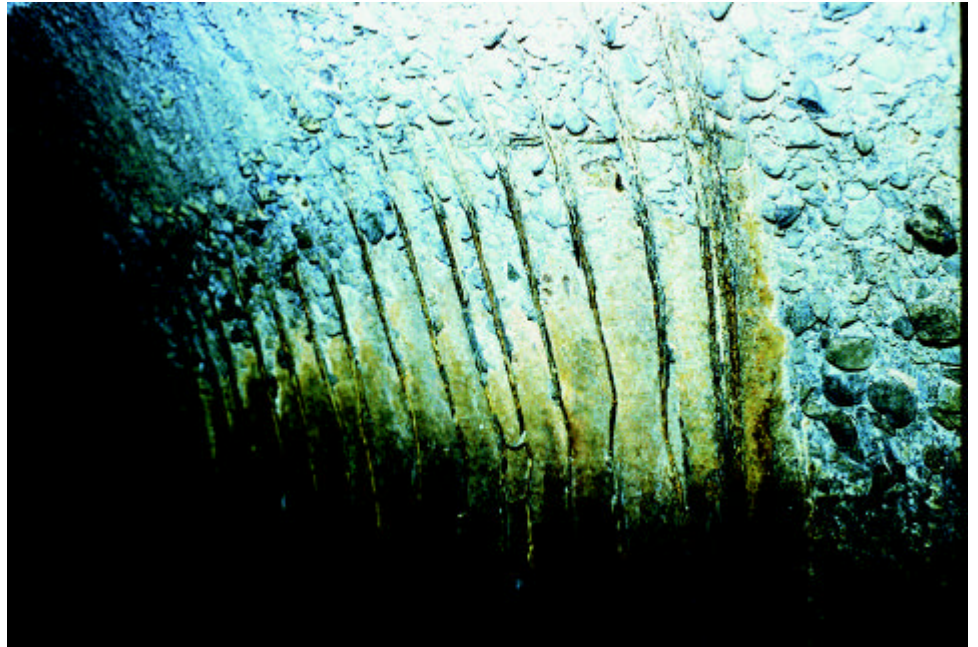
Photo #04:  
**Section 138, station 201+73, 7-foot diameter sewer, West Roxbury-Open space behind McDonalds parking lot. Top of pipe 14 feet below ground. Photo shows significant deterioration of concrete and steel reinforcing.**

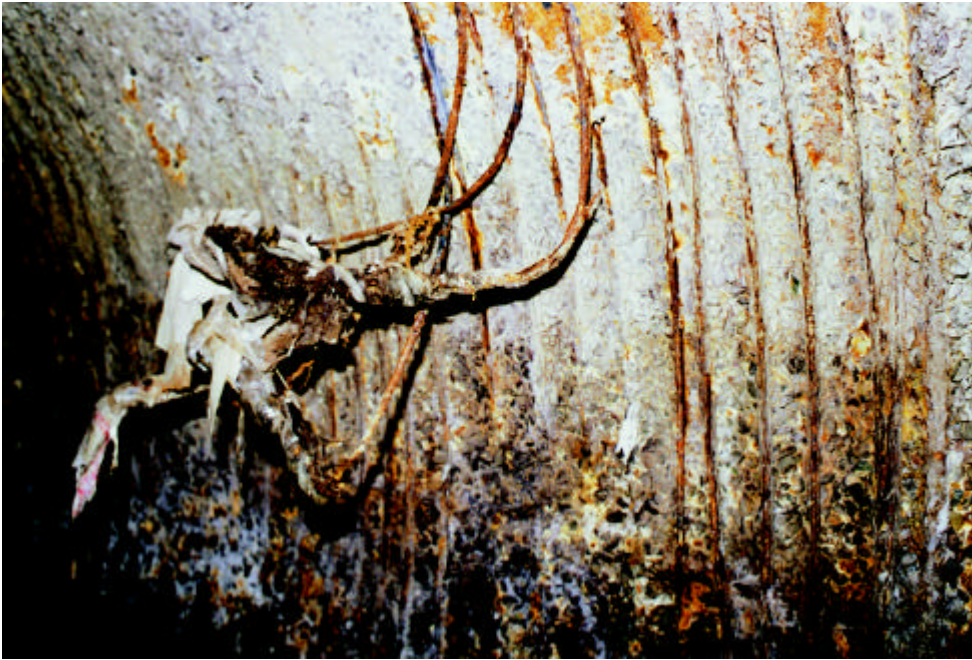
Photo #06:  
**Section 138, station 200+60, 7-foot diameter sewer, West Roxbury - Open space behind McDonalds parking lot. Top of pipe 12 feet below ground. Photo shows significant deterioration of concrete. Reinforcing steel completely compromised.**

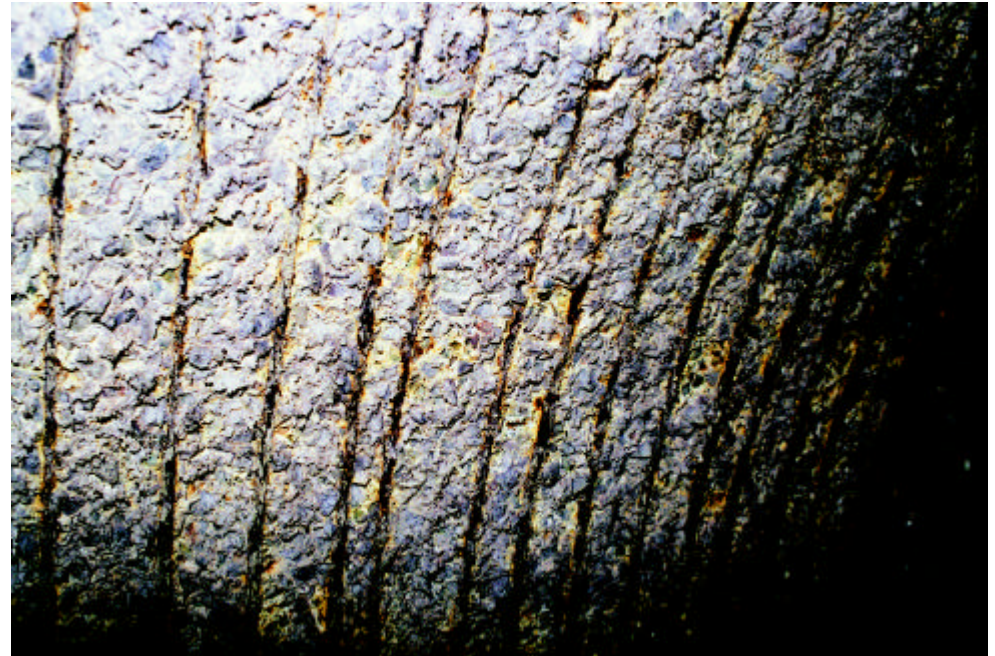
Photo #07:  
**Section 138, station 200+88, 7-foot diameter sewer, West Roxbury-Open space behind McDonalds parking lot. Top of pipe 12 - feet below ground. Significant deterioration of concrete and steel reinforcing.**

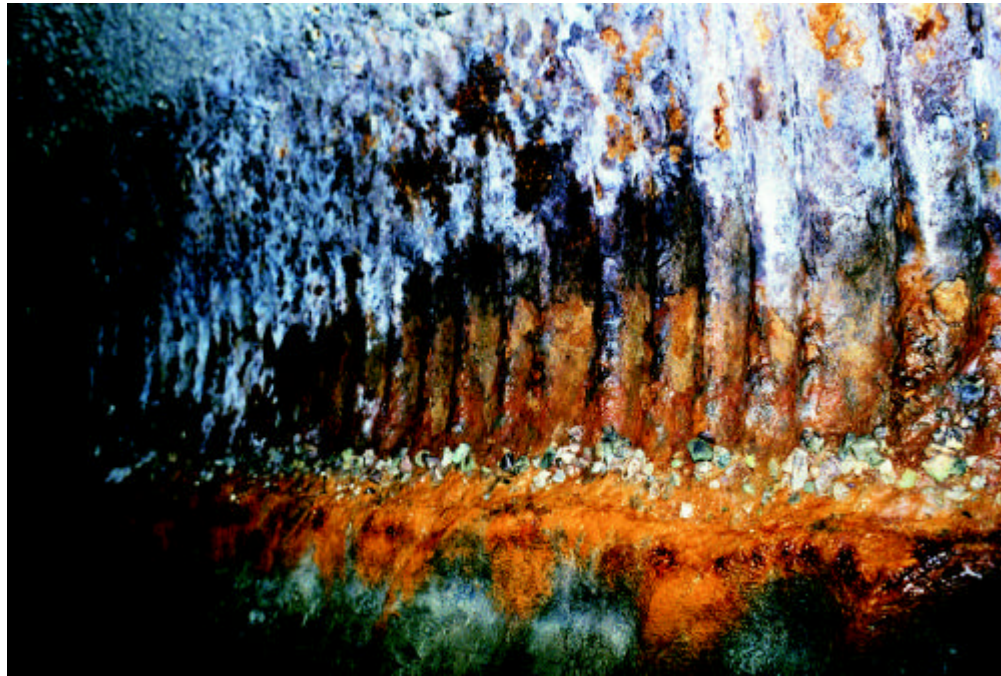
Photo #11:  
**Section 138, station 199+23, 7-foot diameter sewer, West Roxbury - Open space at the back edge of McDonalds parking lot. Top of pipe 14 - feet below ground. View of water line. Significant deterioration at air - water interface.**

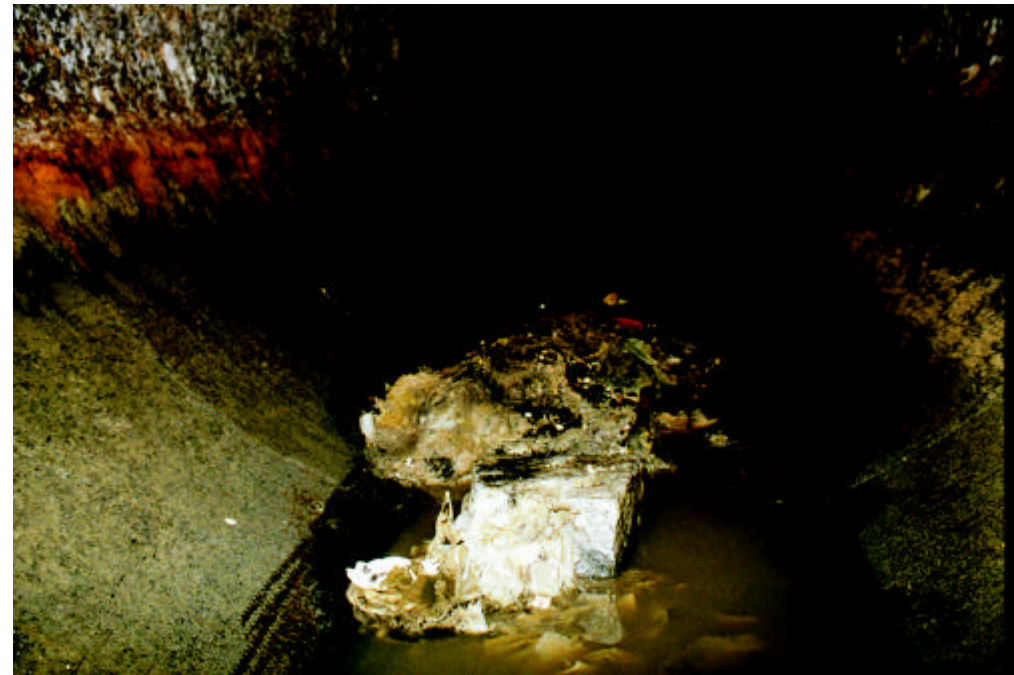
Photo #13:  
**Section 138, station 198+63, 7-foot diameter sewer, West Roxbury-Below McDonalds parking lot. Top of pipe 17 - feet below surface. Debris at sewer invert. Corrosion above water line.**

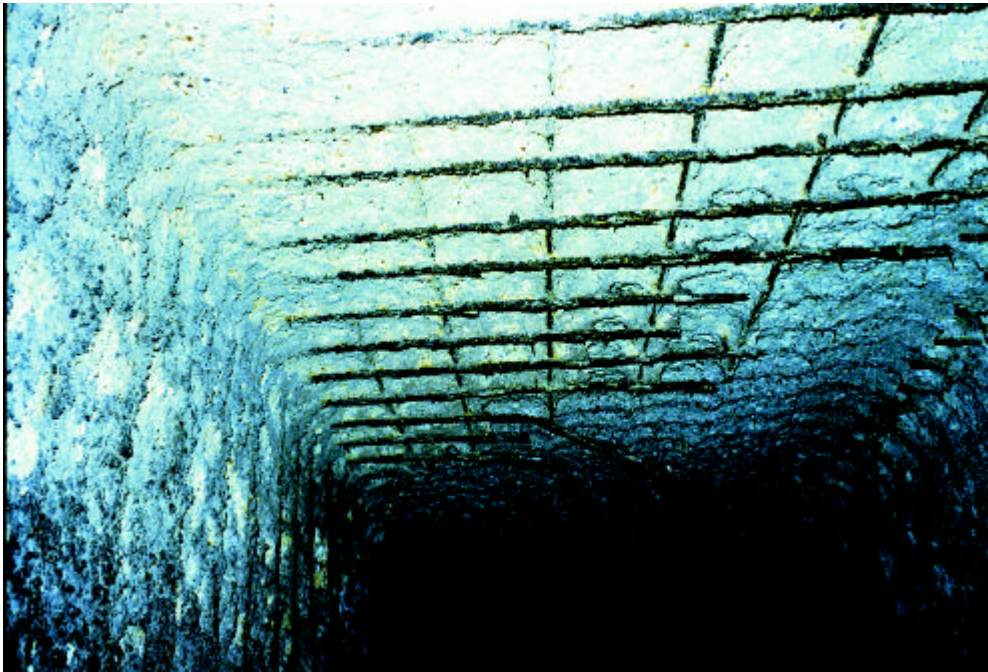
Photo #34:  
**Section 137 Drop Chamber - Top of  
roof slab 20 feet below New Haven  
Street - Significant deterioration of  
18 - inch roof slab. Steel reinforcing  
severely compromised.**

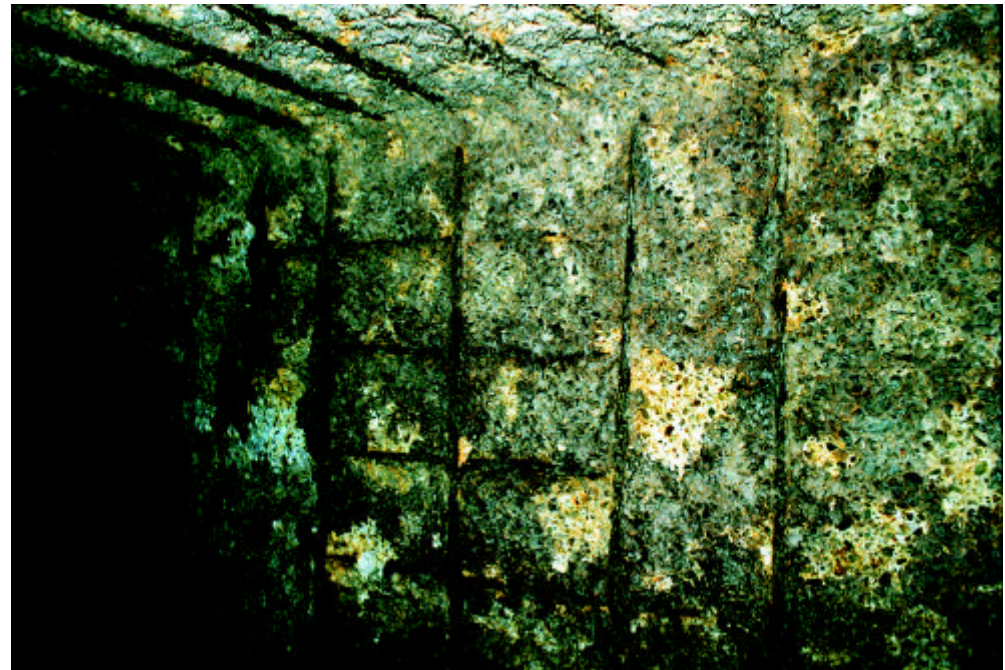
Photo #35:  
**Section 137 Drop Chamber - Top of  
roof slab 20 feet below New Haven  
Street. Significant deterioration of  
roof slab and south wall.**
