Presentation to

WSCAC

Status of MWRA Water System Dams

May 16, 2017

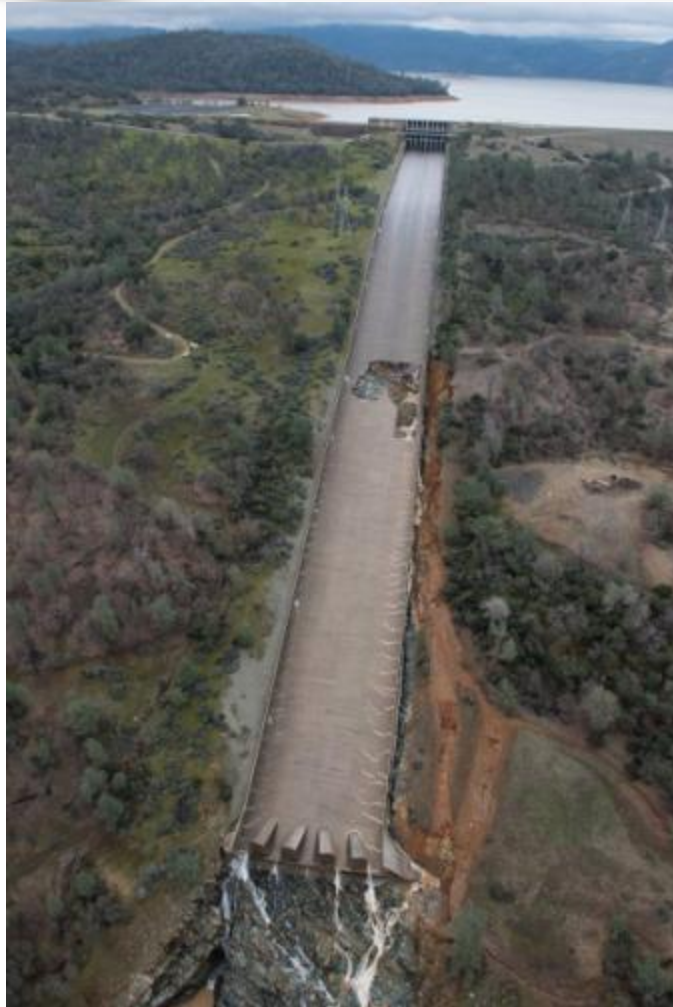
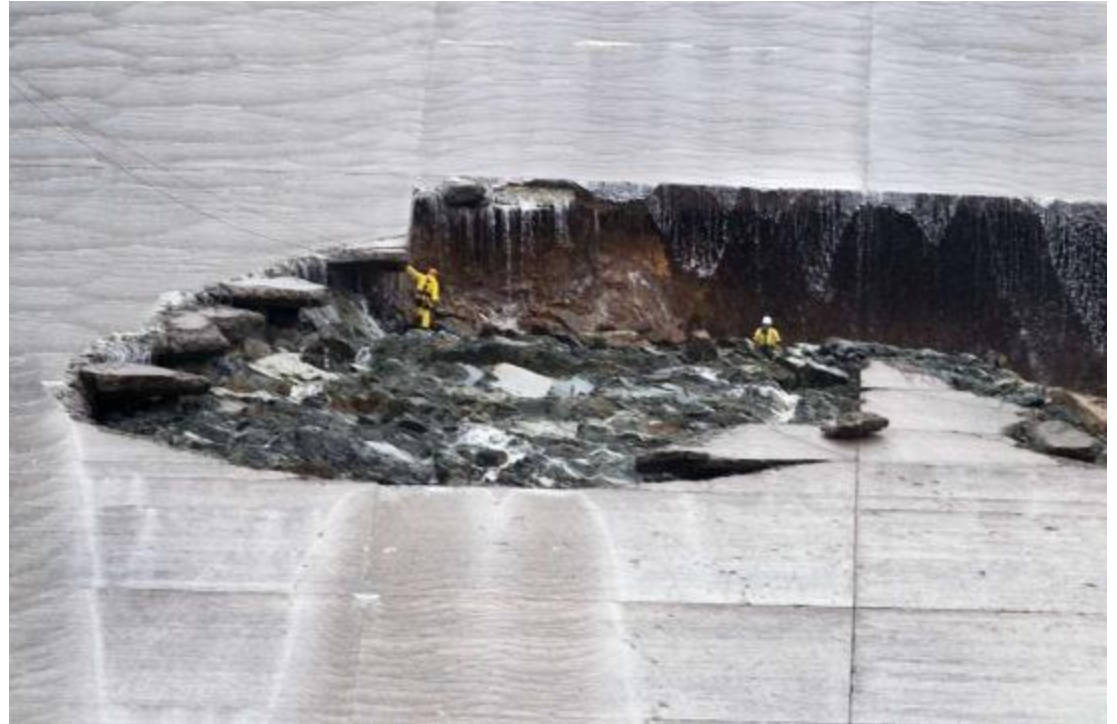
Problem began with a primary spillway failure

Spillway bedding undermined and progressive failure

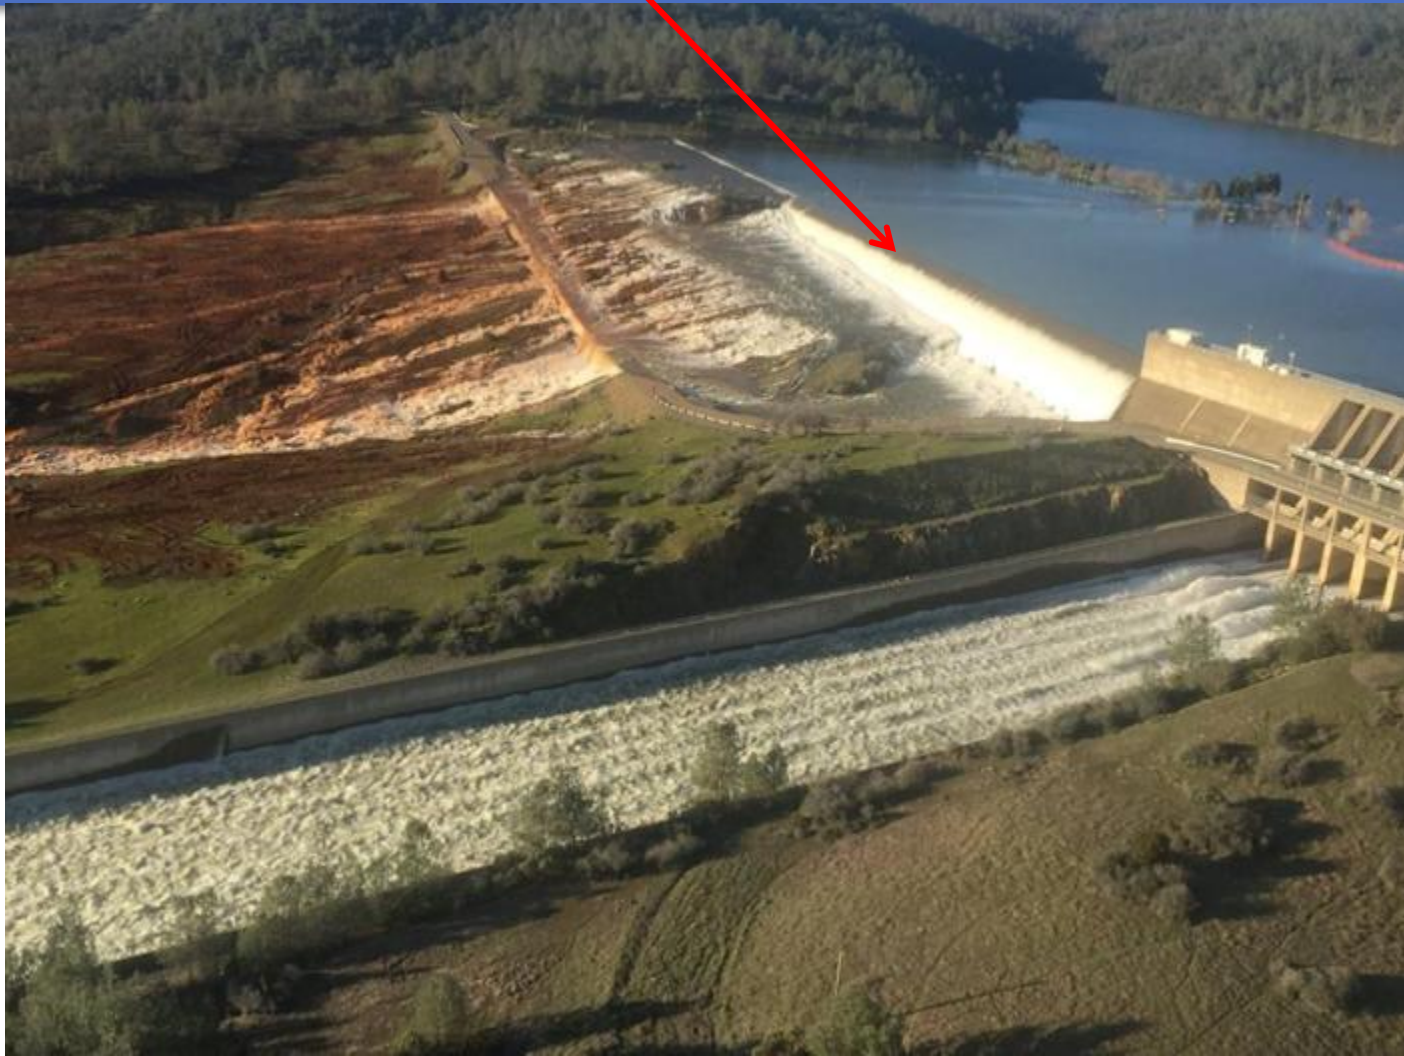
Emergency spillway activates for the first time

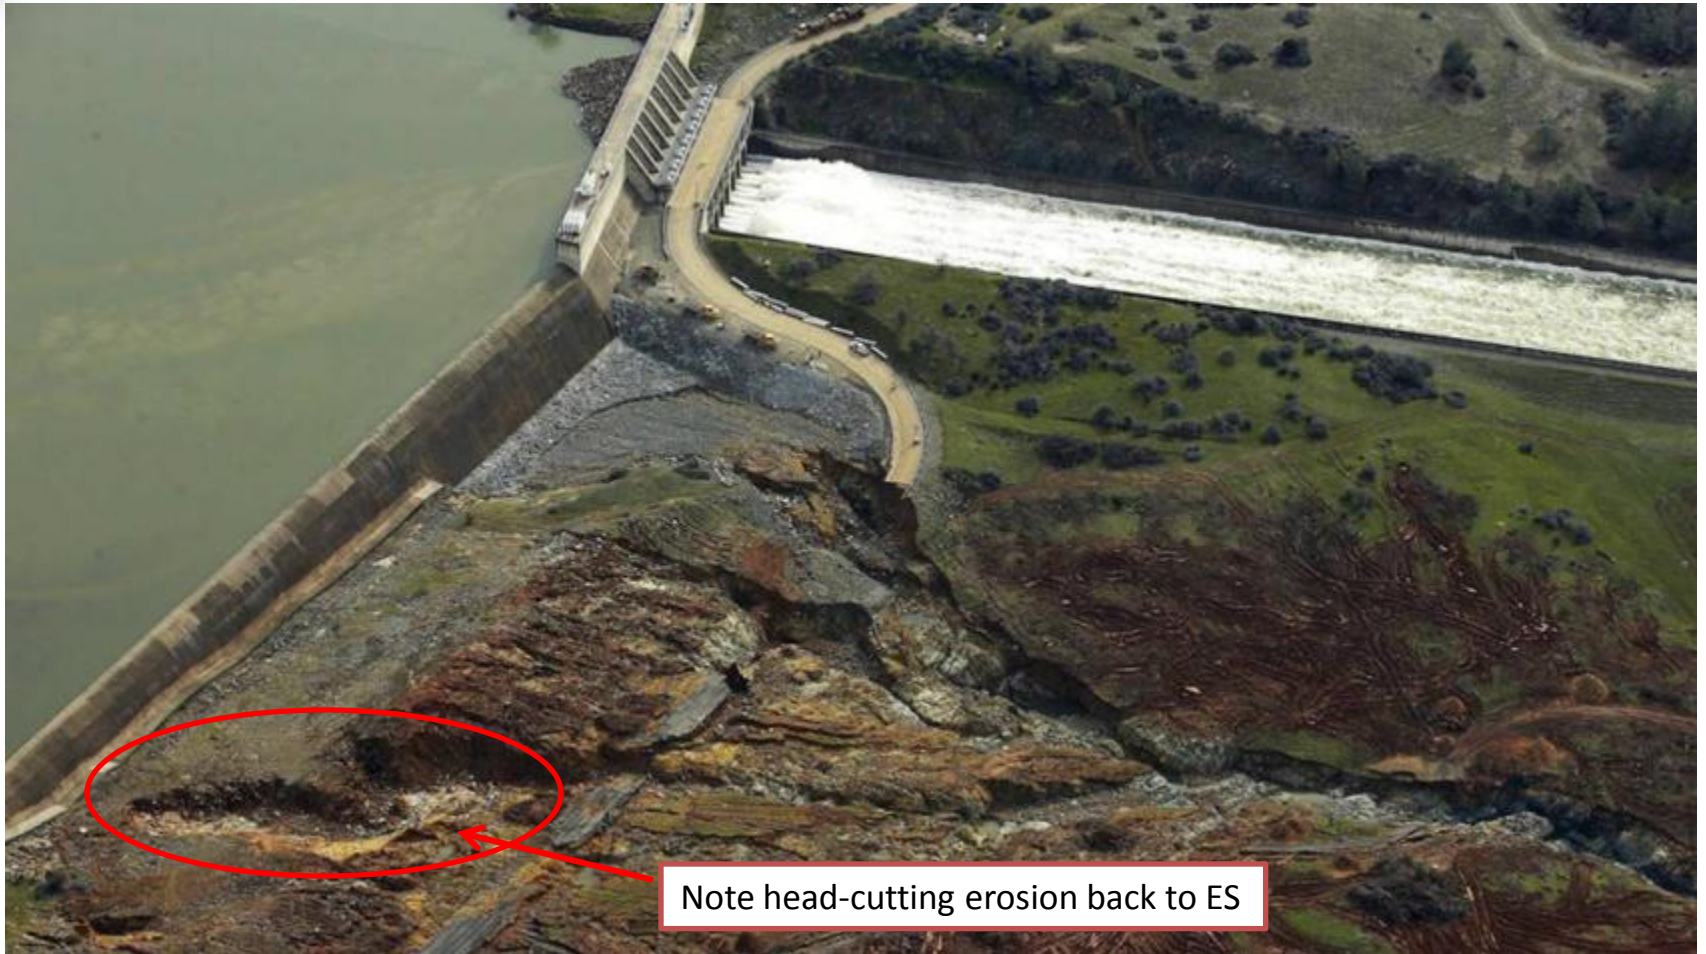
Downstream of Emergency Spillway severely eroded

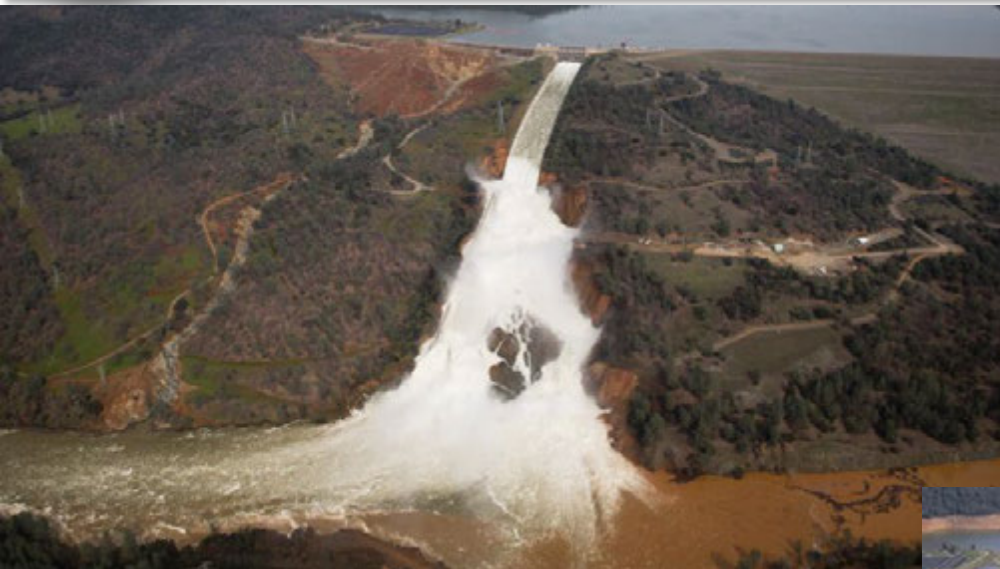
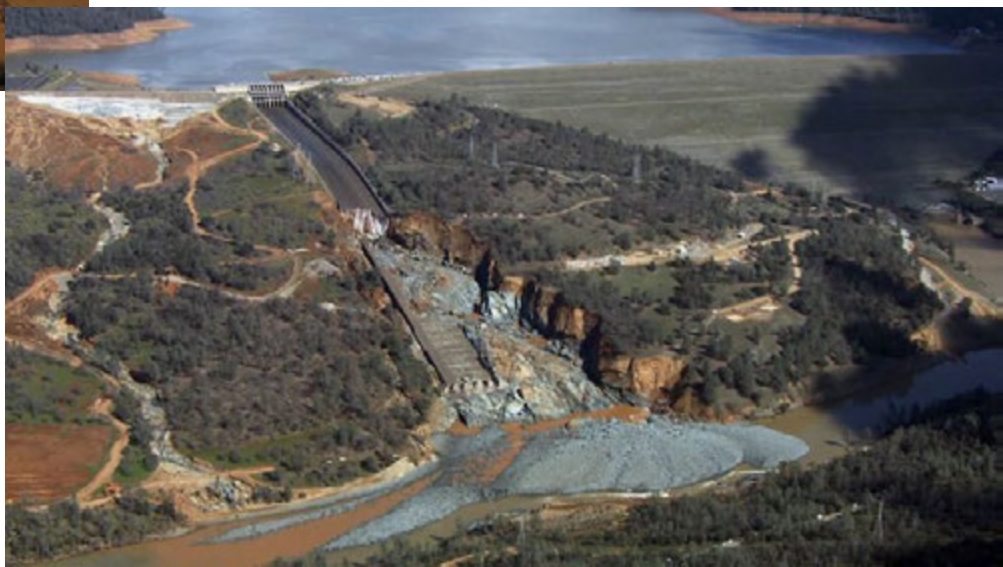
Primary Spillway Damage

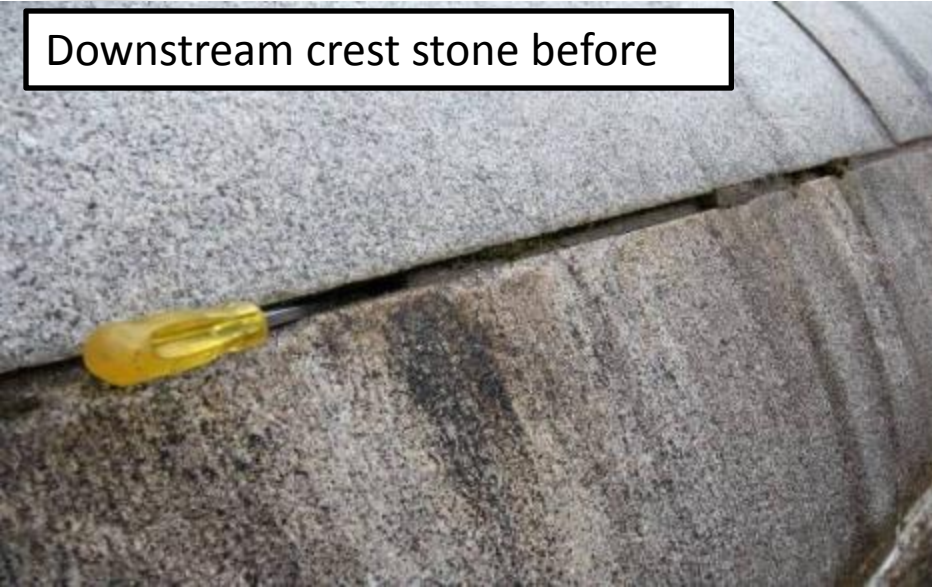
Downstream crest stone before

Quabbin Spillway Repointing and Grouting 2010

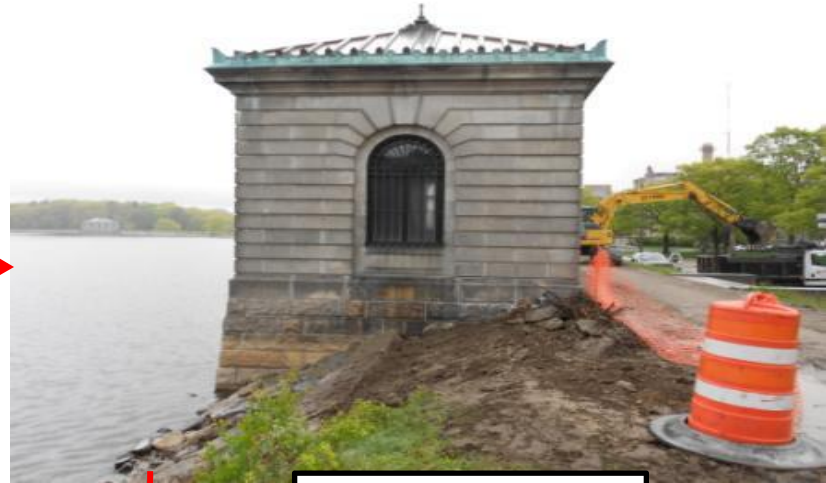
Missing riprap
