MASSACHUSETTS WATER RESOURCES AUTHORITY

Board of Directors Report

Key Indicators of MWRA Performance

Third Quarter FY2014

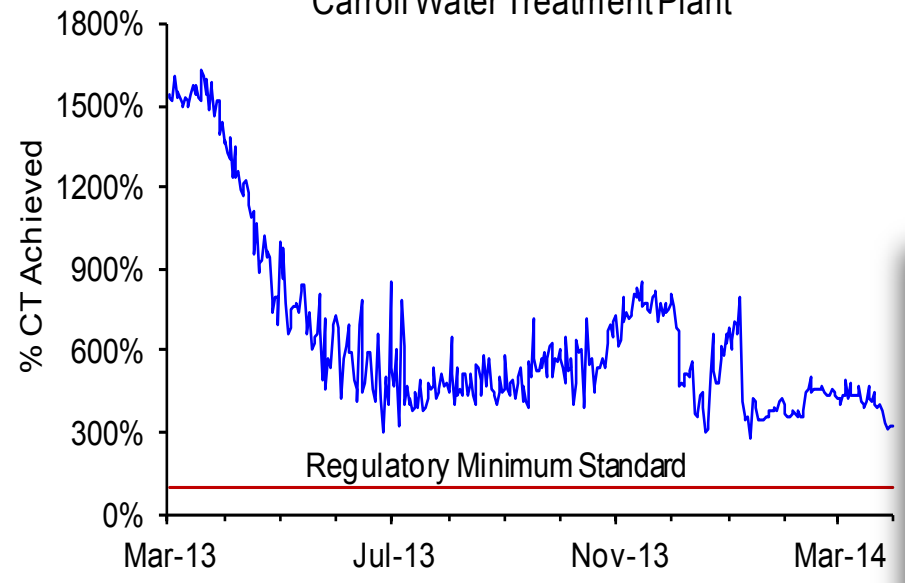
***Giardia* CT Percent Achievement**
Carroll Water Treatment Plant

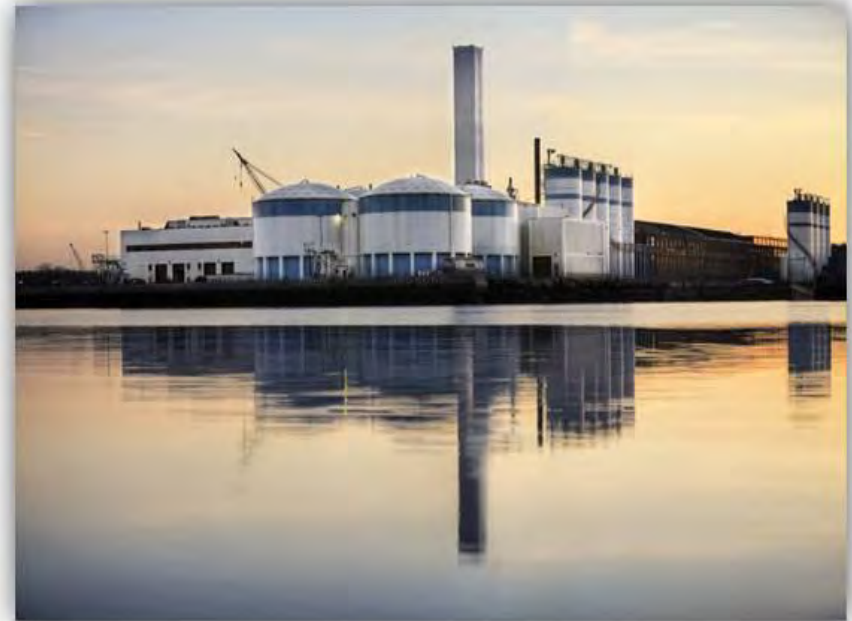
Pellet Plant – Contract O&M Since 1991

- Process 103 Dry Tons/Day
 - Receive Digested Sludge
 - Dewater with Centrifuges
 - Dry with Thermal Dryers
 - Produce Class A Fertilizer Pellet
- Develop and Maintain Diverse Markets for beneficial reuse
 - Land Application
 - Fertilizer Blenders
 - Alternate Fuels
- Maintain Facility and Equipment

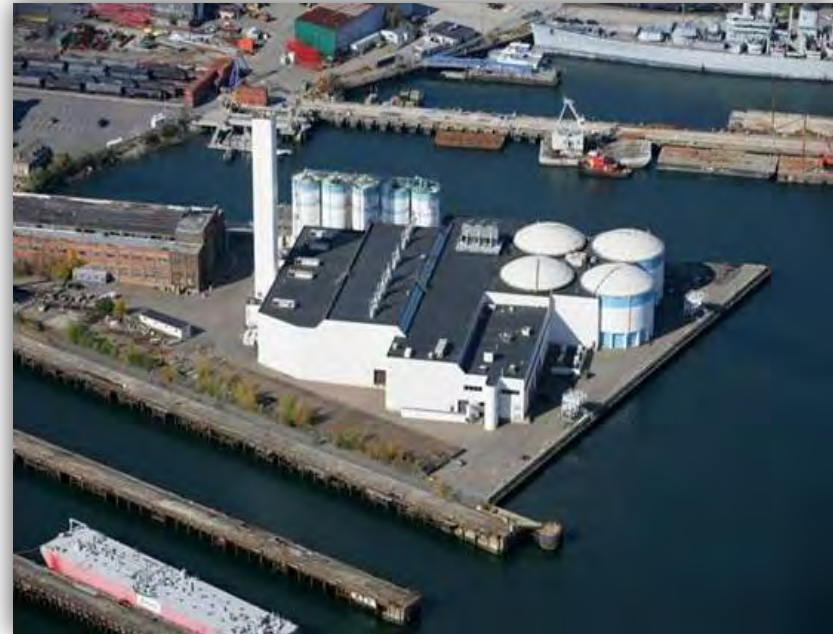
Pellet Plant – Contract Renewal Preparation Step 1

Condition Assessment Findings

- Facility is in excellent condition
 - 20-year life remaining
(with continued maintenance)
- Some Electrical Equipment Outdated
 - NEFCo replaced all but one PLC
 - NEFCo replaced every centrifuge control panel

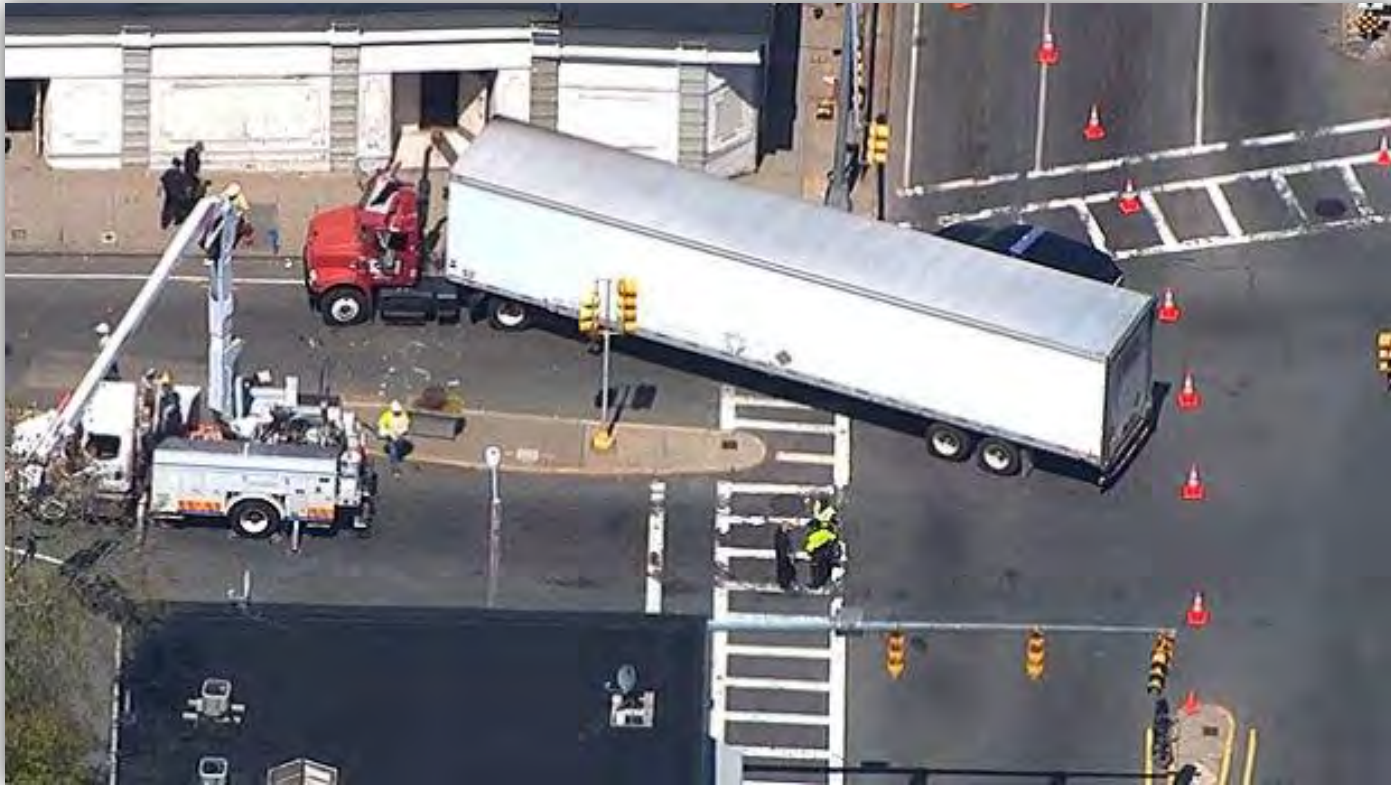
May 7 , 2014 Power Outage

- Initiated by truck accident

- Unique outage:
 - Power went out and came back on several times in a 15-minute window
- Equipment Damage:
 - Four centrifuge 300 hp variable frequency drives damaged
- All Impacted Equipment Repaired within 5 days
 - One unit repaired, three units replaced under warranty
- No long term operational impacts
 - Short term disruption at Pellet Plant, no impacts to DITP Operation

- Pelletizing Plant susceptible to damage from major power failures
- NEFCo is working with OEM to prevent issue from reoccurring

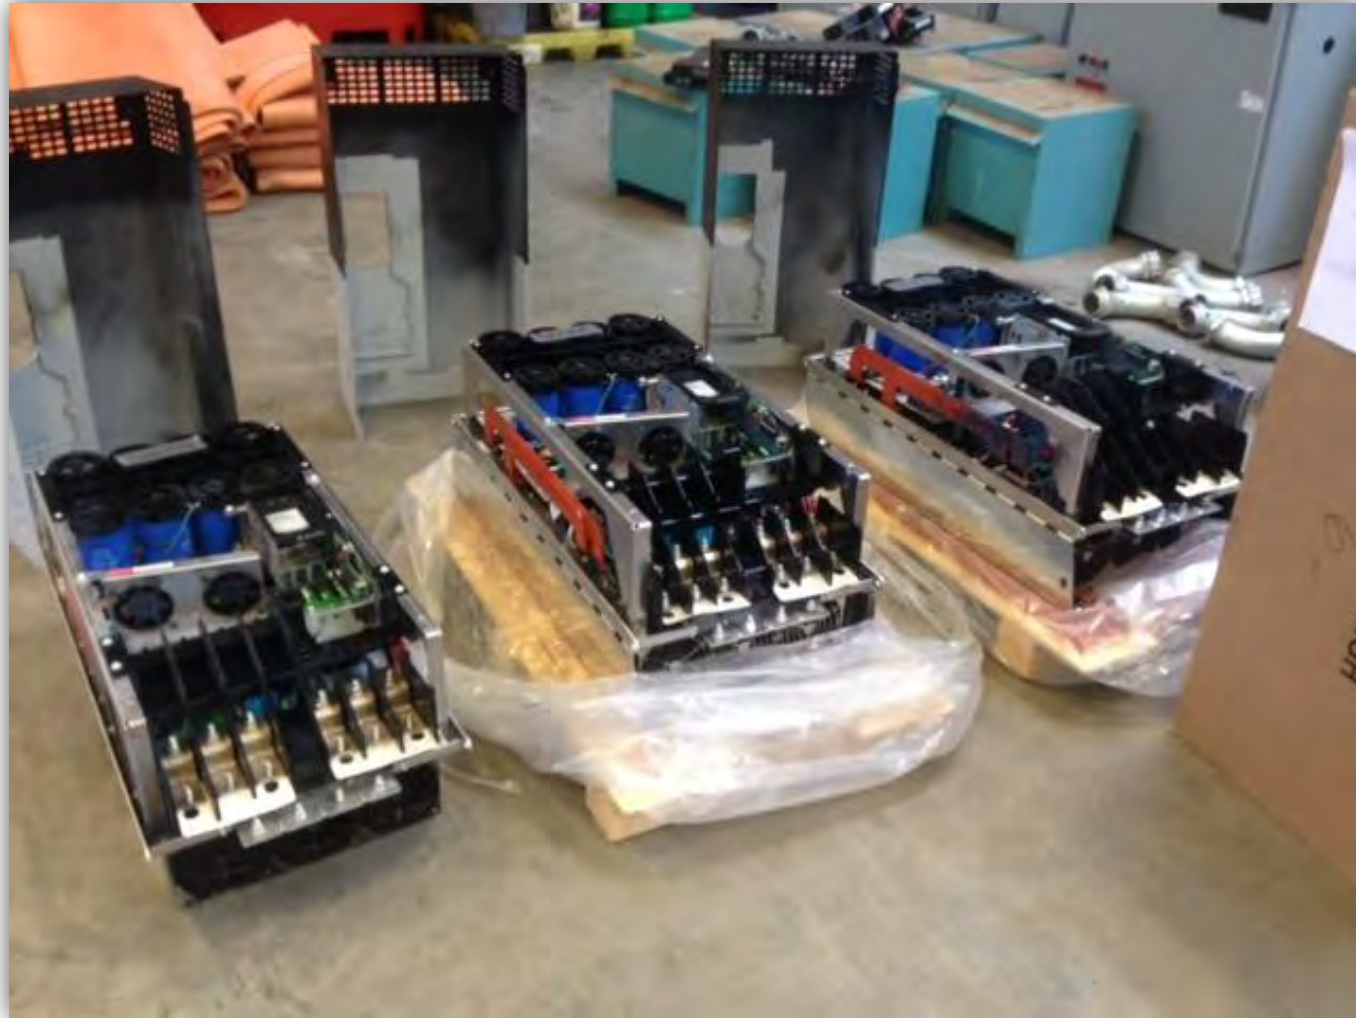
Scorching Visible on House of Damaged VFDs

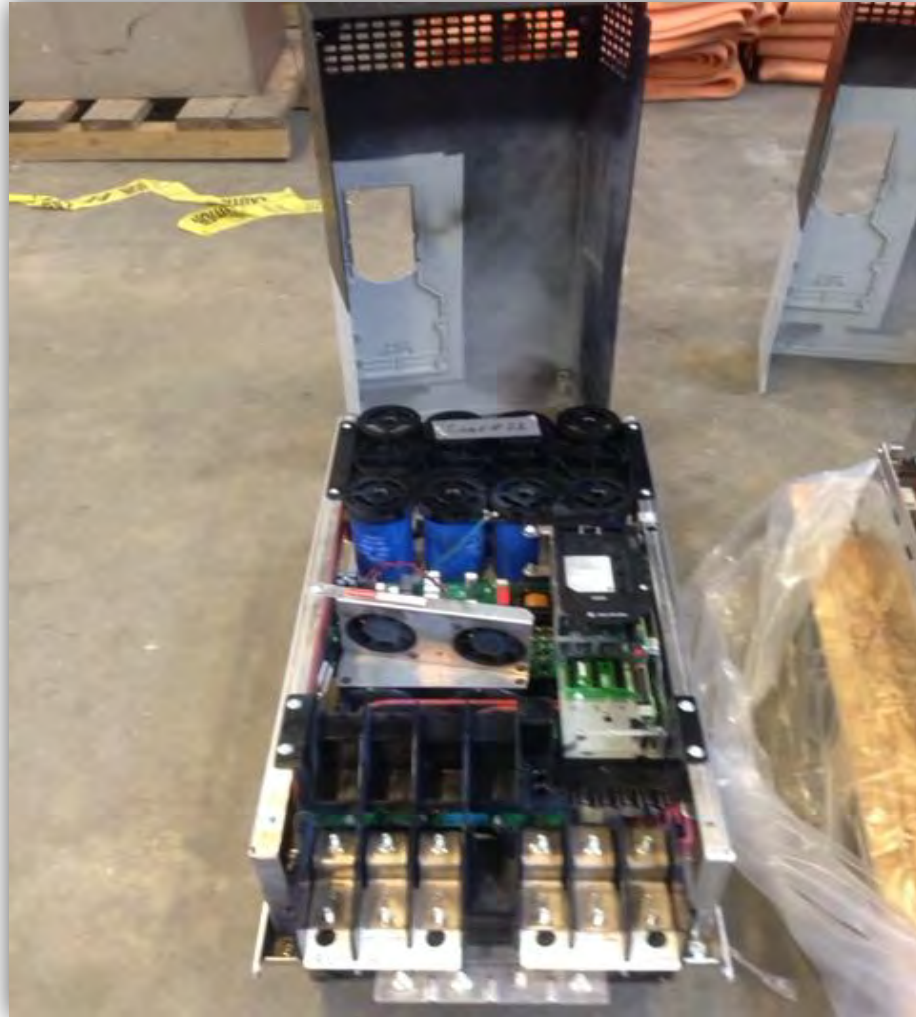
Centrifuge No. 11 VFD

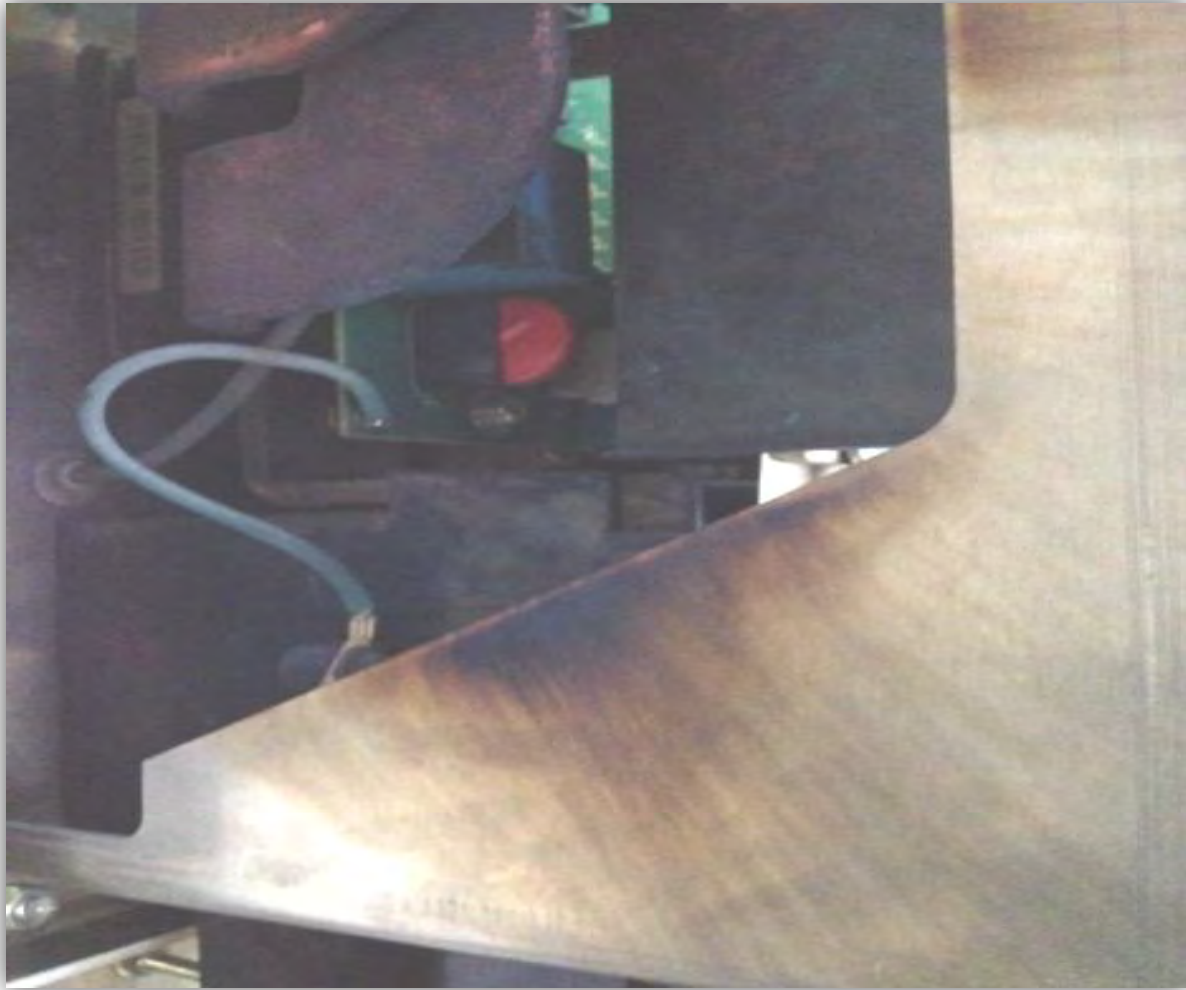
Damage to Centrifuge Panel No. 7

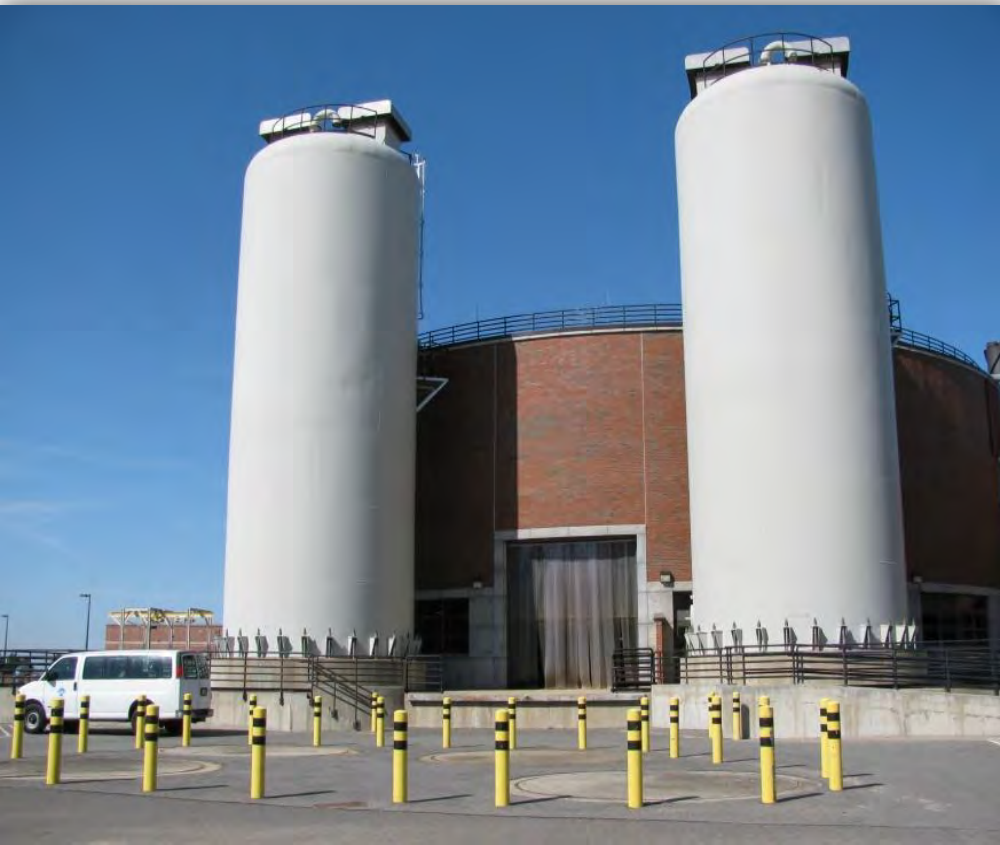
North Main Pump Station

Receives the North Sewer System Flow from Boston Main Drainage Tunnel and North Metropolitan Relief Tunnel

Facility capacity is 788 MGD

Ten 3,500 hp Raw Wastewater Pumps rated at 110-150 MGD each

RWW Pumps, Piping and Valves installed during Boston Harbor Project in 1995

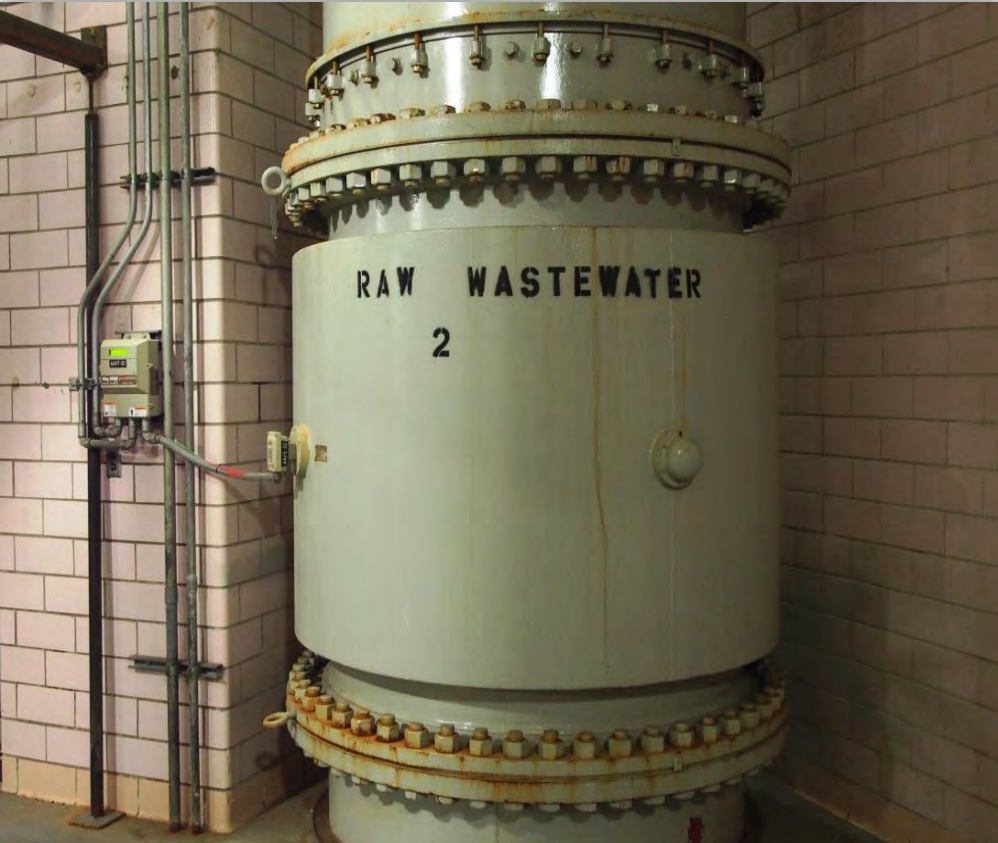
North Main Pump Station: Magnetic Flow Meters

- Ten 60-inch Magnetic Flow Meters located at Level B2
- Existing electronics for these flow meters are now obsolete

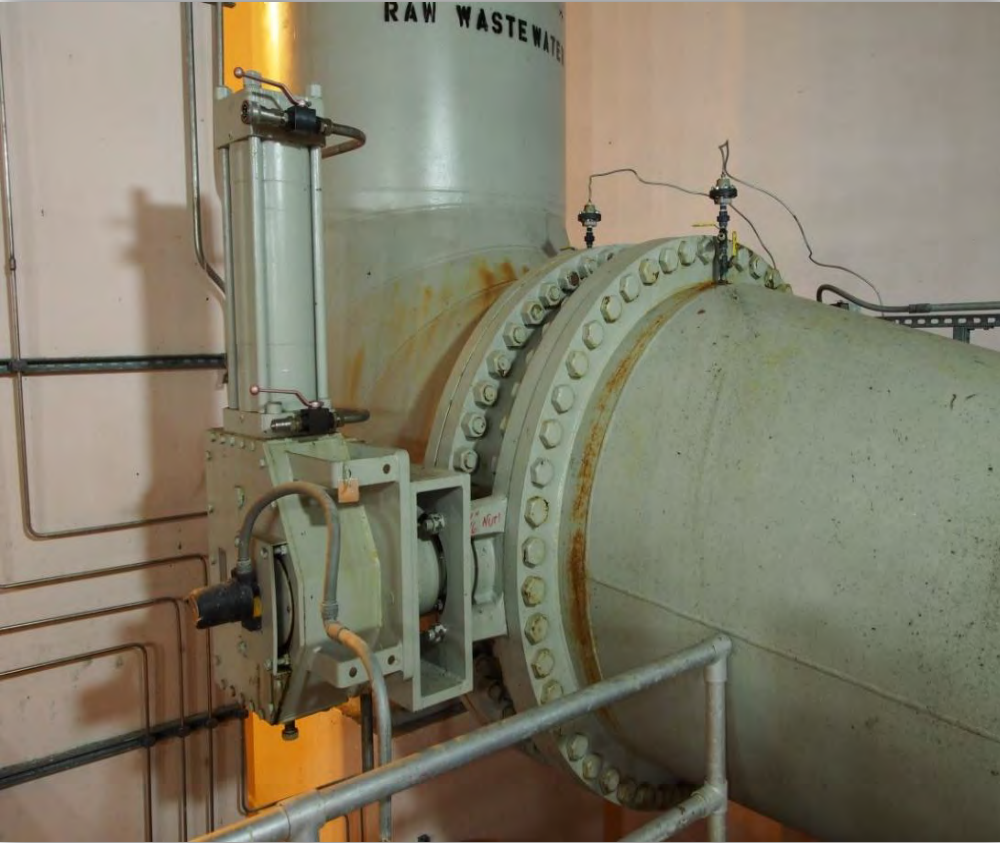
North Main Pump Station: Butterfly Check Valves

- Ten 60-inch Butterfly Check Valves located on pump discharge at Level B5
- These valves will be replaced while the 96-inch RWW header is isolated with a blind flange

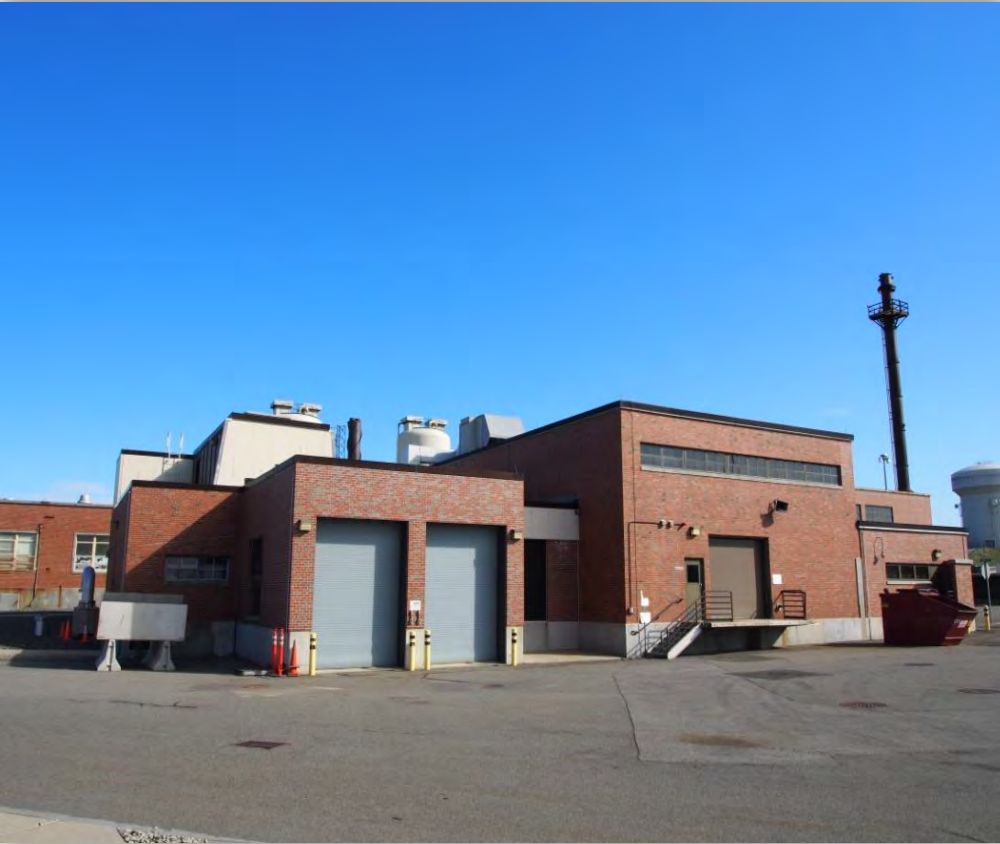
Winthrop Terminal Facility

Receives North Sewer System Flow from North Metropolitan Trunk Sewer

Facility capacity is 125 MGD

Six 600 hp Raw Wastewater Pumps rated at 32 MGD each

RWW Pumps, Piping and Valves installed during Boston Harbor Project in 1995

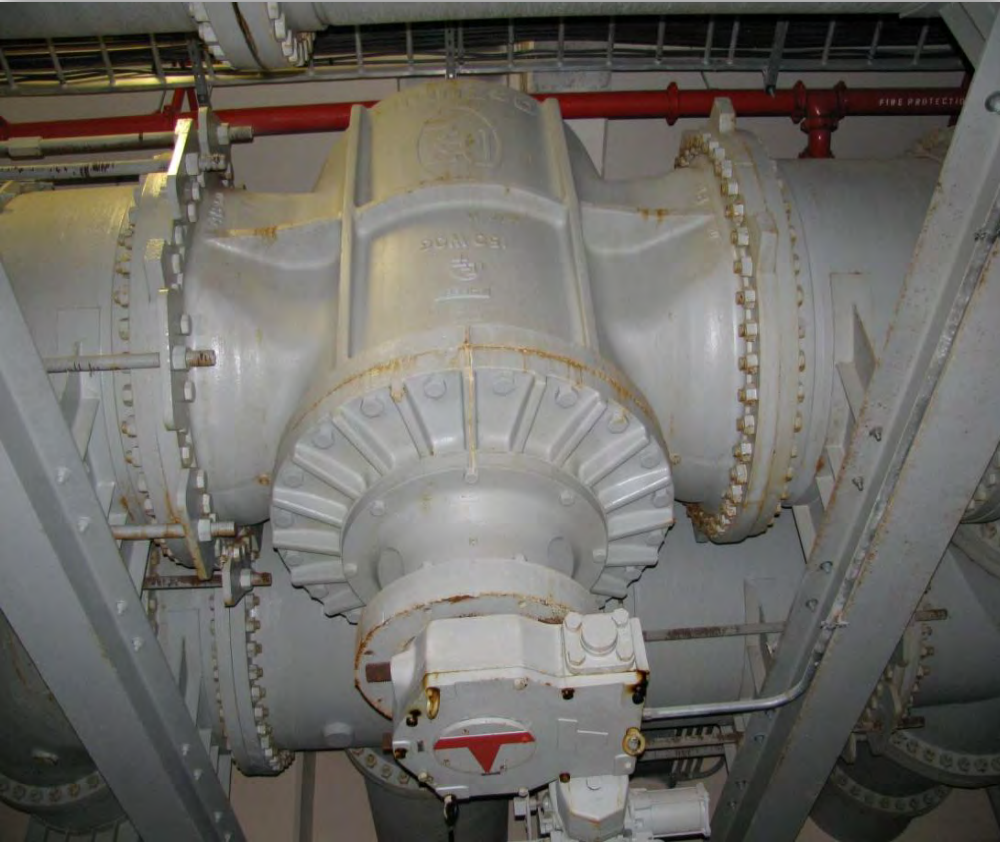
Winthrop Terminal Facility: Force Mains

- Three 48-inch Electrically Operated Plug Valves on WTF Force Mains
- Valves do not provide positive shutoff preventing safe isolation at facility

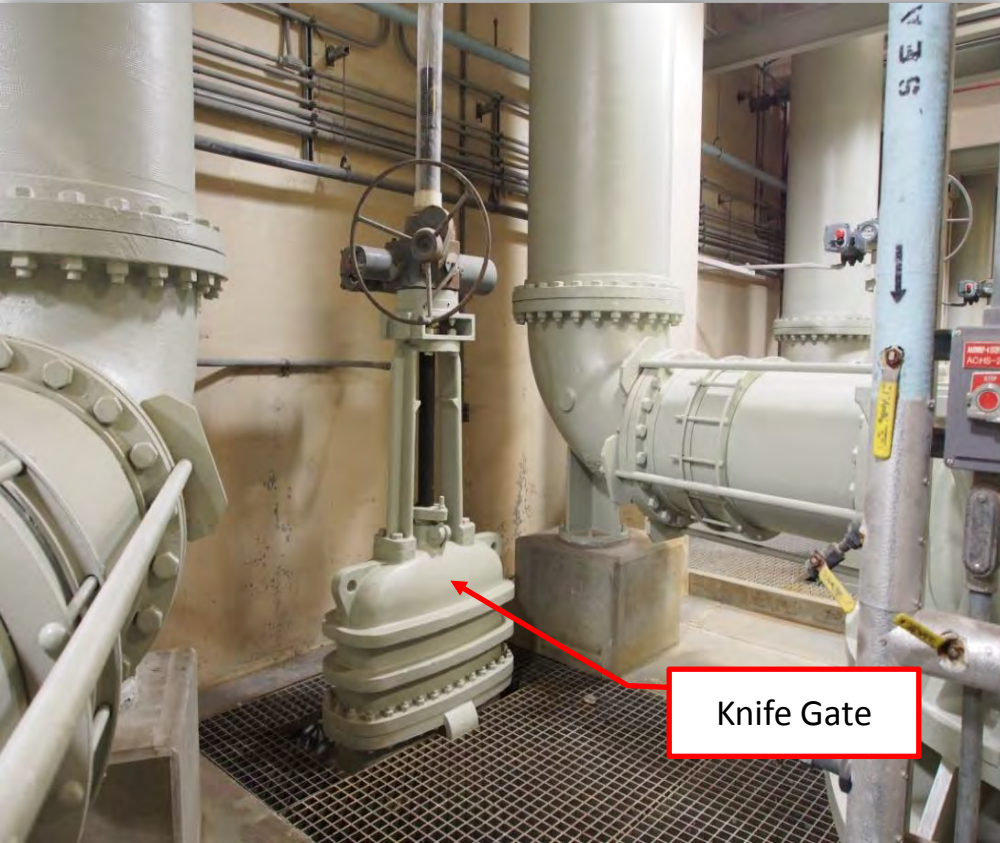
Winthrop Terminal Facility: Pump Suction

- Six electrically operated Knife Gates and Piping on RWW Pump Suction
 - Two 36-inch (#2&5)
 - Four 30-inch (#1,3,4,6)

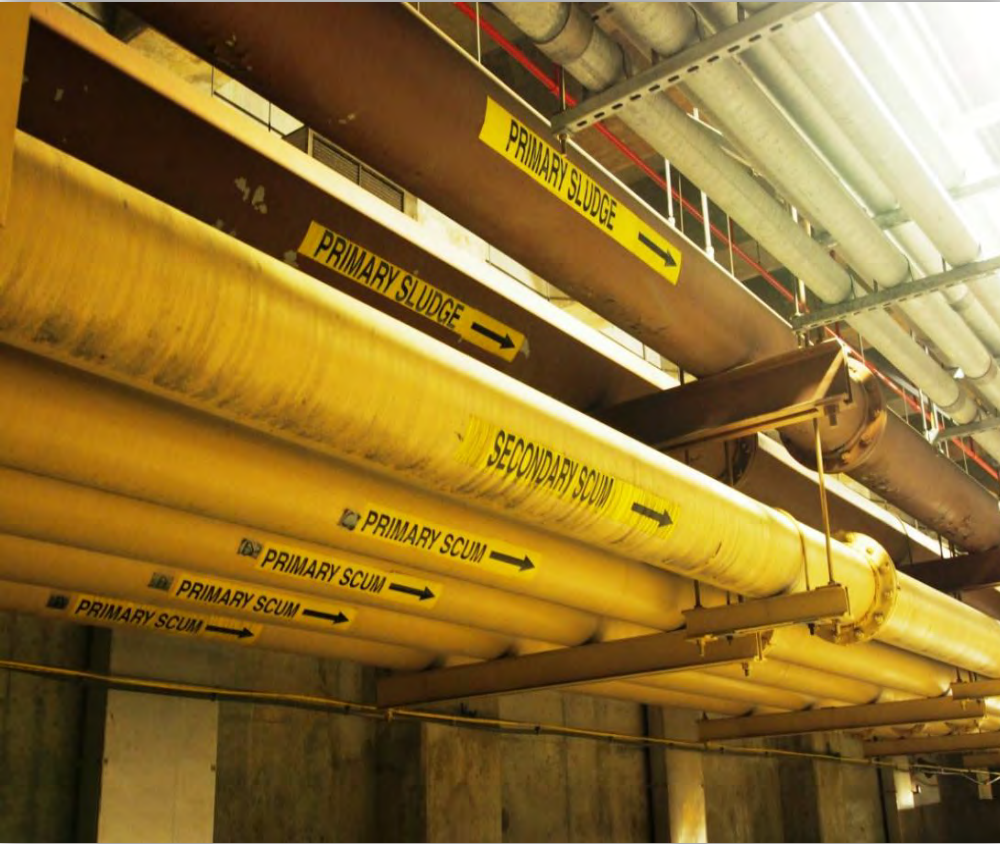
Primary Sludge and Scum Piping and Valve Replacement

- Replace ~6,500 linear feet of Primary Sludge Piping and 96 plug valves from Primary Clarifiers to Gravity Thickener Distribution Box (4" -14")
- Replace ~2,000 linear feet of Scum Piping and eleven plug valves in Residuals Connecting Gallery (10" - 12")

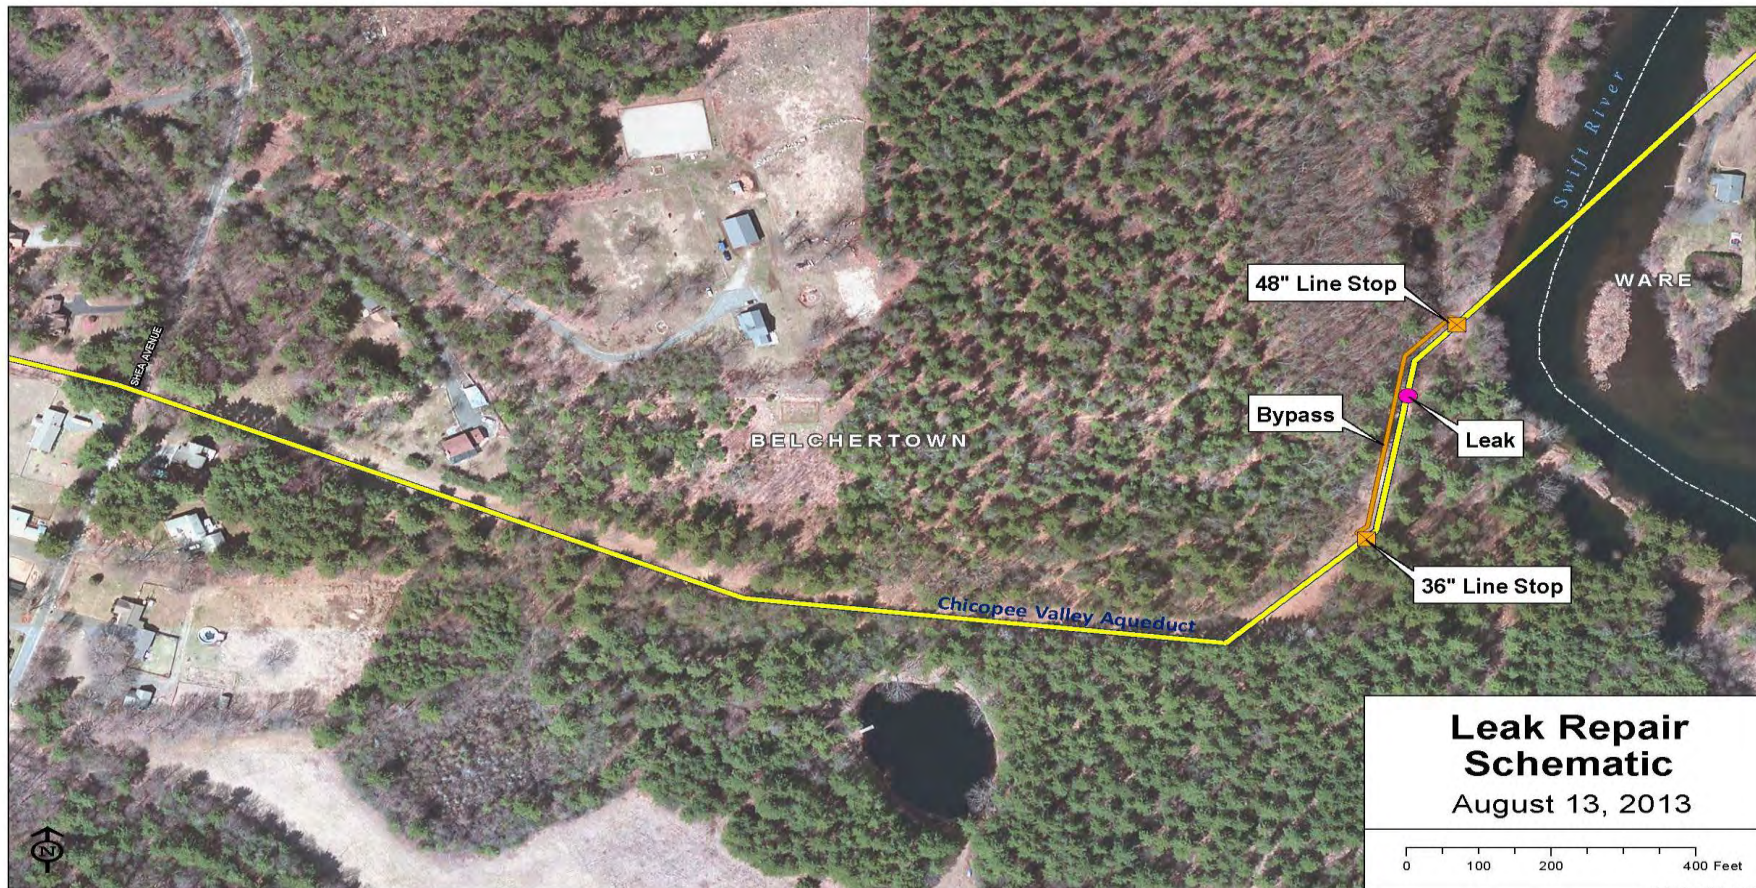
Leak Repair Schematic

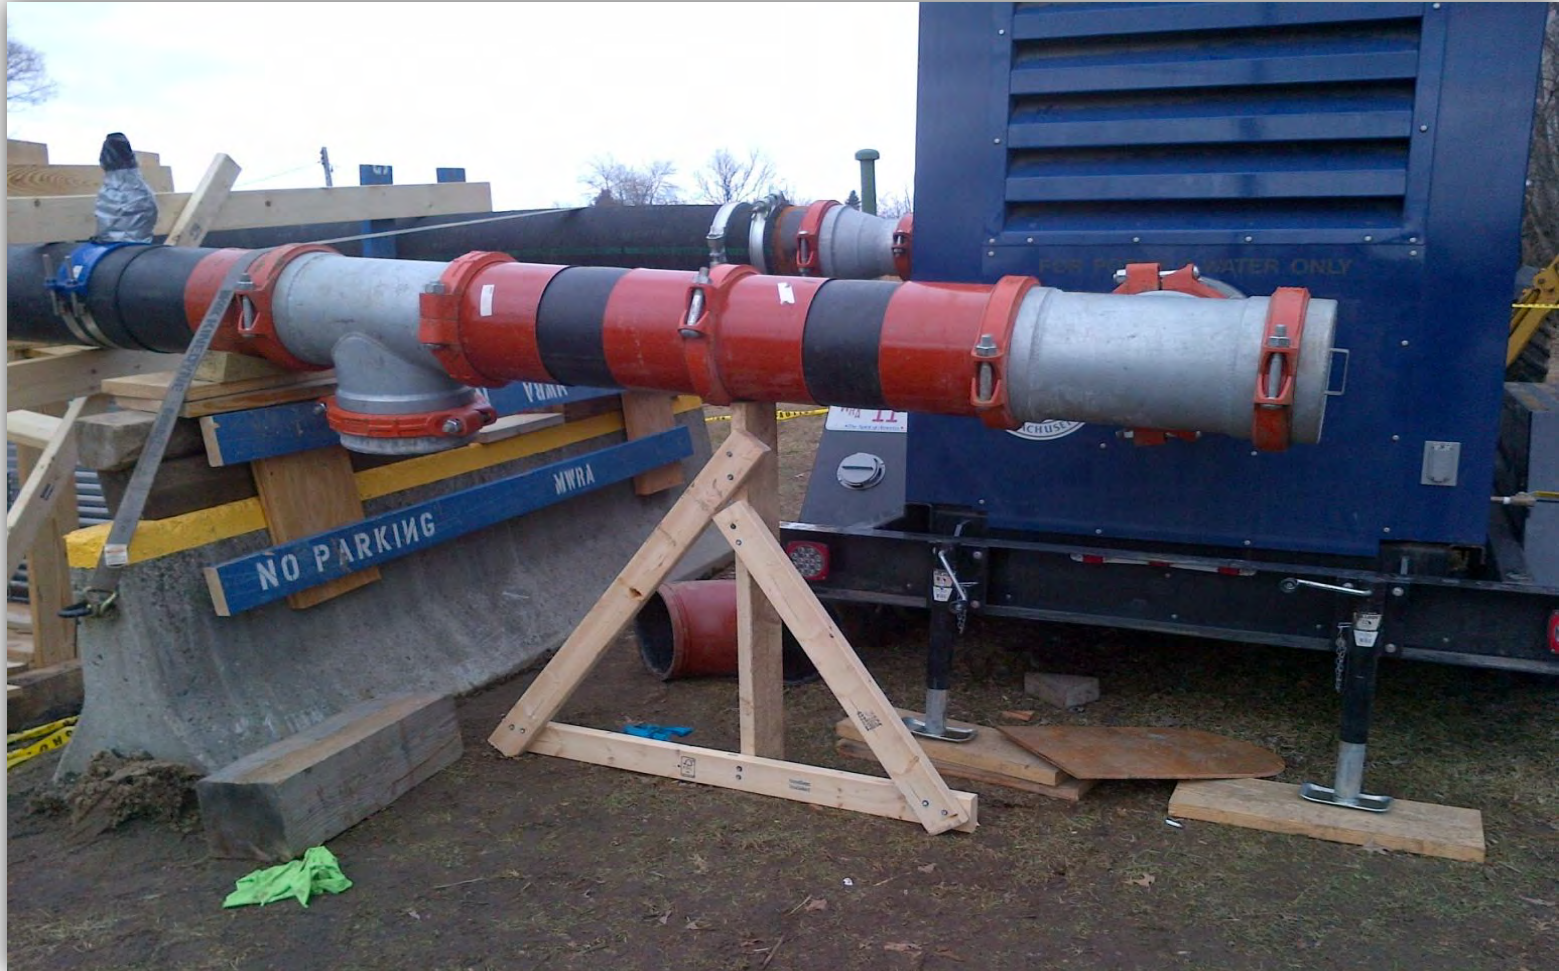
50

CVA Emergency Connection, West Street, Ludlow

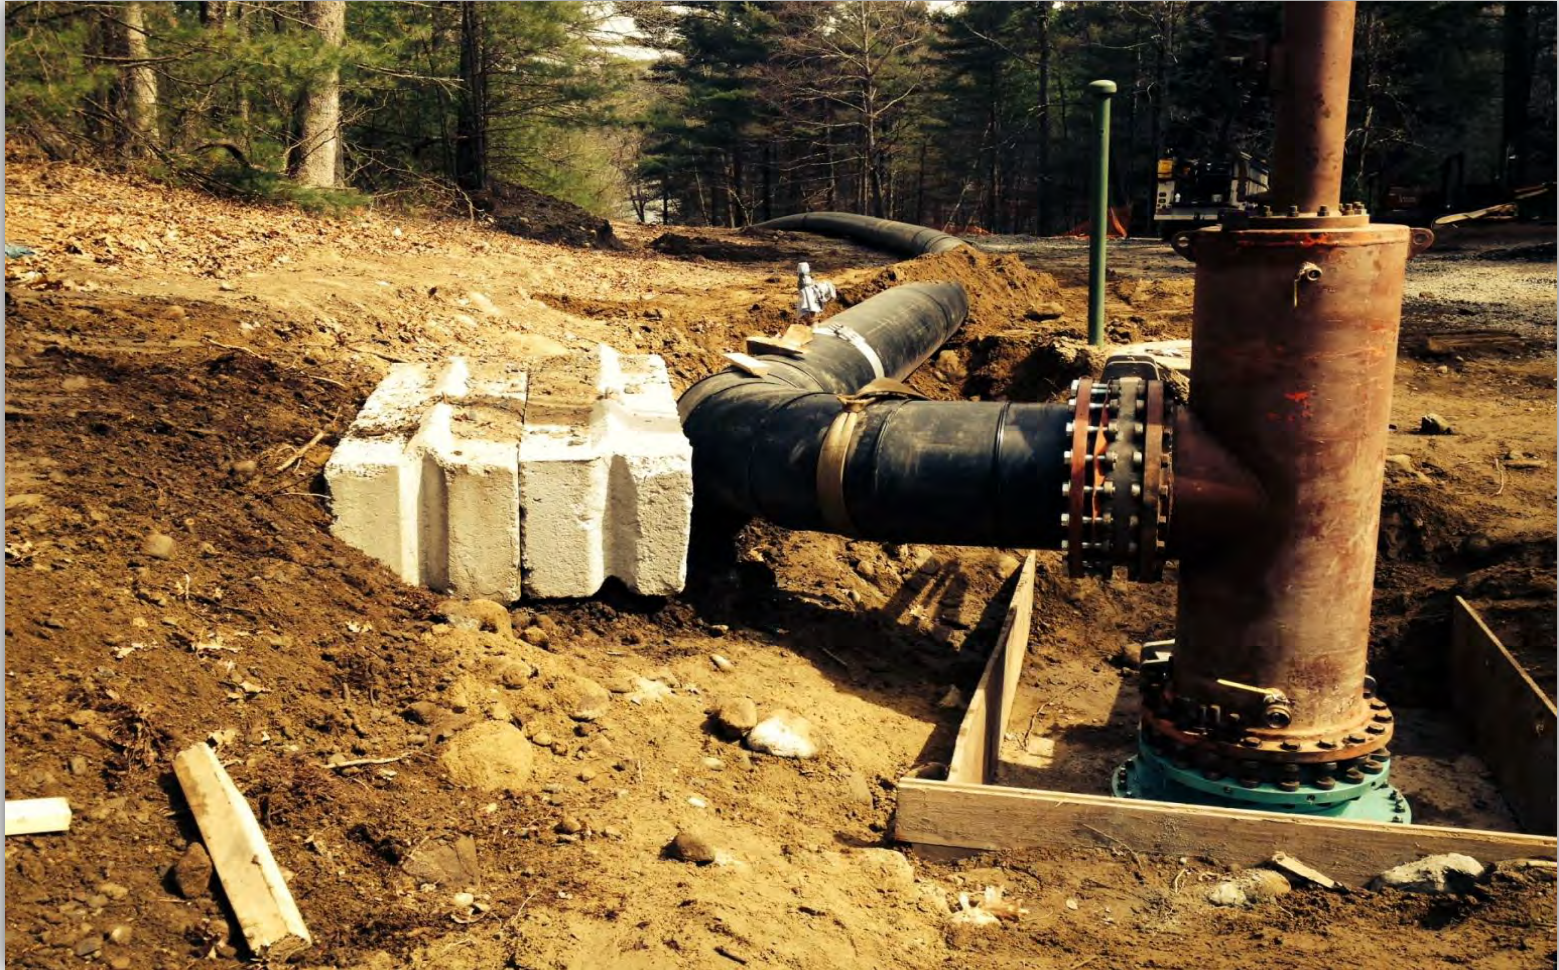
36-Inch Linestop And 24-Inch Bypass

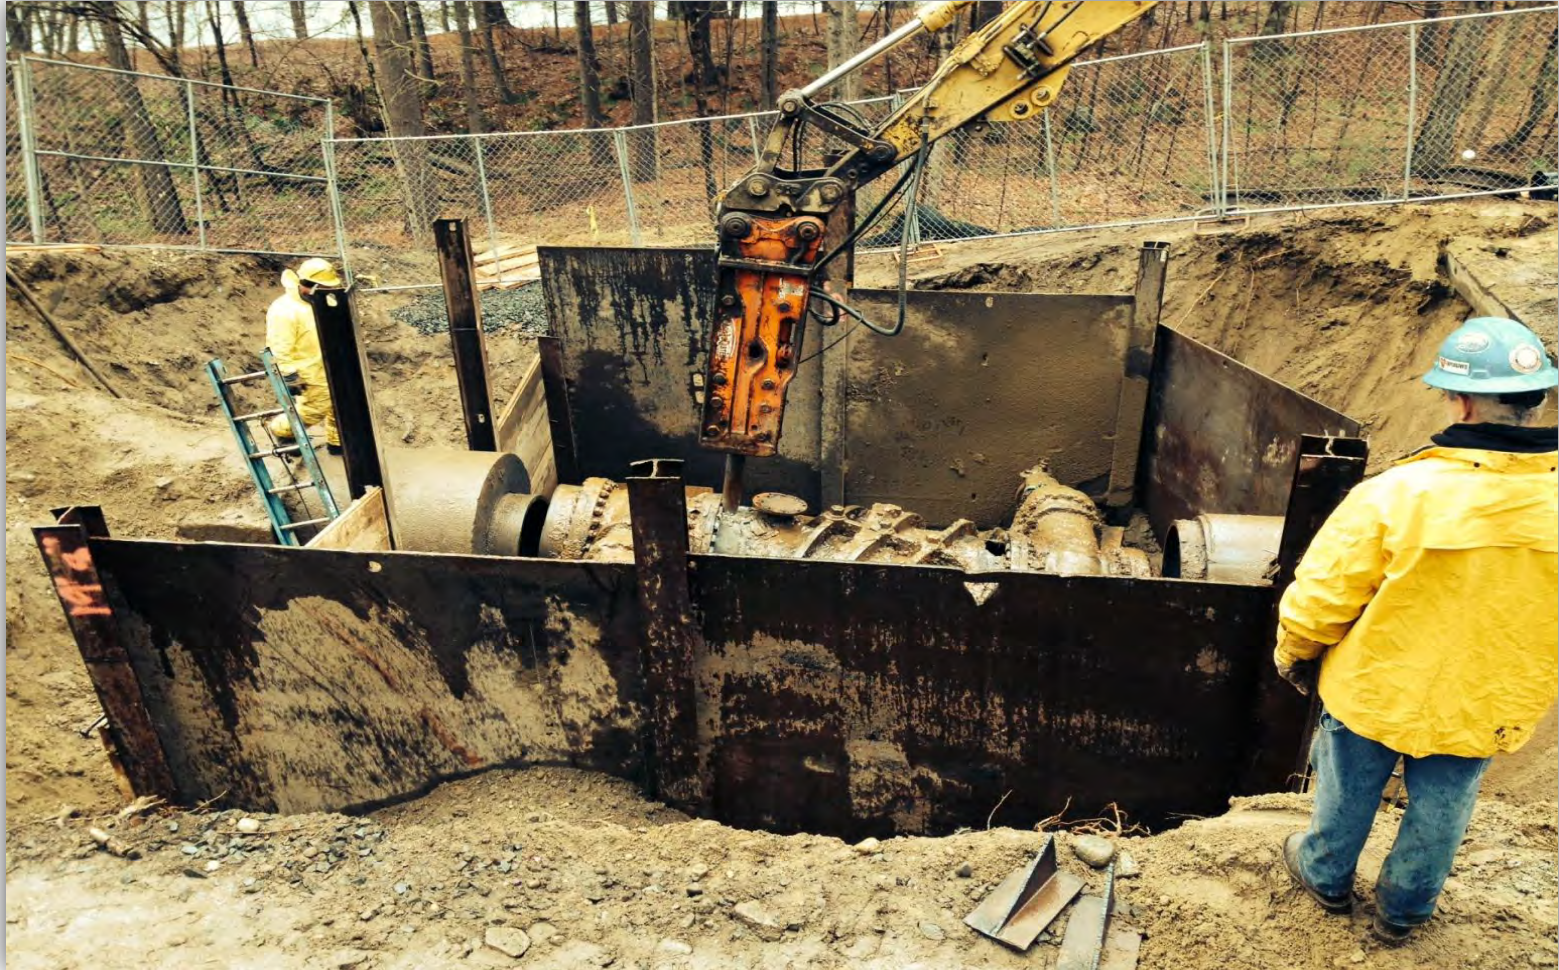
52

Demolition Of Existing Valves And Fittings

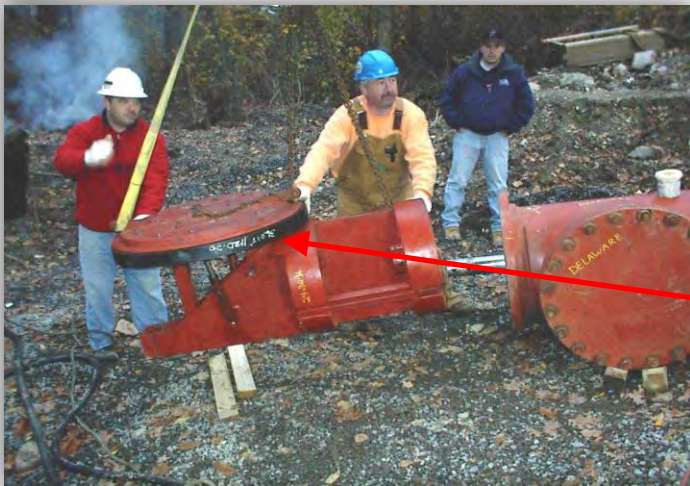
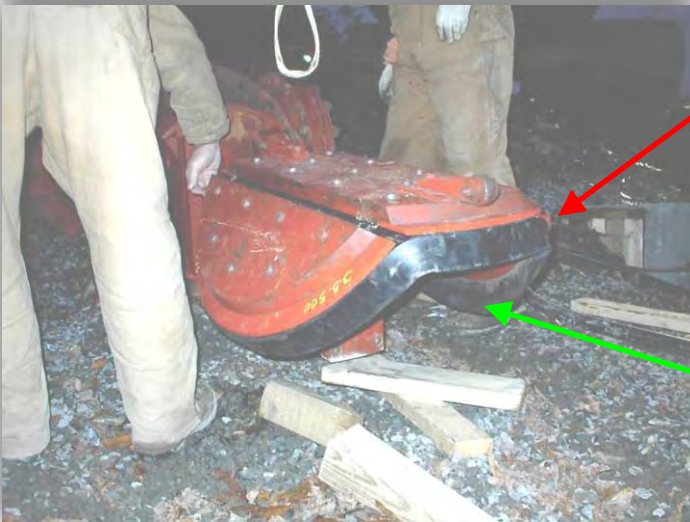
How The Linestop Works

36" diameter folding head allows for insertion through 24" hole. When fully inserted the leafs fold completely out. The pressure side of the stopped main is behind the gasket and folding leafs making an even tighter seal.

Live side of main when deployed

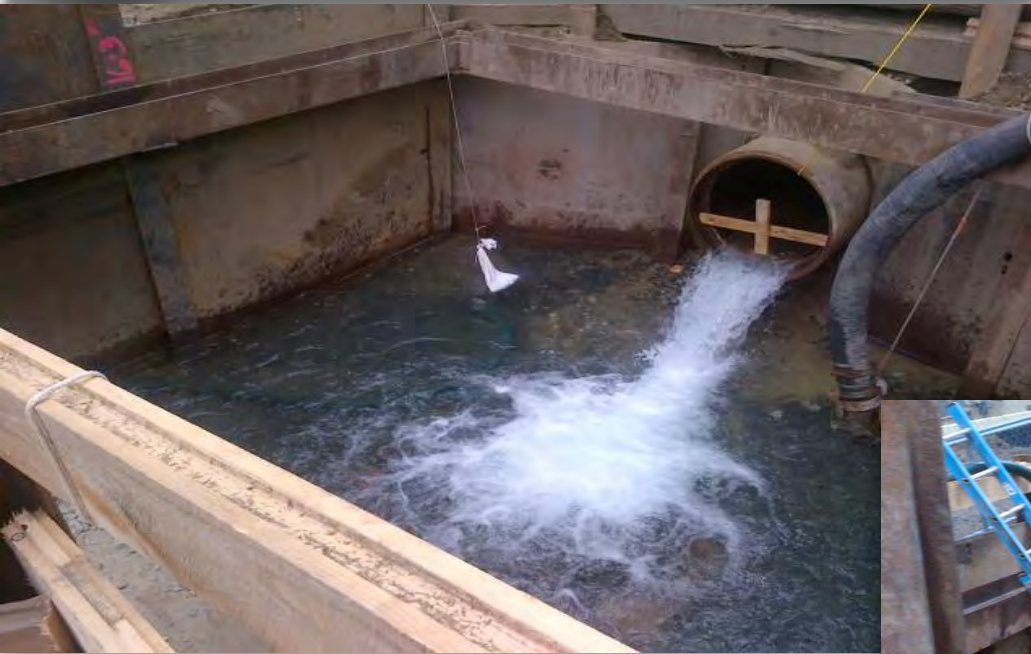
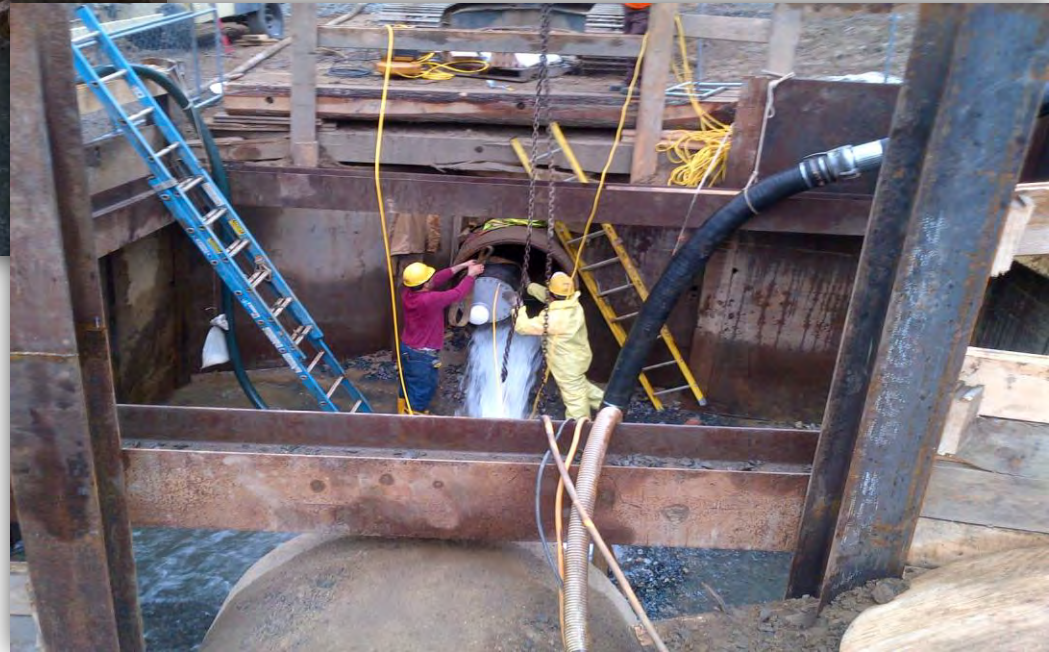
36-Inch Bag Installation

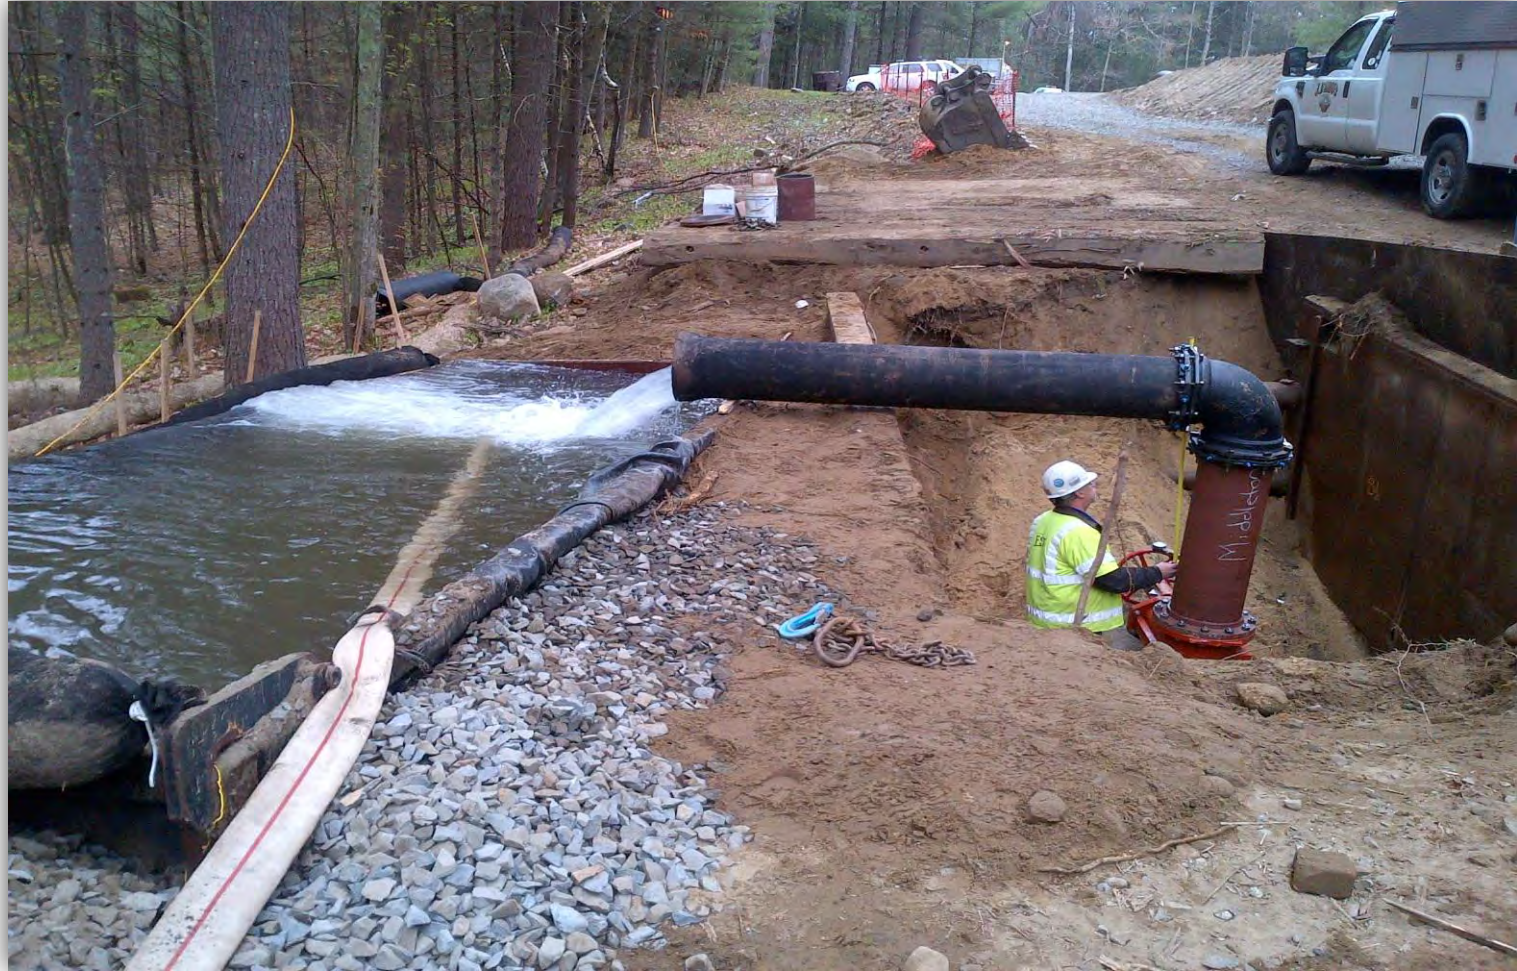
12-Inch Outlet To Relieve Pressure On Bag
