MASSACHUSETTS WATER RESOURCES AUTHORITY

Board of Directors Report

Key Indicators of MWRA Performance

Third Quarter FY2014

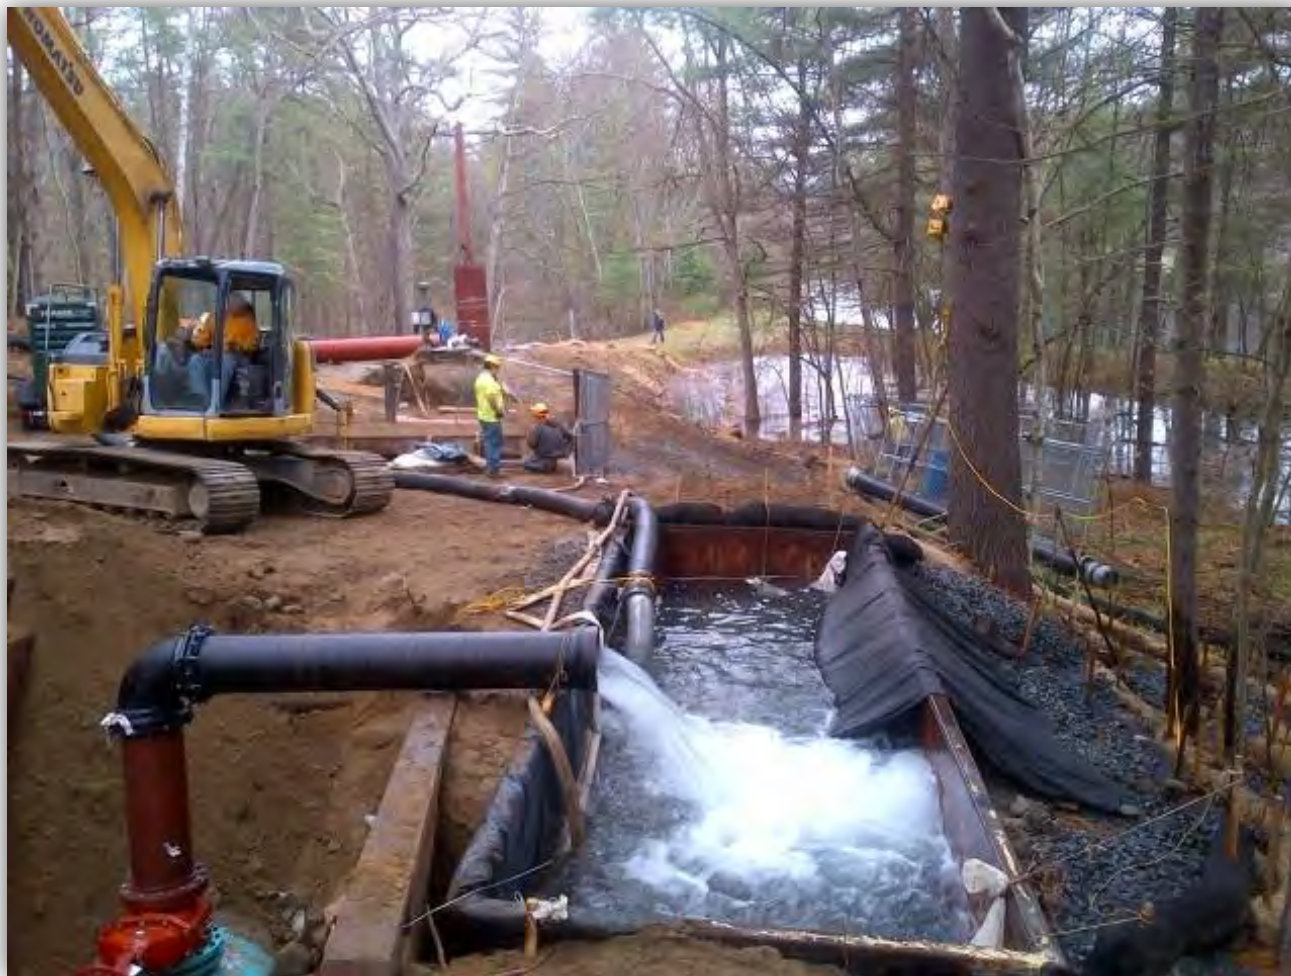
Leakage Control

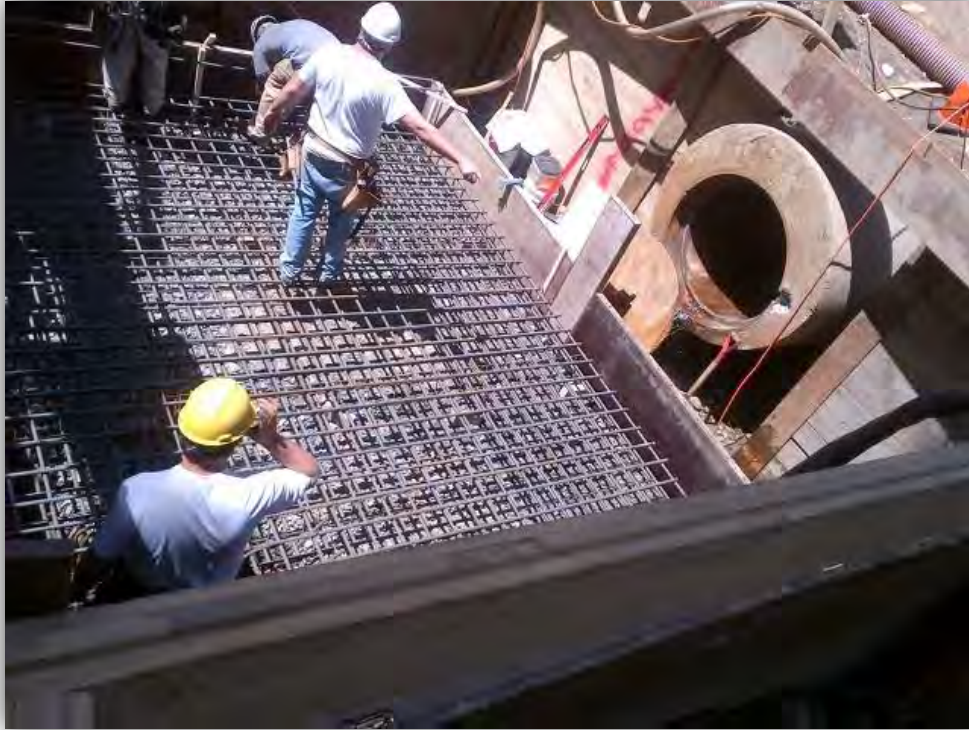
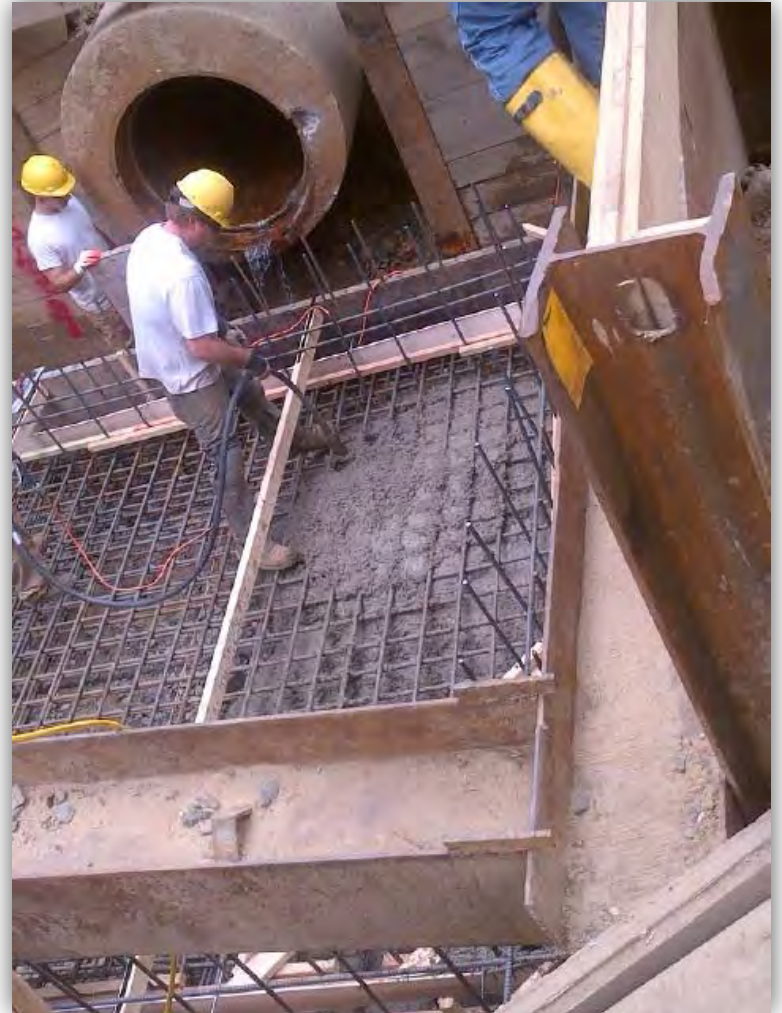
Pouring Concrete Floor
