***Automated Vehicle Locator
Tracking System
Contract A606***

***Annual Industrial Waste Report
TRAC***

***MWRA's Outfall Monitoring Overview
2015 Results***

***Chemical Incident at the
Clinton Wastewater Treatment Plant***

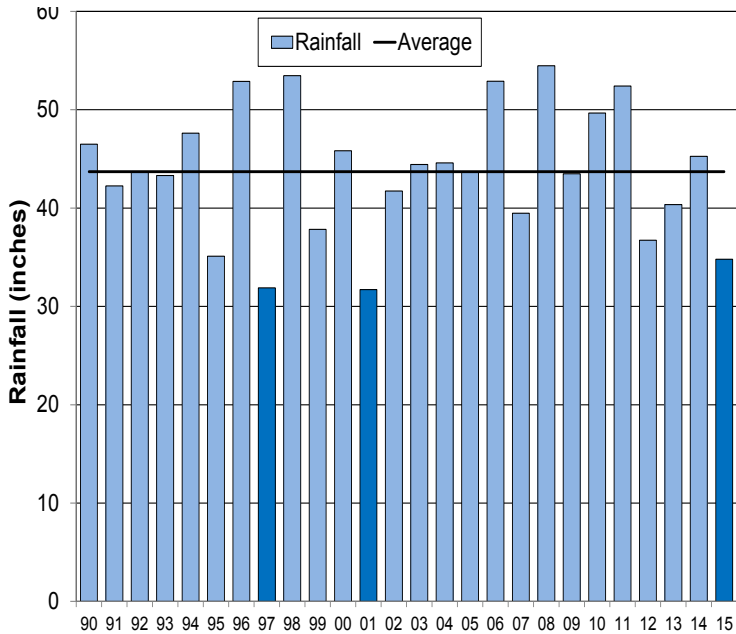
Boston rainfall, 1990-2015

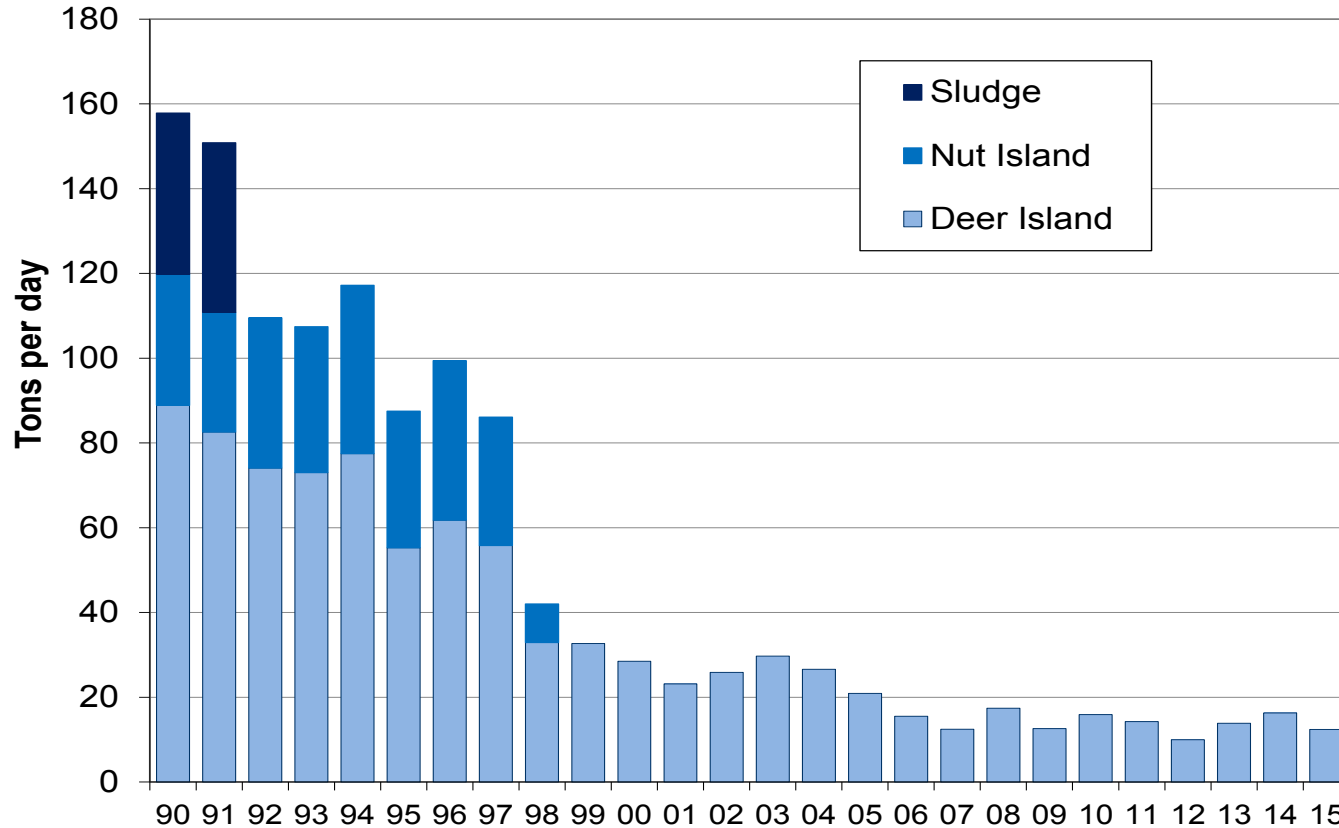
Total Solids Discharged (tons/day), 1990-2015

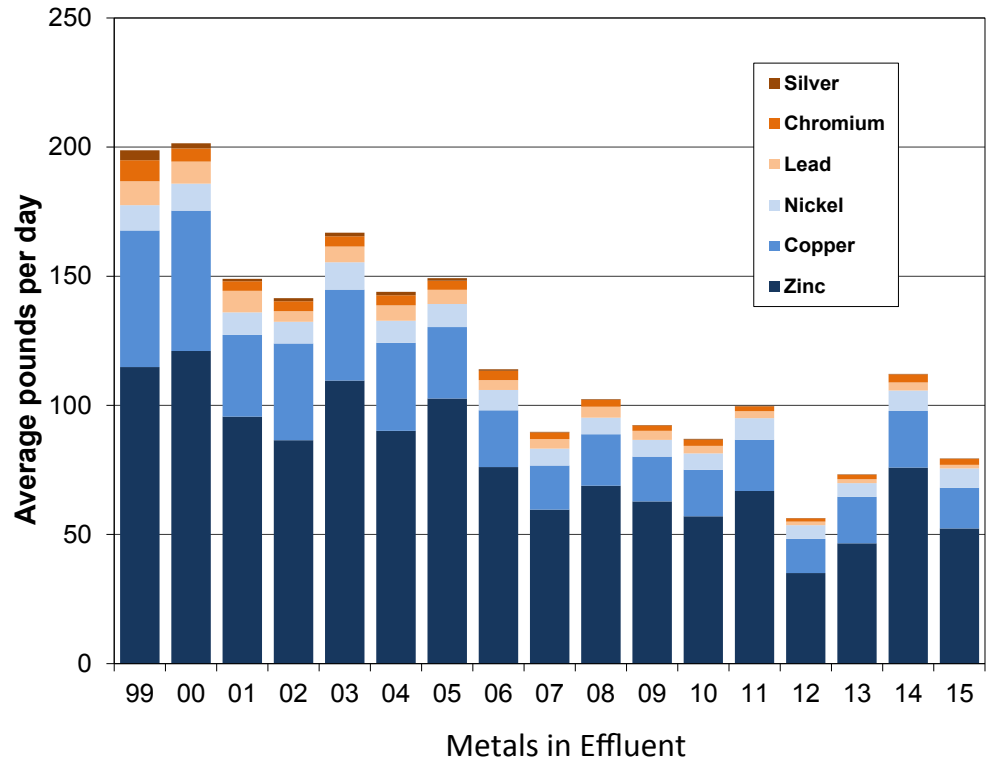
Contaminants in DITP Effluent, 2015

- Metals remained low in 2015
- Organic contaminants (not shown) are also effectively removed by source control, secondary treatment

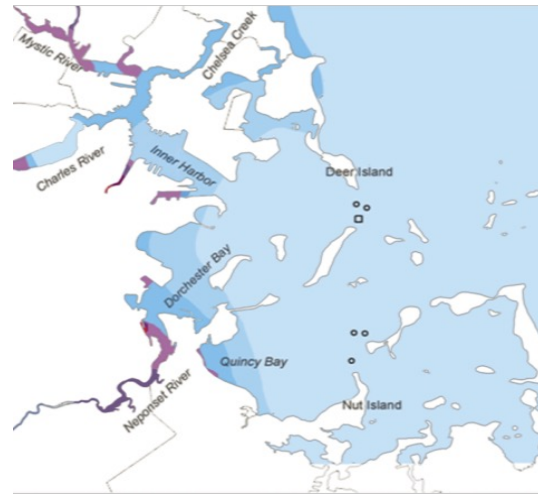
Most Boston Harbor projects complete (post-2007)

Geometric mean (colonies/100 mL)
Sampled during rainfall
>=0.2 inches within 24 hours

Blue contours meet swimming
standard, red-purple
contours exceed swimming standard

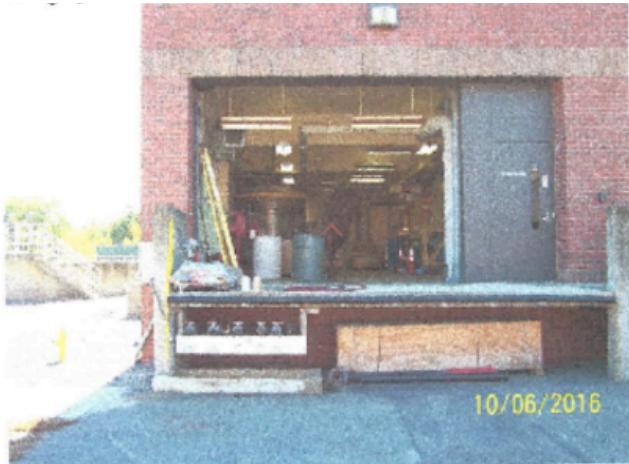
Chemical Building fill station at the north wall

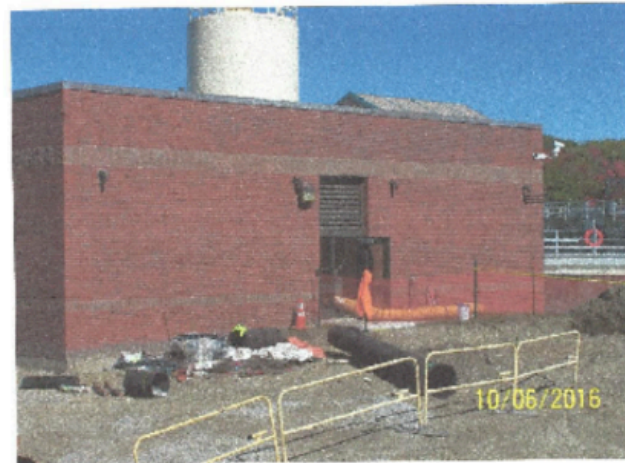
Chemical Building pressure release/vents at the south end

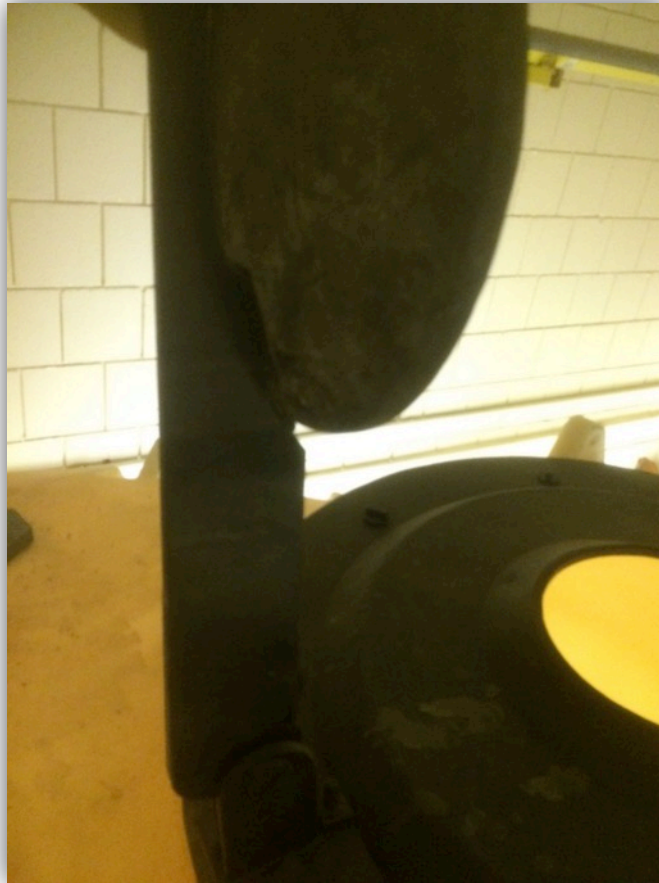
Sodium Hypochlorite Pressure Relief Valve

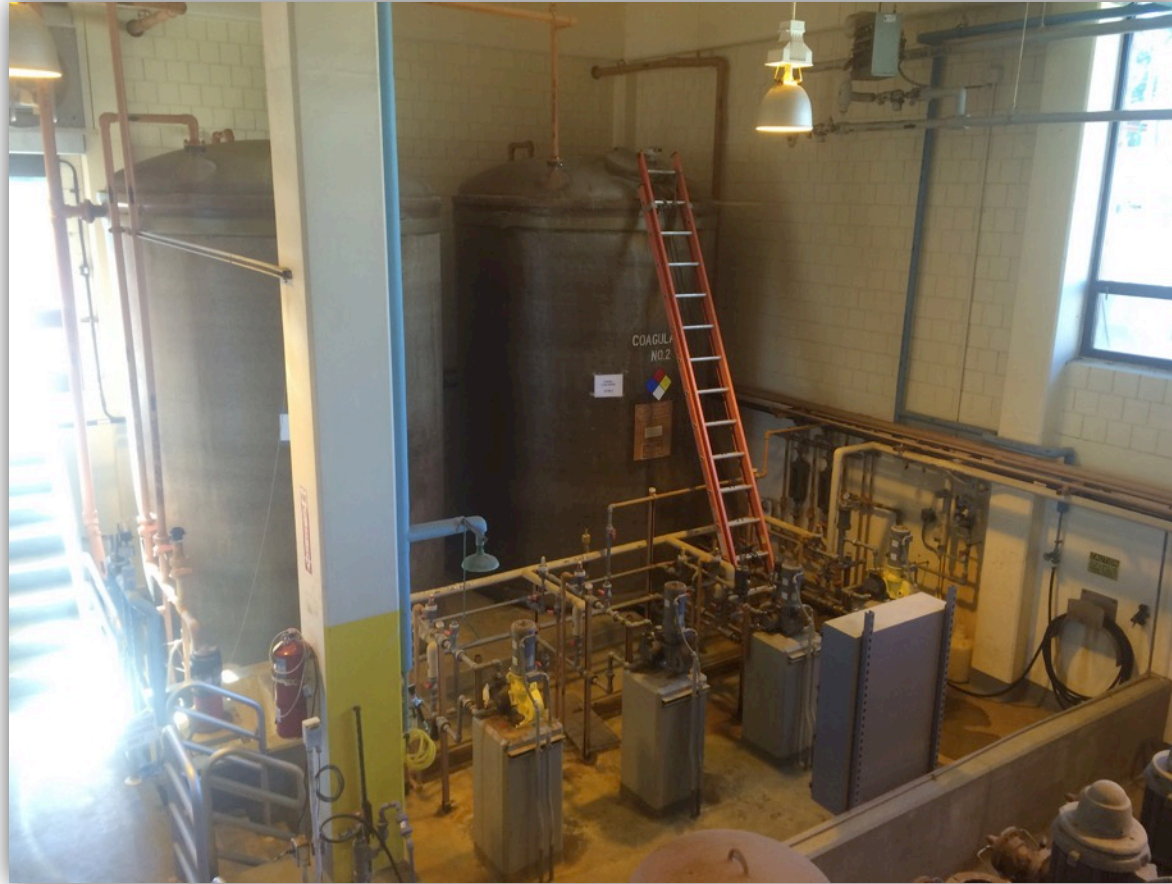
Ferric Chloride Storage Tanks & Containment Area

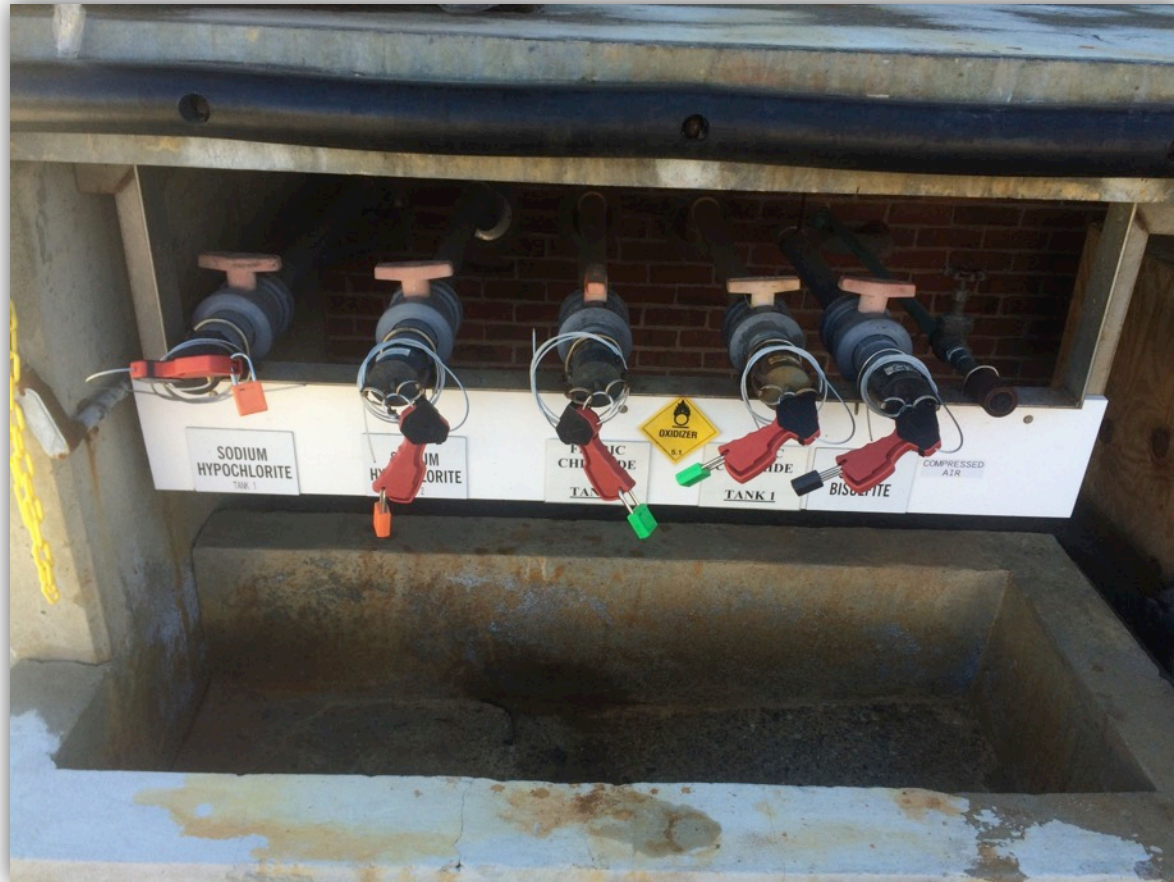
Chemical Delivery Station – Lessons Learned: Locks Installed

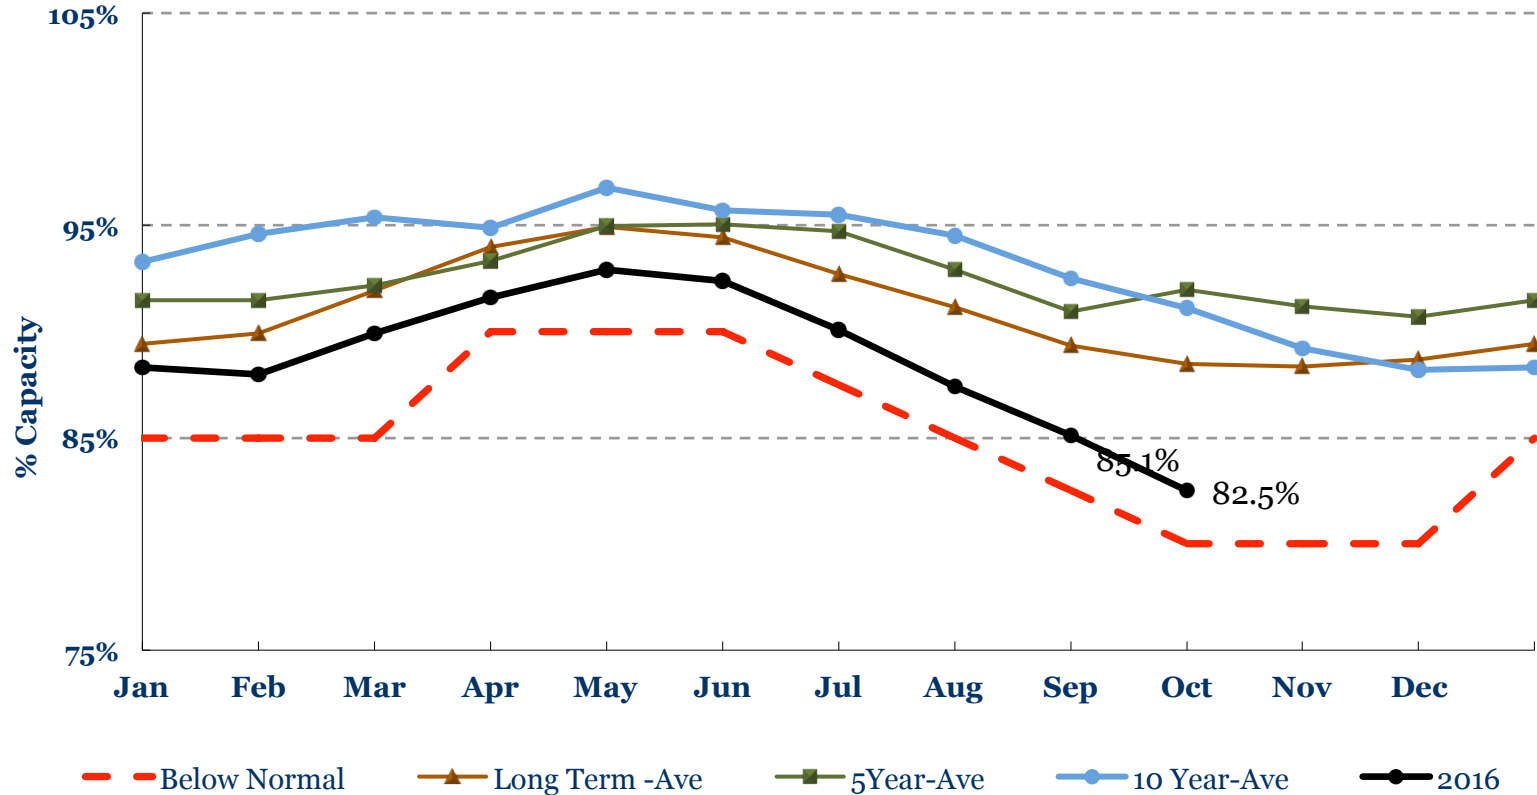
Quabbin Reservoir Volume - First of the Month

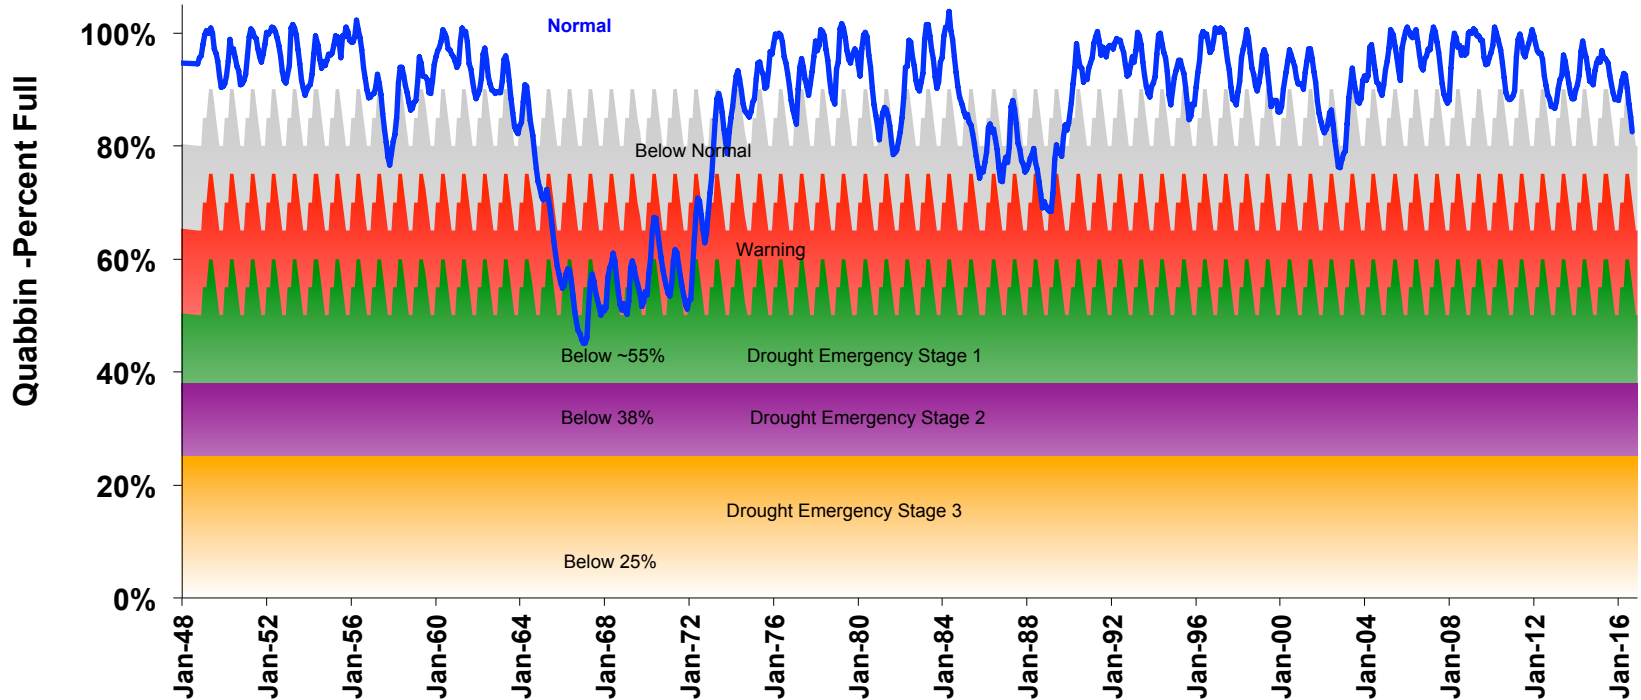
Quabbin's Long-Term Track
