Massachusetts Water Resources Authority

***Supply and Delivery of Ferrous Chloride
to the Deer Island Treatment Plant
WRA-4425***

***Clinton Wastewater Treatment Plant
Phosphorus Reduction Design, CA/RE
Contract 7377, Amendment 4***

***Southern Extra High Pipeline,
Section 111 – Boston
Contract 6454, Change Order 3***

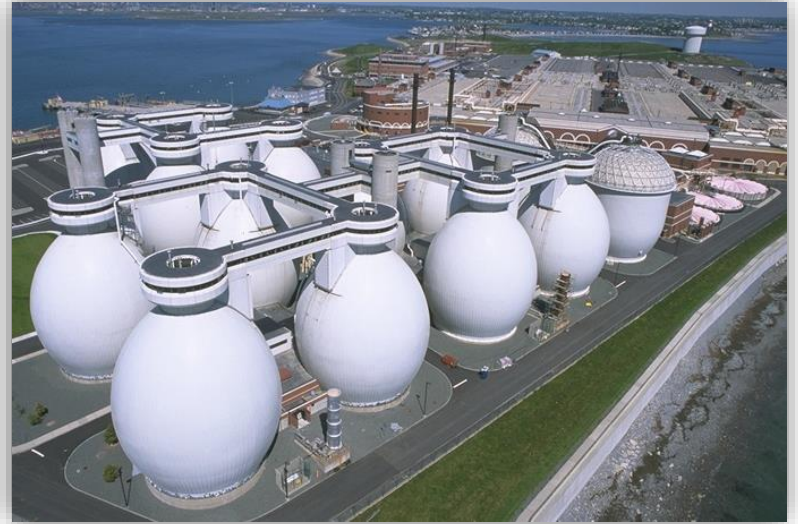
Supply and Delivery of Ferrous Chloride to Deer Island

- Used at Deer Island to:
 - Pretreat sludge to minimize hydrogen sulfide (H_2S) formation in digester gas
 - Prevent struvite in digesters and downstream pipes

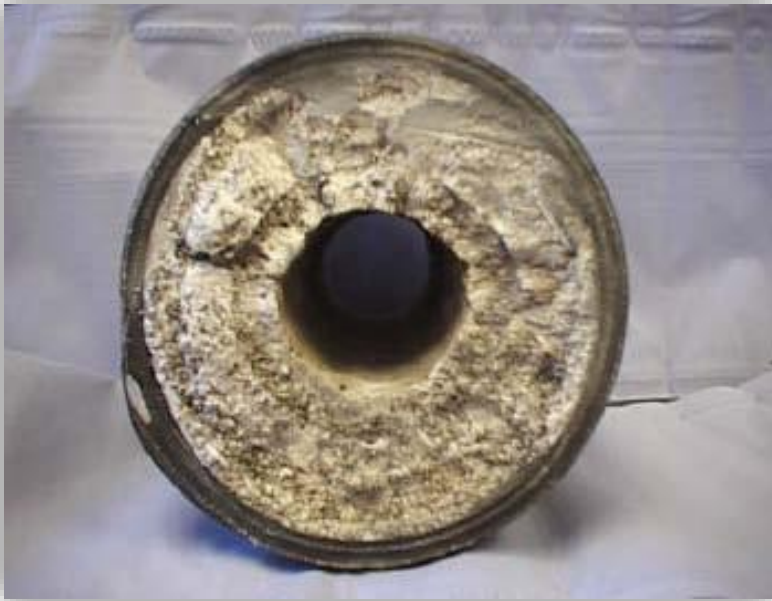
What Is Struvite And Why Do We Have To Prevent It?

Struvite = Magnesium Ammonium Phosphate Hexahydrate $Mg (NH_4) PO_4 (H_2O)_6$

- A scale that forms in anaerobic digesters with secondary treatment processes
- Mostly limited to coastal plants (salt water is high in mg)
- Clogs lines increasing equipment downtime. Could take entire digester unit out for months or years

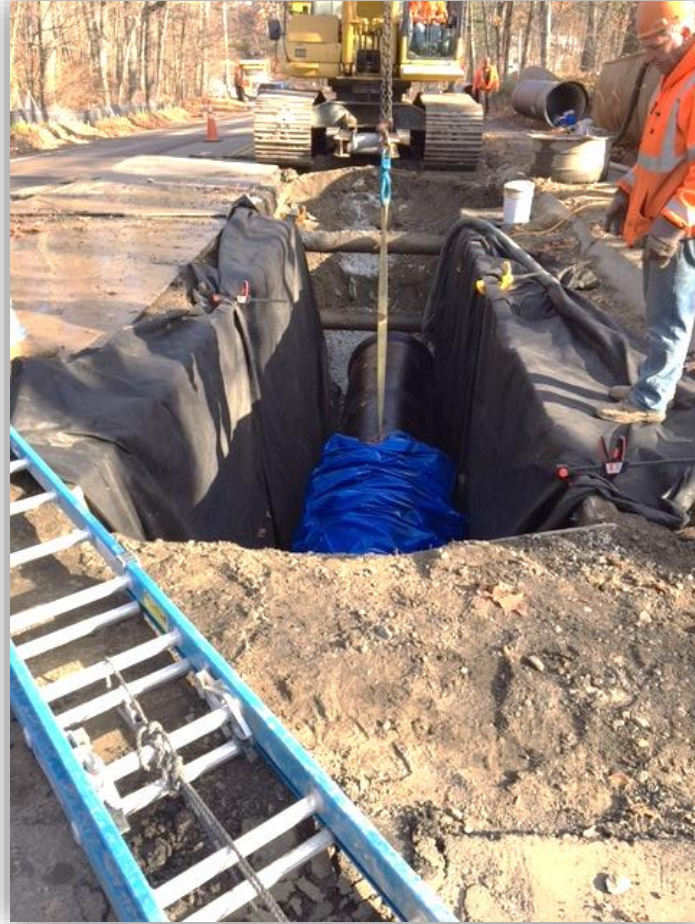
36-inch Ductile Iron Pipe Being Installed Dedham Parkway, Boston

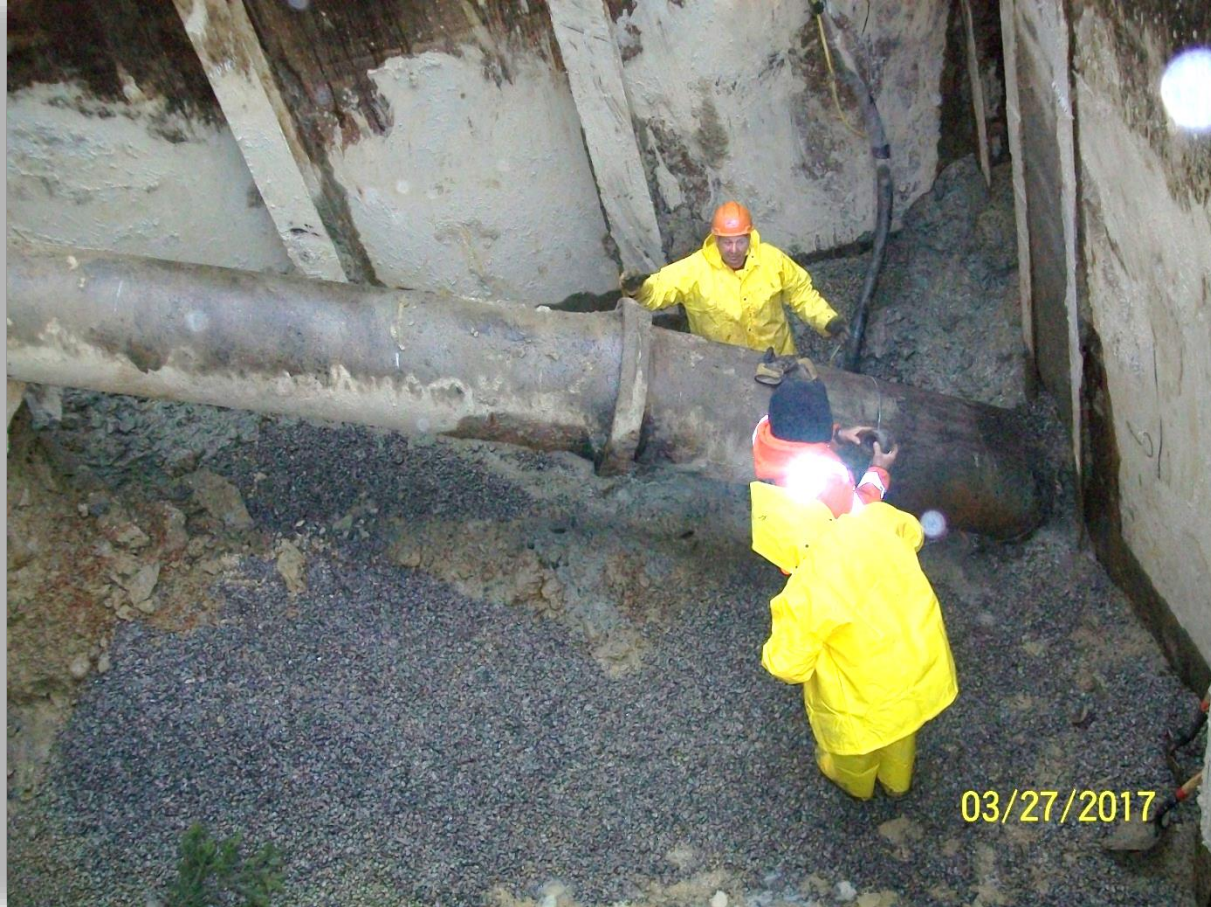
Existing Usiflex Pipe Joint On Section 42

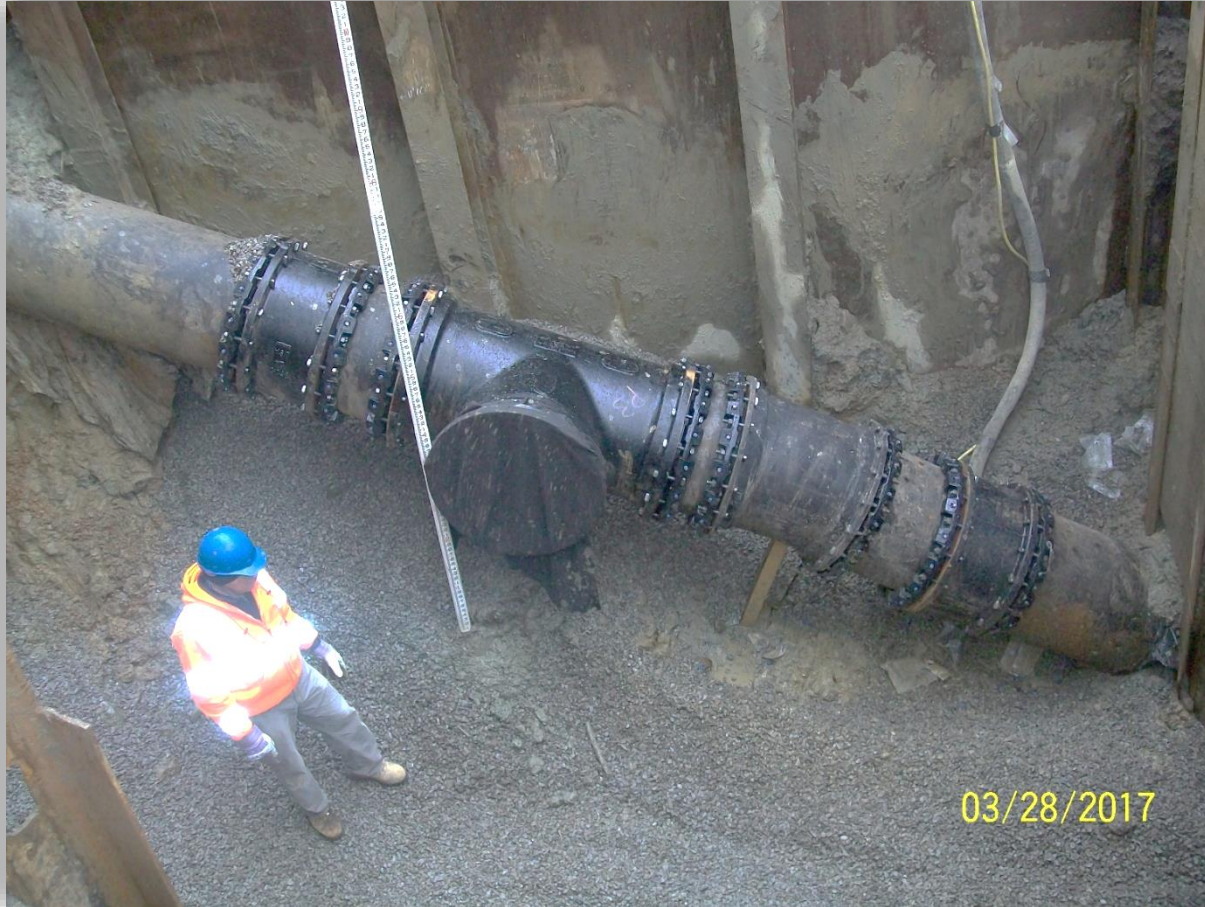
Tee Installed On Section 42

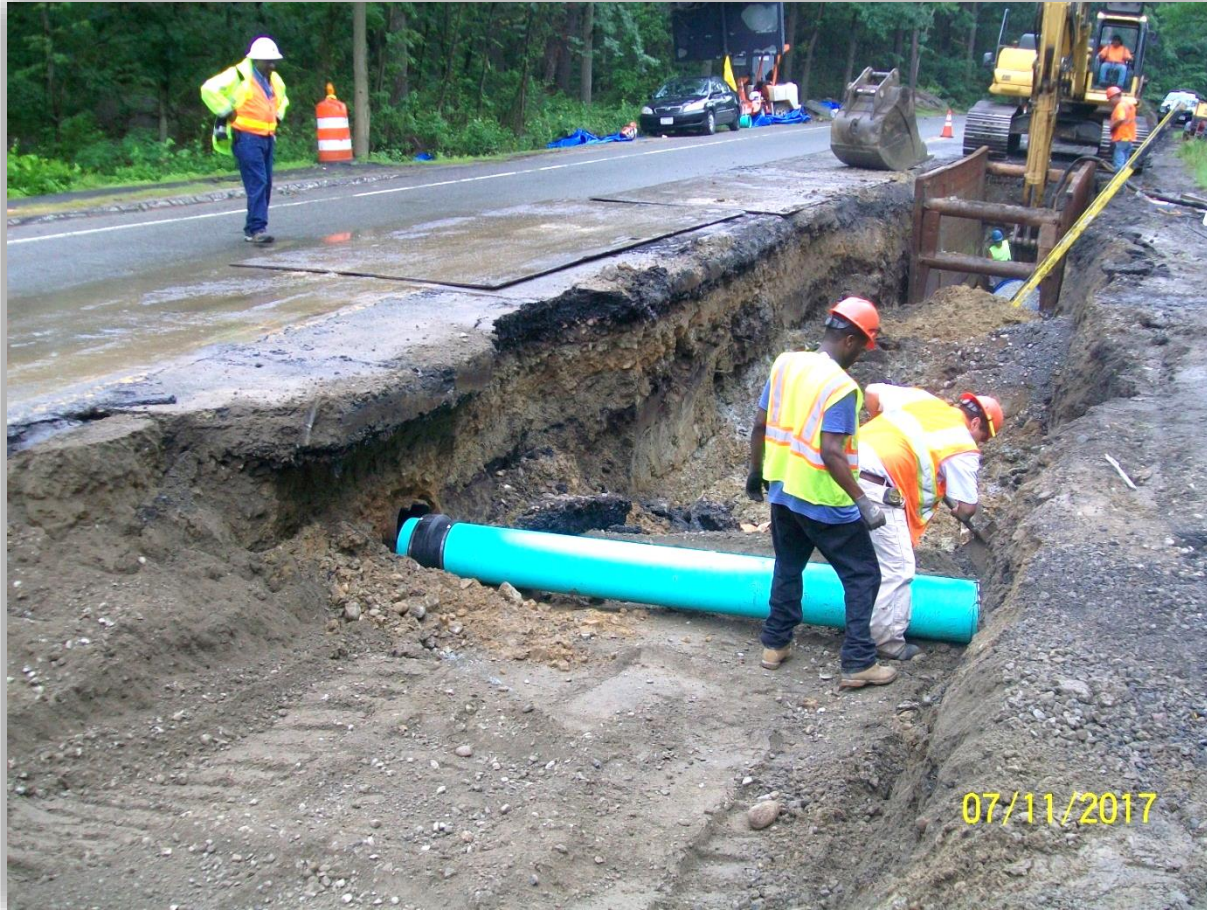
12-inch Drain Repair on Enneking Parkway

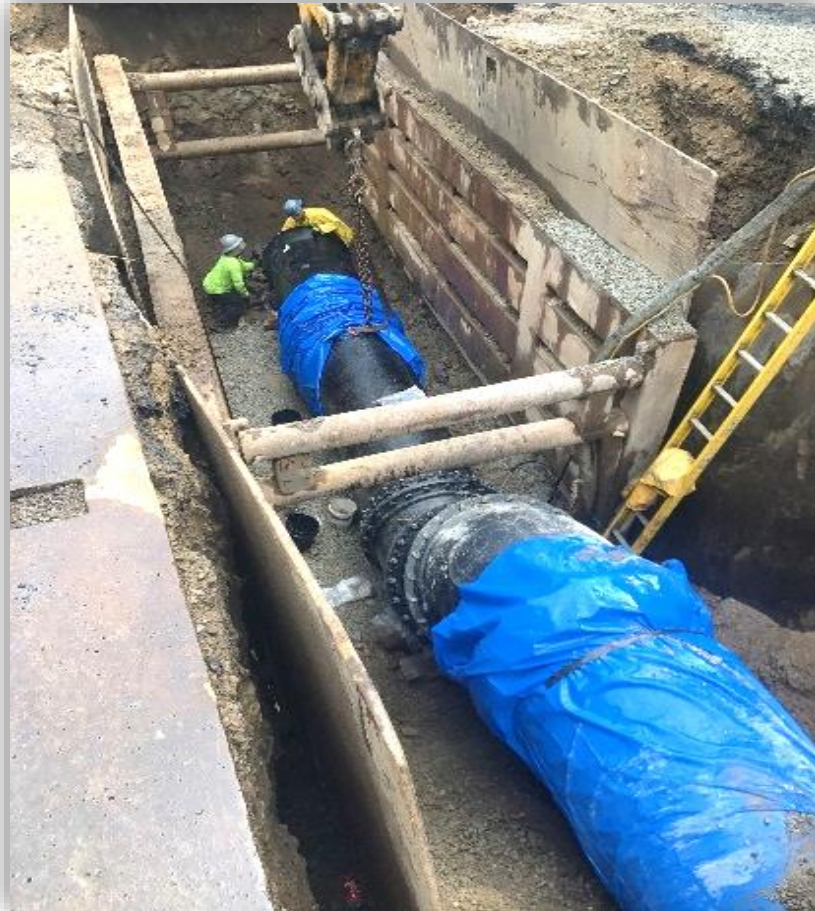
Typical Installation of Vertical Offsets

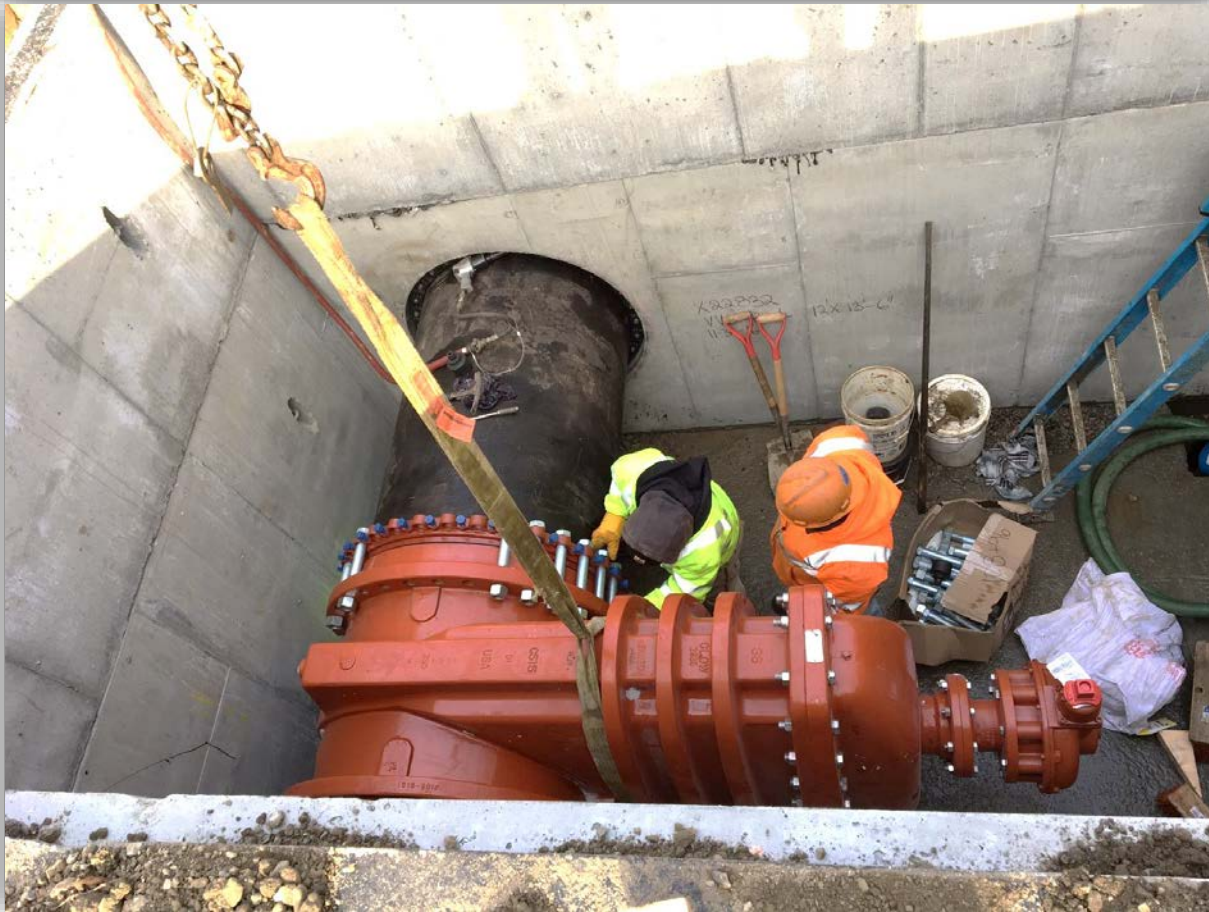
36-inch Gate Valve Vault

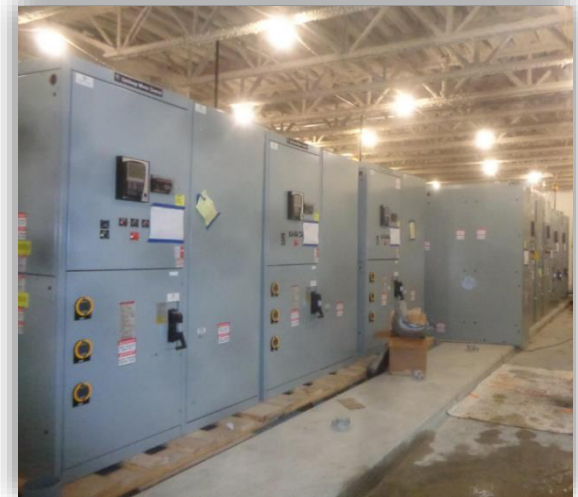
Change Order 25 – Pump Power Fluctuation Ride Through

- Millisecond power fluctuations - pumps susceptible to shutdown
- Pump start-up – over 1 hour
- May experience several power fluctuations per day
- For power ride through:
 - Provide DC Battery Circuits in each MCC
 - Provide UPS for each Pump Control Valve
