Update on Lead and Copper

March 21, 2018

SEH Redundancy Pipeline Section 111

***Update on Infiltration/Inflow
Local Financial Assistance Program***

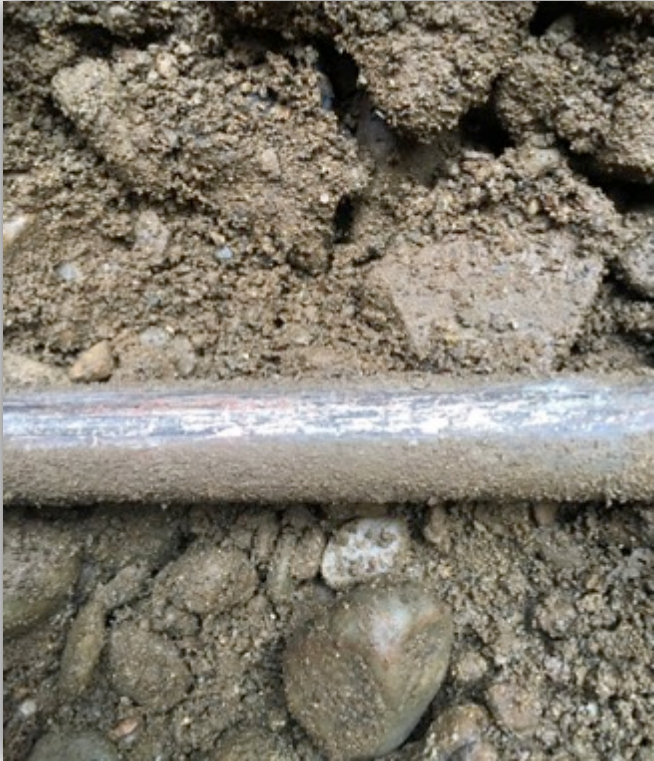
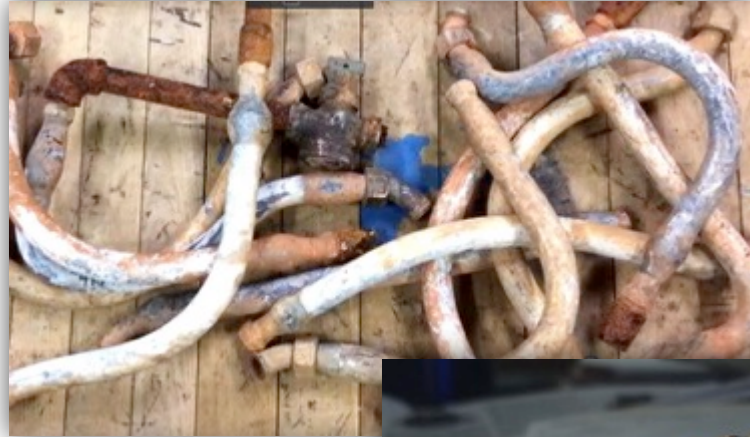
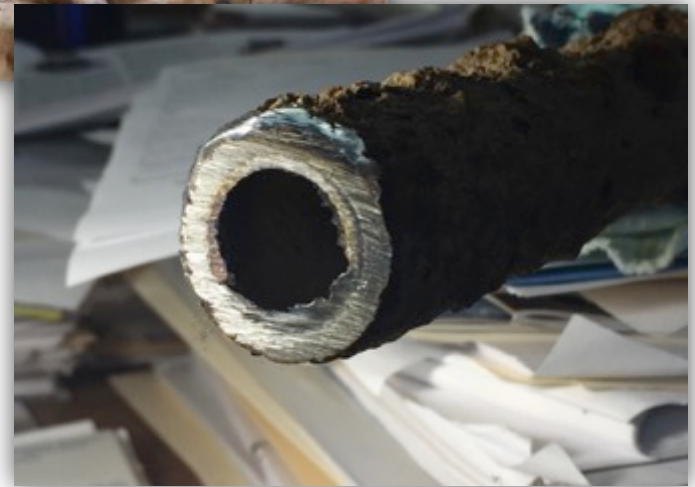
Lead and Lead-Lined Service Pipes

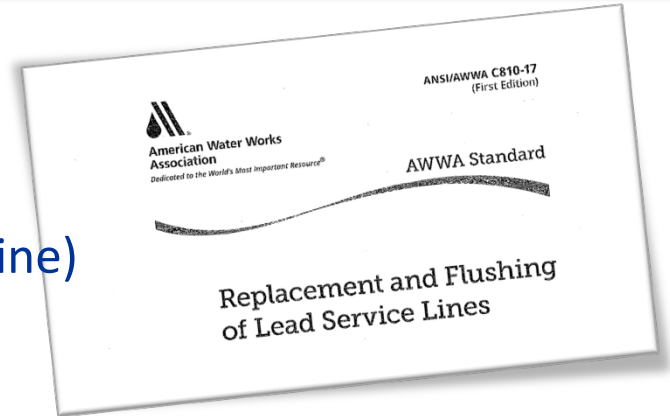
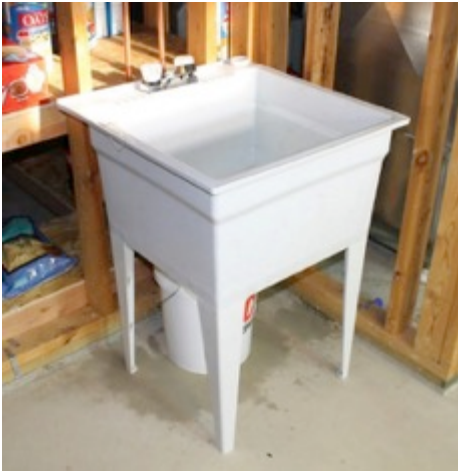
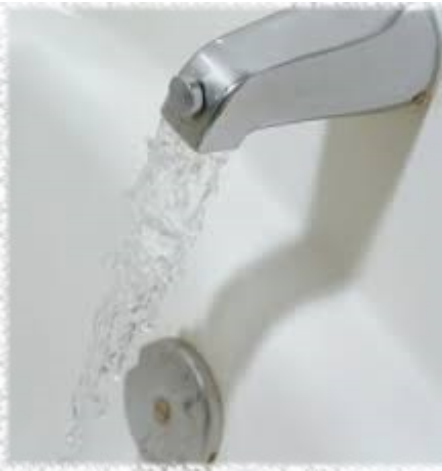
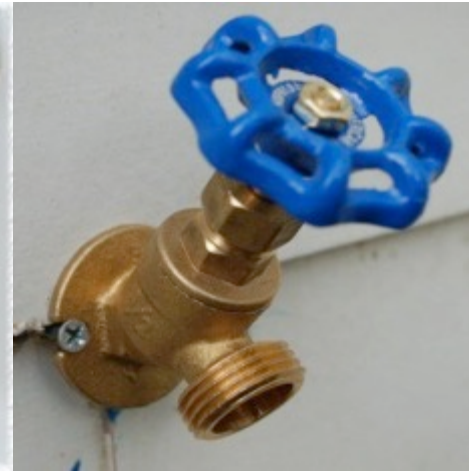
Post Construction Flushing

Flushing of interior plumbing after service line replacement
(or after ANY service disruption in lead service line)

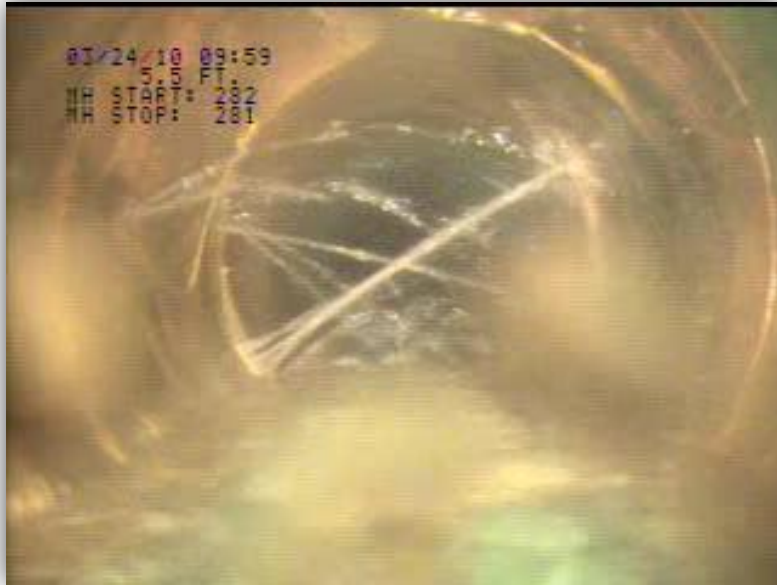
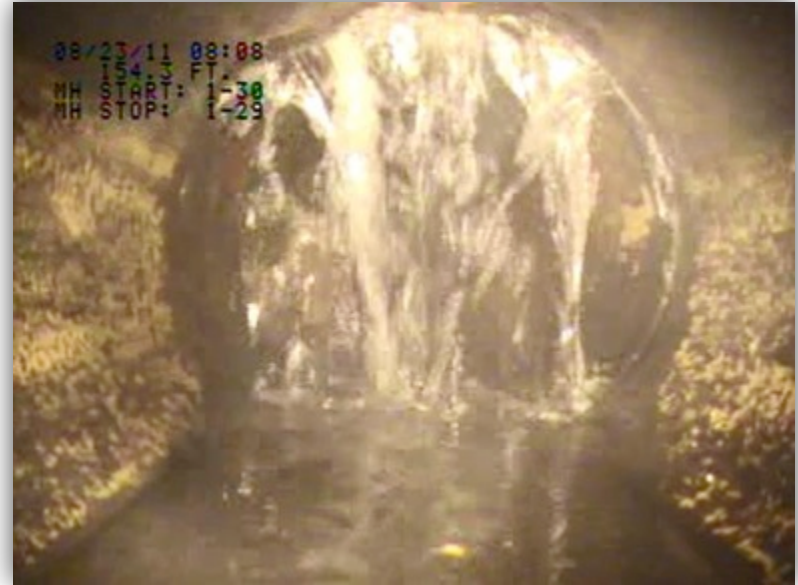
Examples of Infiltration into Sewer Pipelines

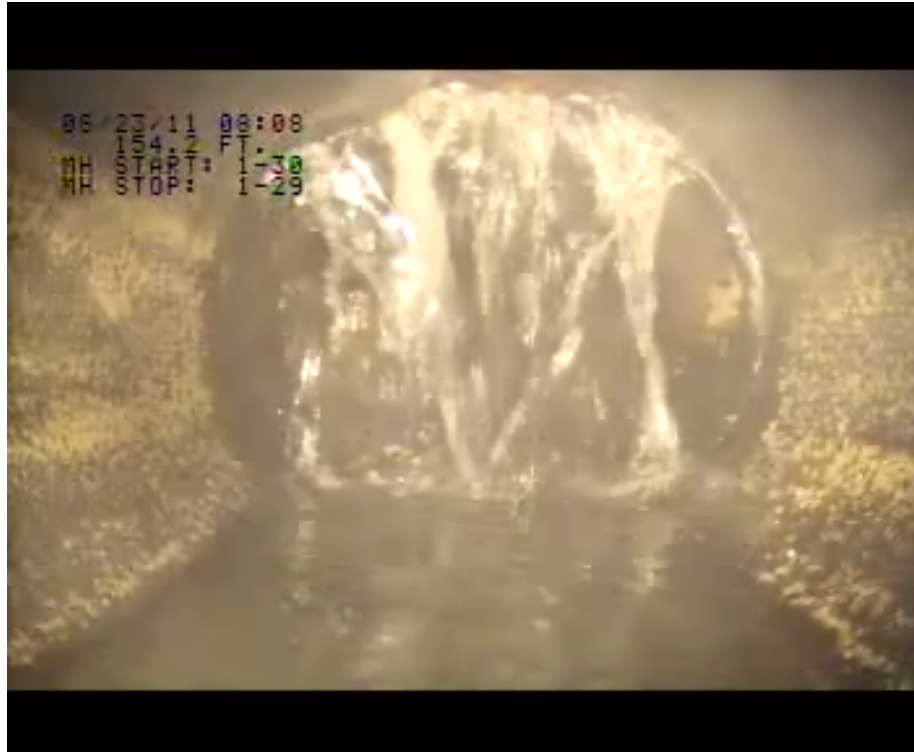
Infiltration at Sewer Pipe Joint

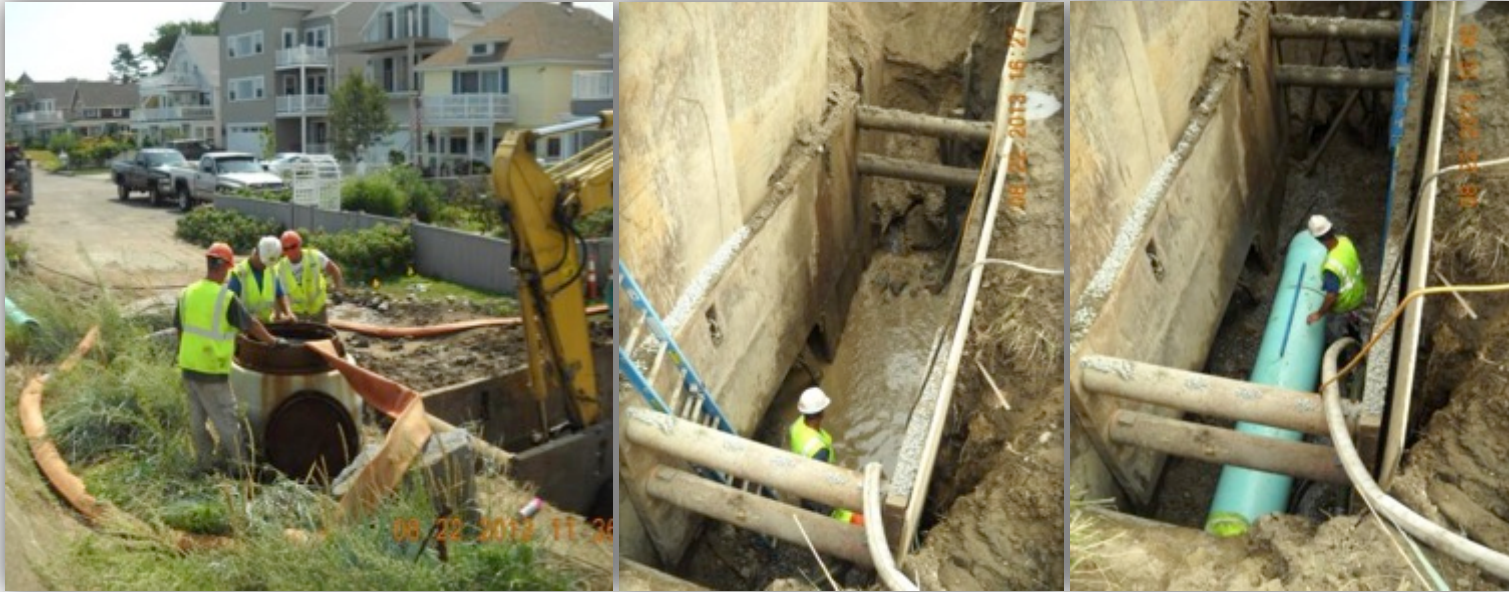
60 miles of sewer replaced

Quincy sewer repair at Salt Marsh

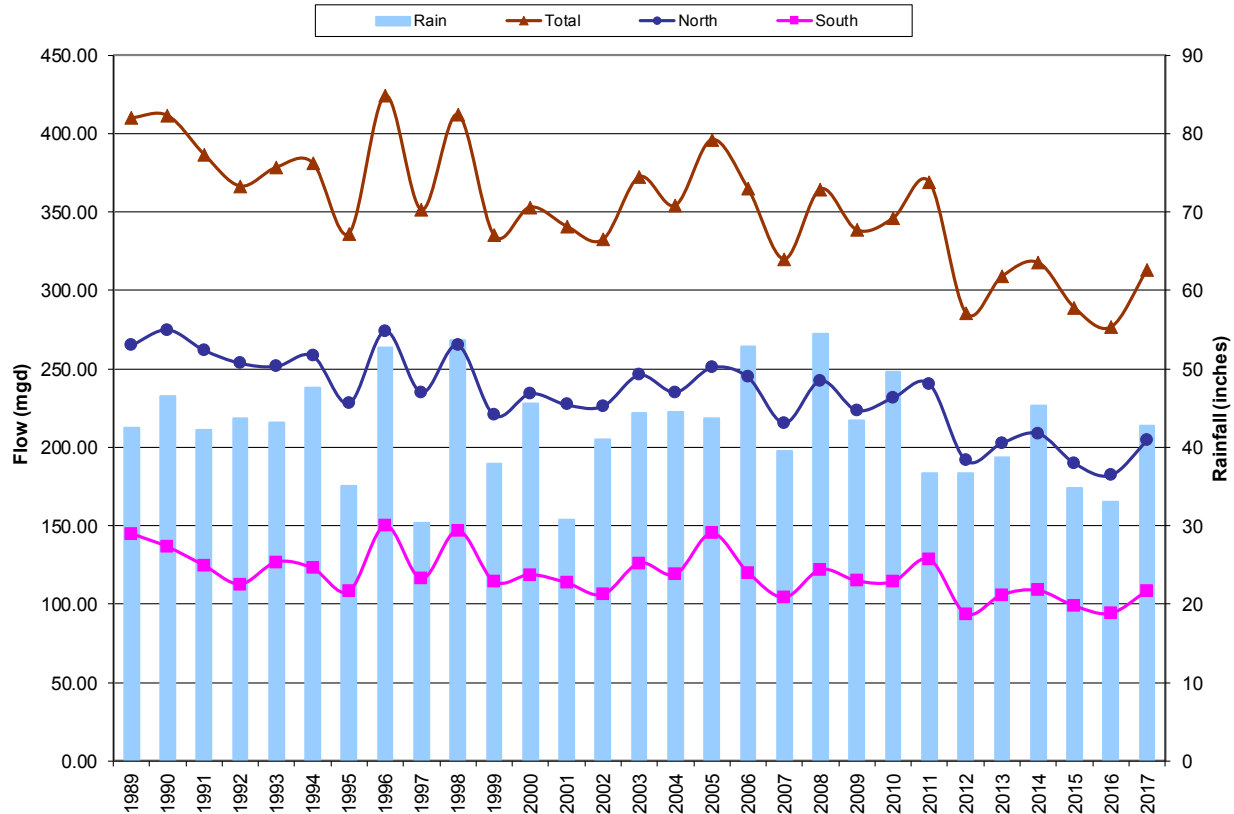
MWRA Long-Term Regional Flow Data
NOAA Annual Rainfall at Logan Airport

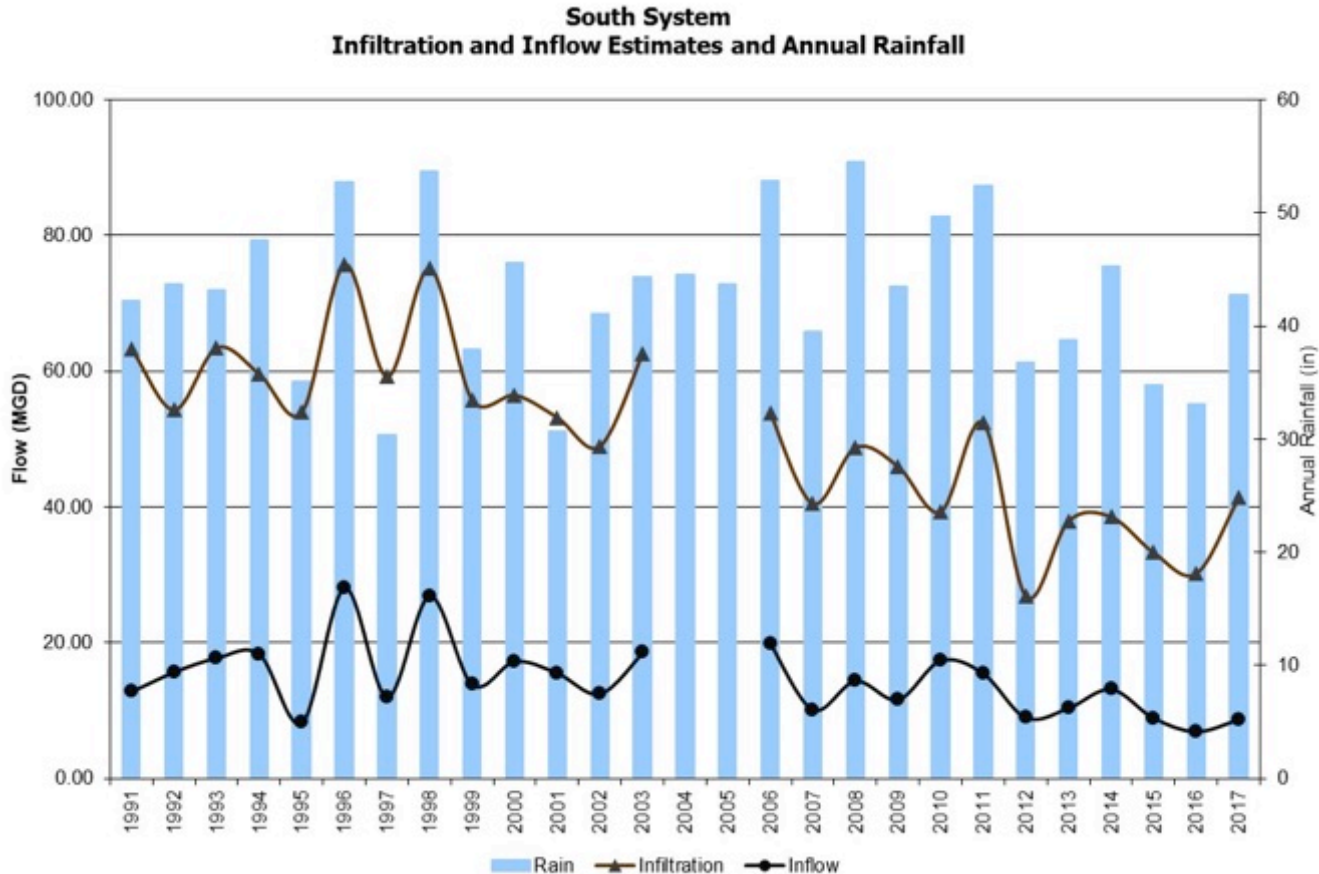
MWRA South System Long-Term Infiltration/Inflow Estimates

*No I/I estimates for 2004-2005 due to wastewater metering system replacement project

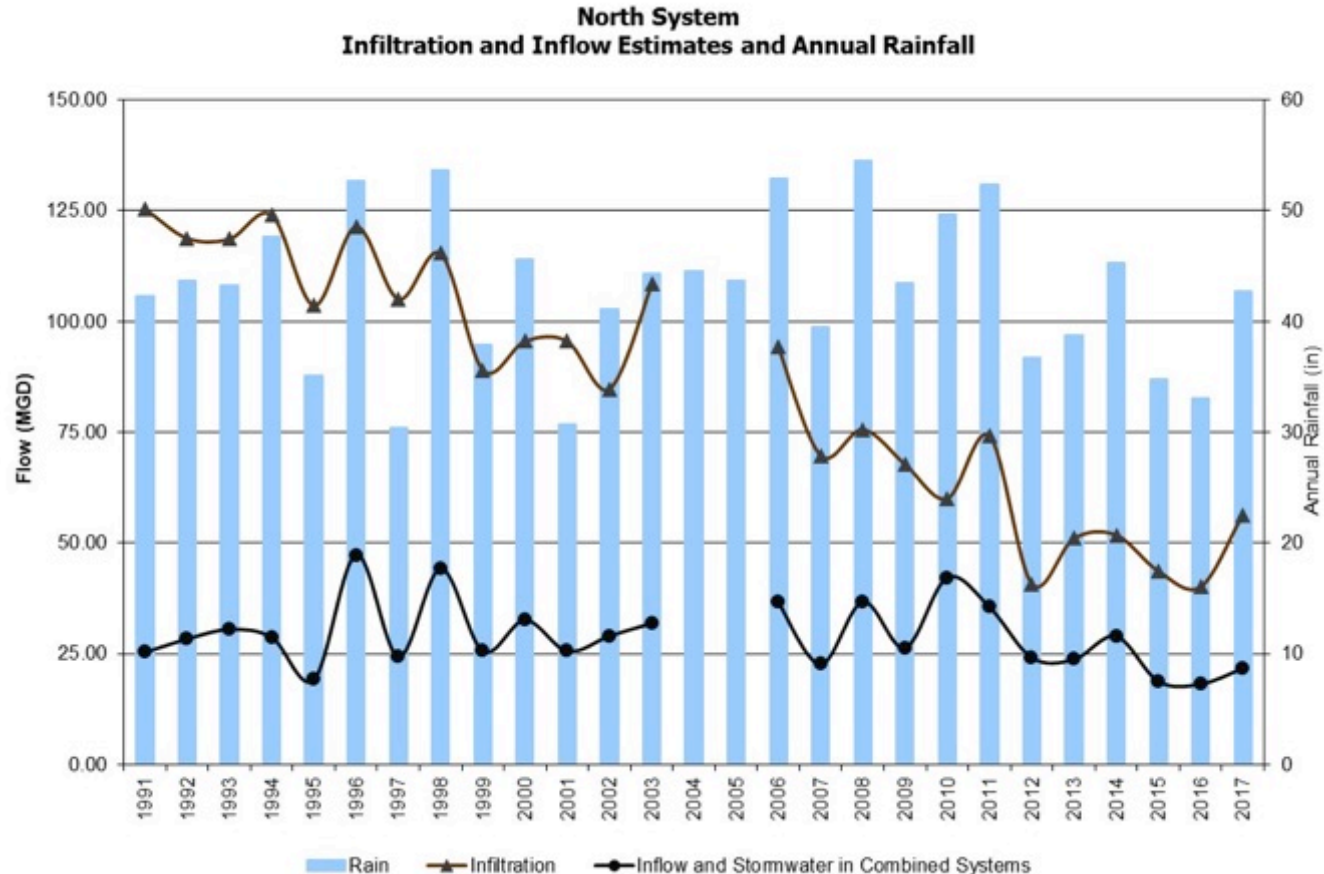
MWRA North System Long-Term Infiltration/Inflow Estimates

*No I/I estimates for 2004-2005 due to wastewater metering system replacement project

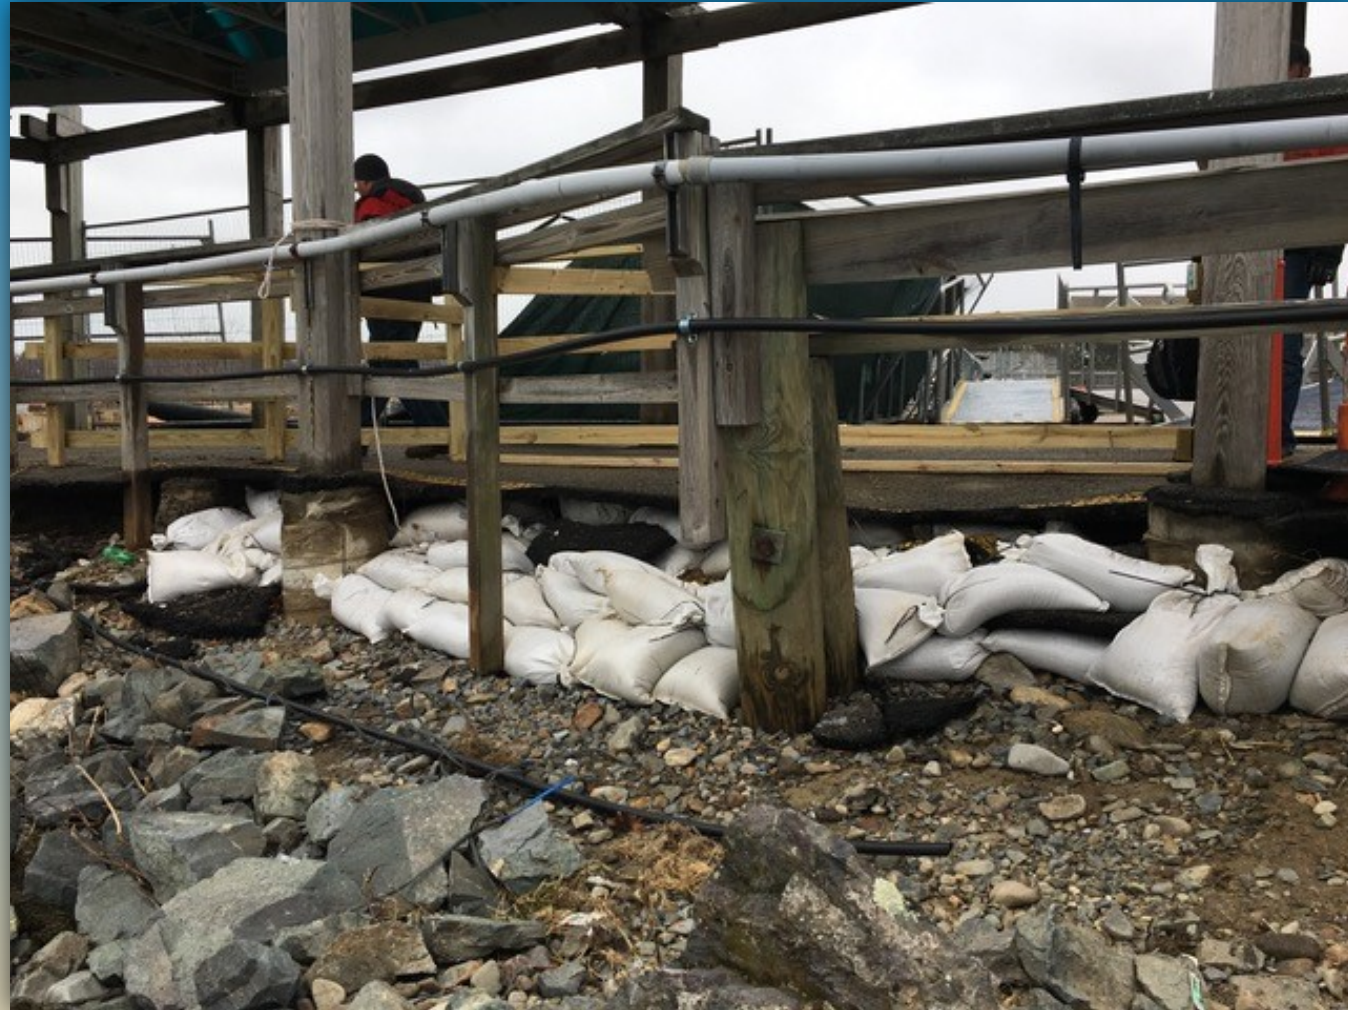
DCR: Hingham Commuter Boat Pier

Undermined revetment and walkway

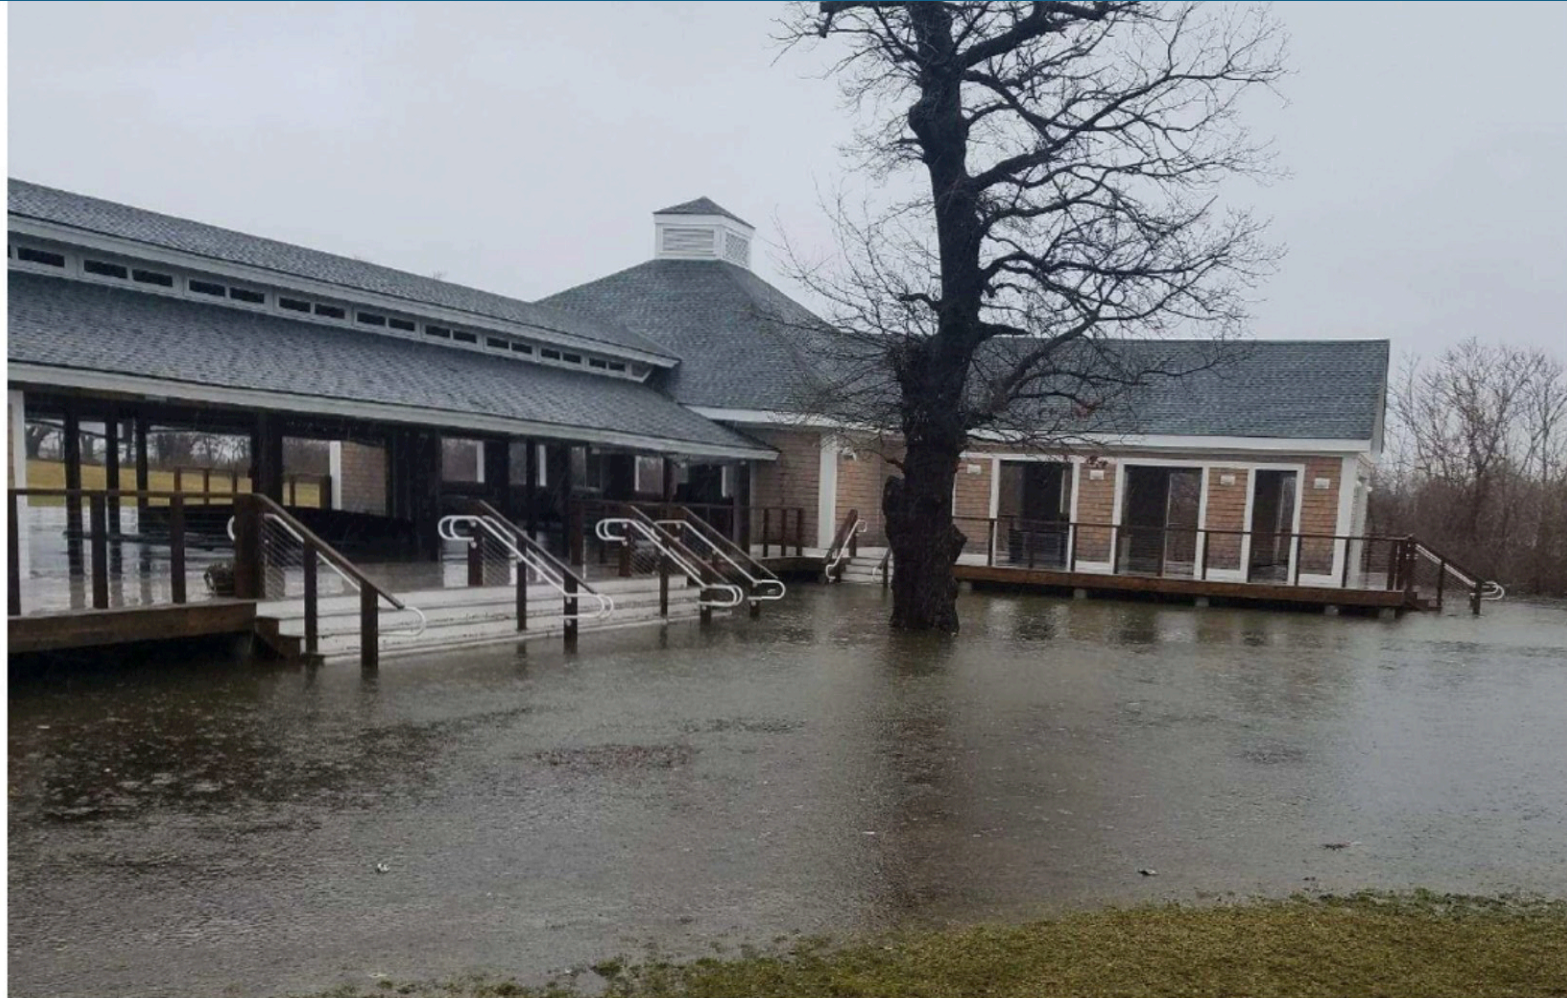
Thompson Island

Once again, the climate-resilient design of the Waterfront Landing paid off. With the main decking placed above the 100 year storm sea level, the storm surge went under, not through, the building. This time without the ice of the Jan. 4 storm.

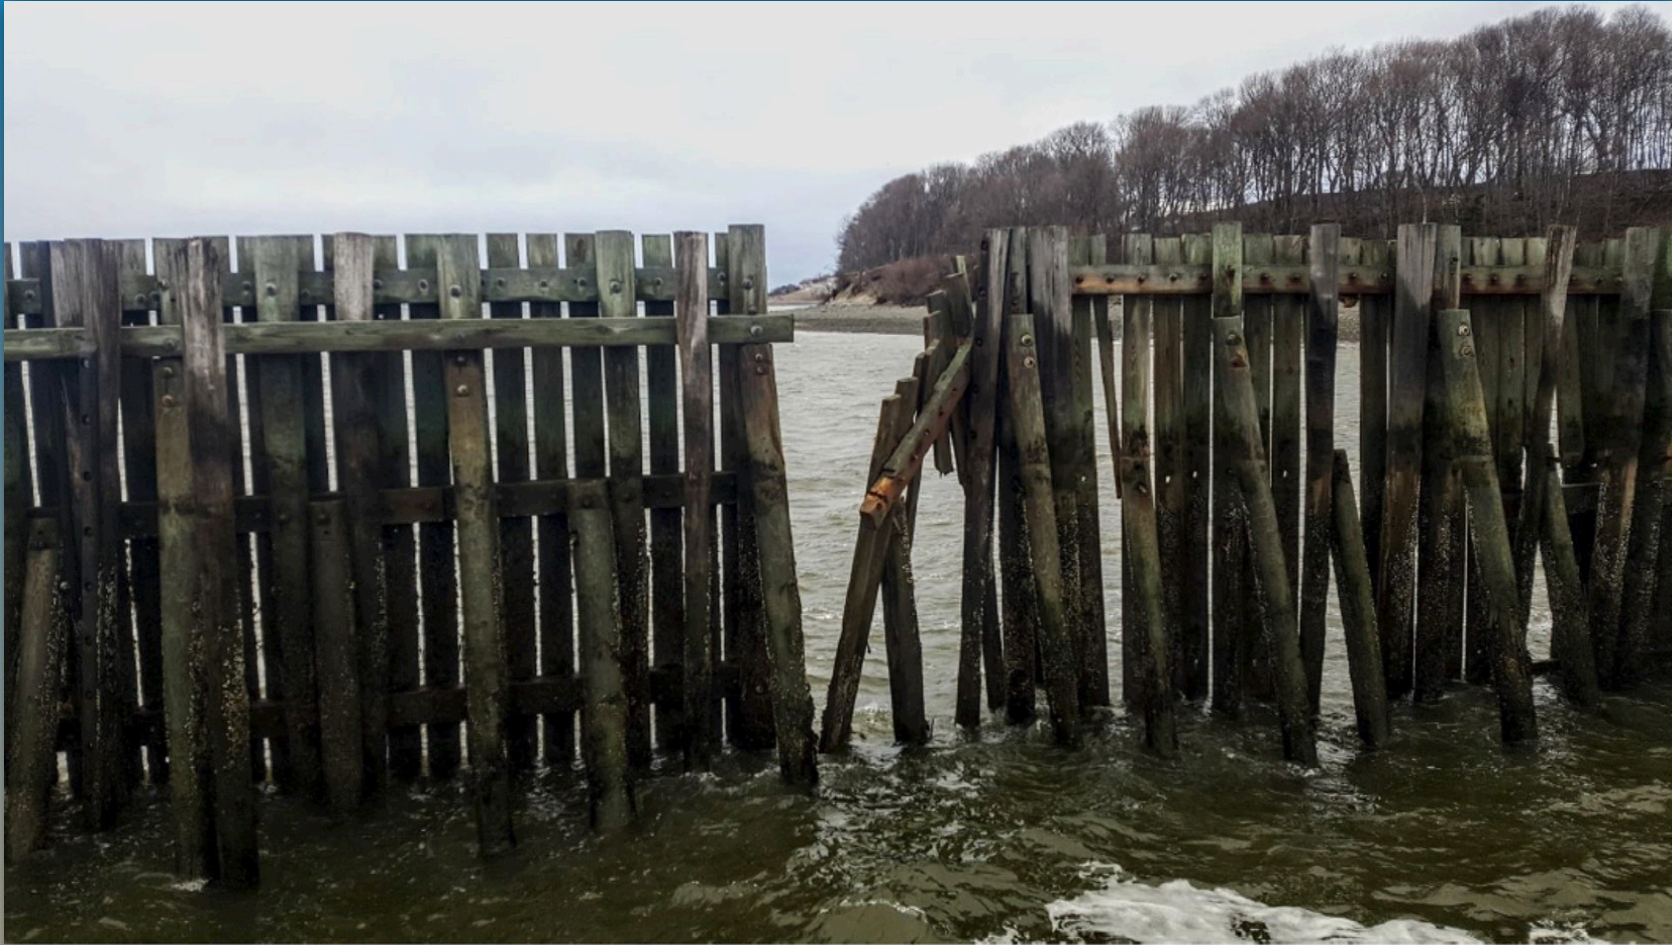
Thompson Island

The greatest damage we sustained was to the wave wall. This breach appears to have been created by the sheer force of wind and waves out of the east and northeast.

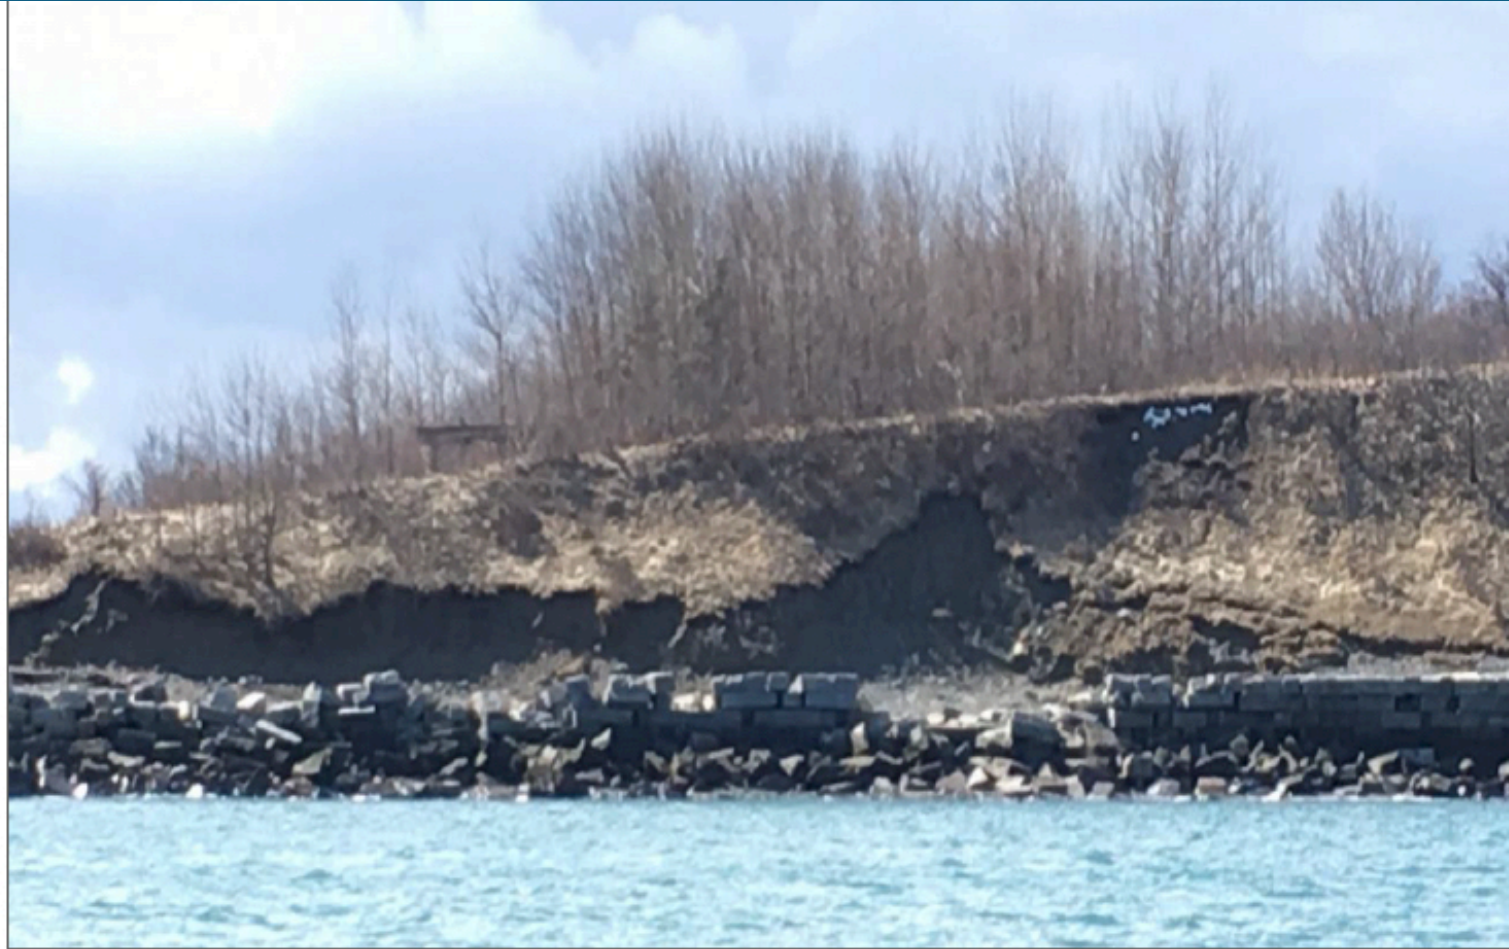
Gallops Island

Looking southwest, showing continued damage to historic seawall and erosion of bluff that protects cemetery

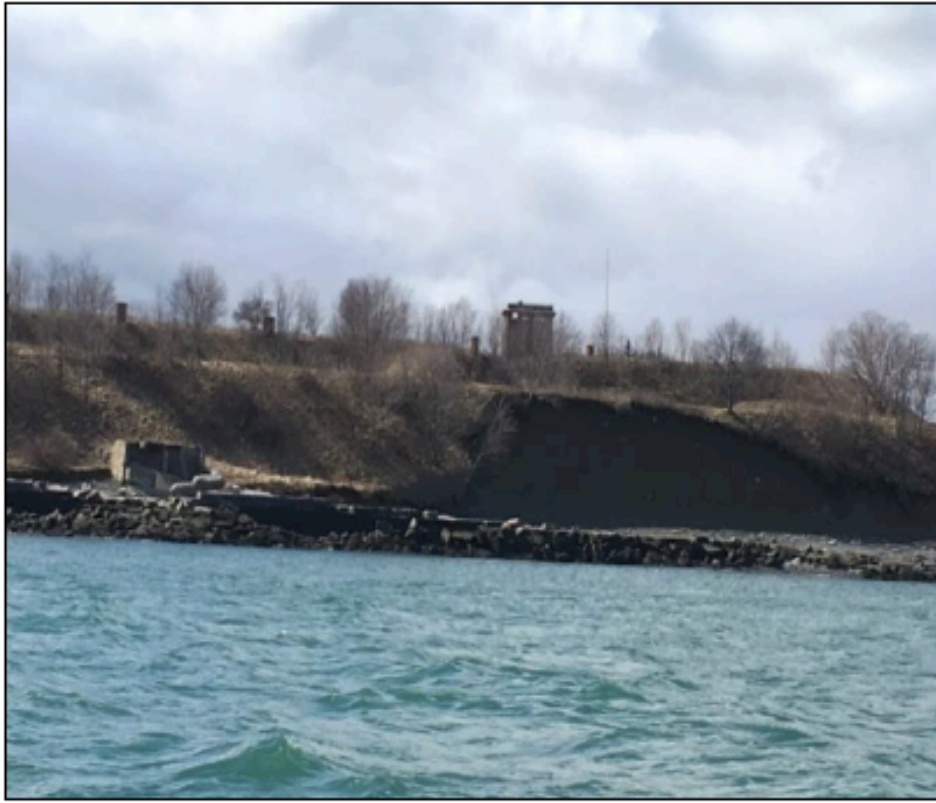
Georges Island and Lovells Island

Looking south, showing continued damage to historic seawall and outer earthworks of Fort Warren

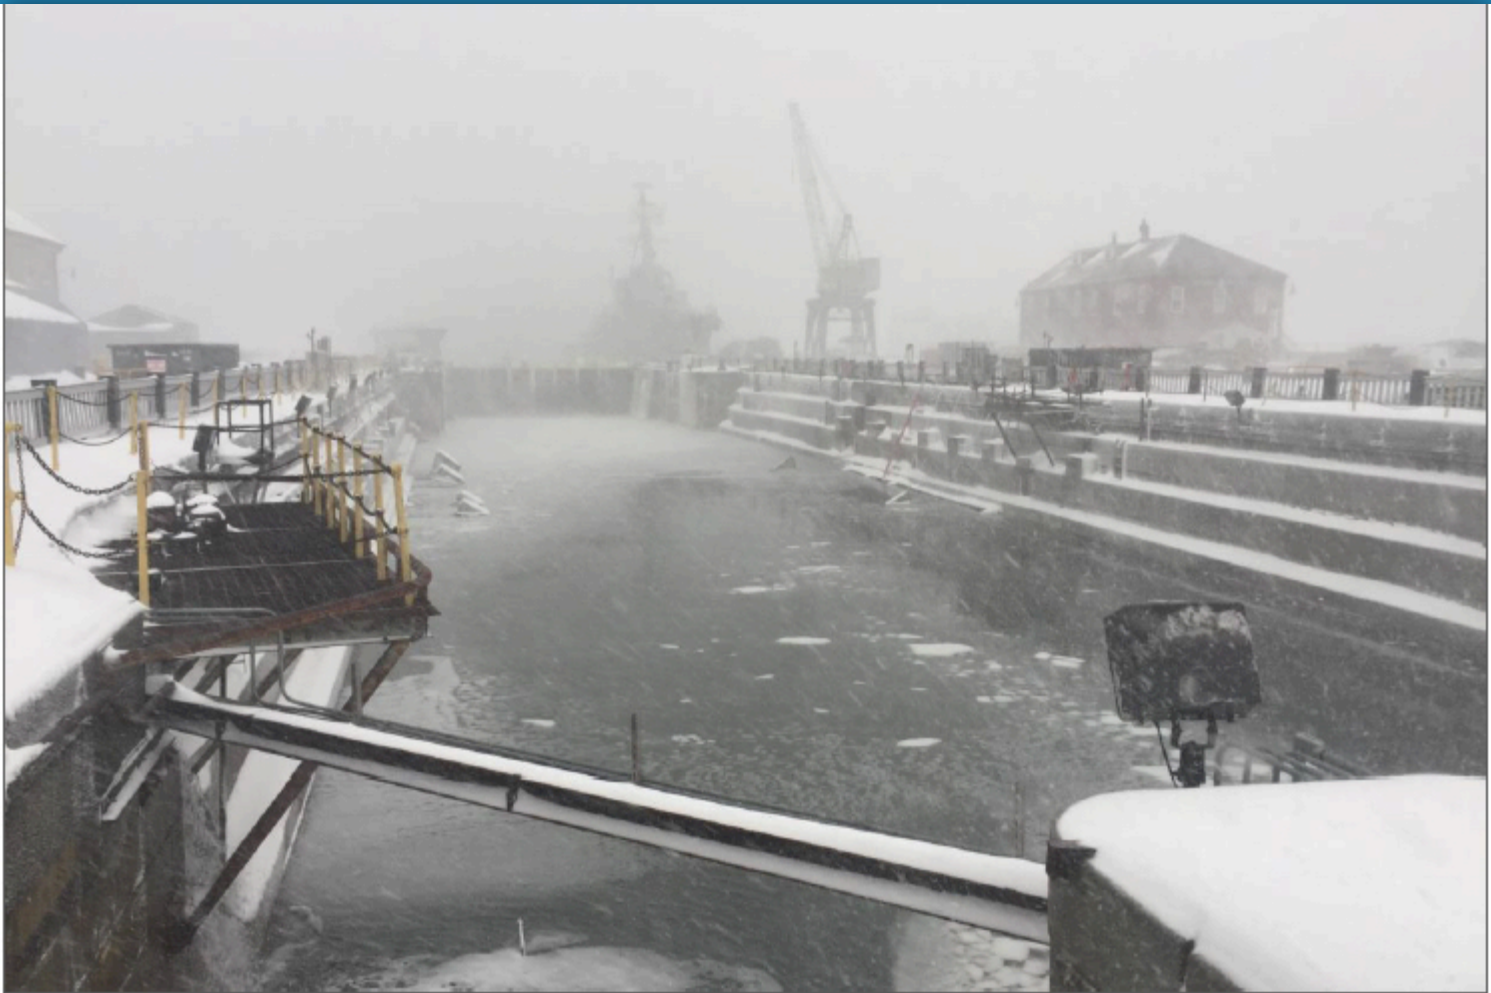
Charlestown Navy Yard

Dry Dock received 15 feet of water from overflow of caisson, overtopping and pump drains

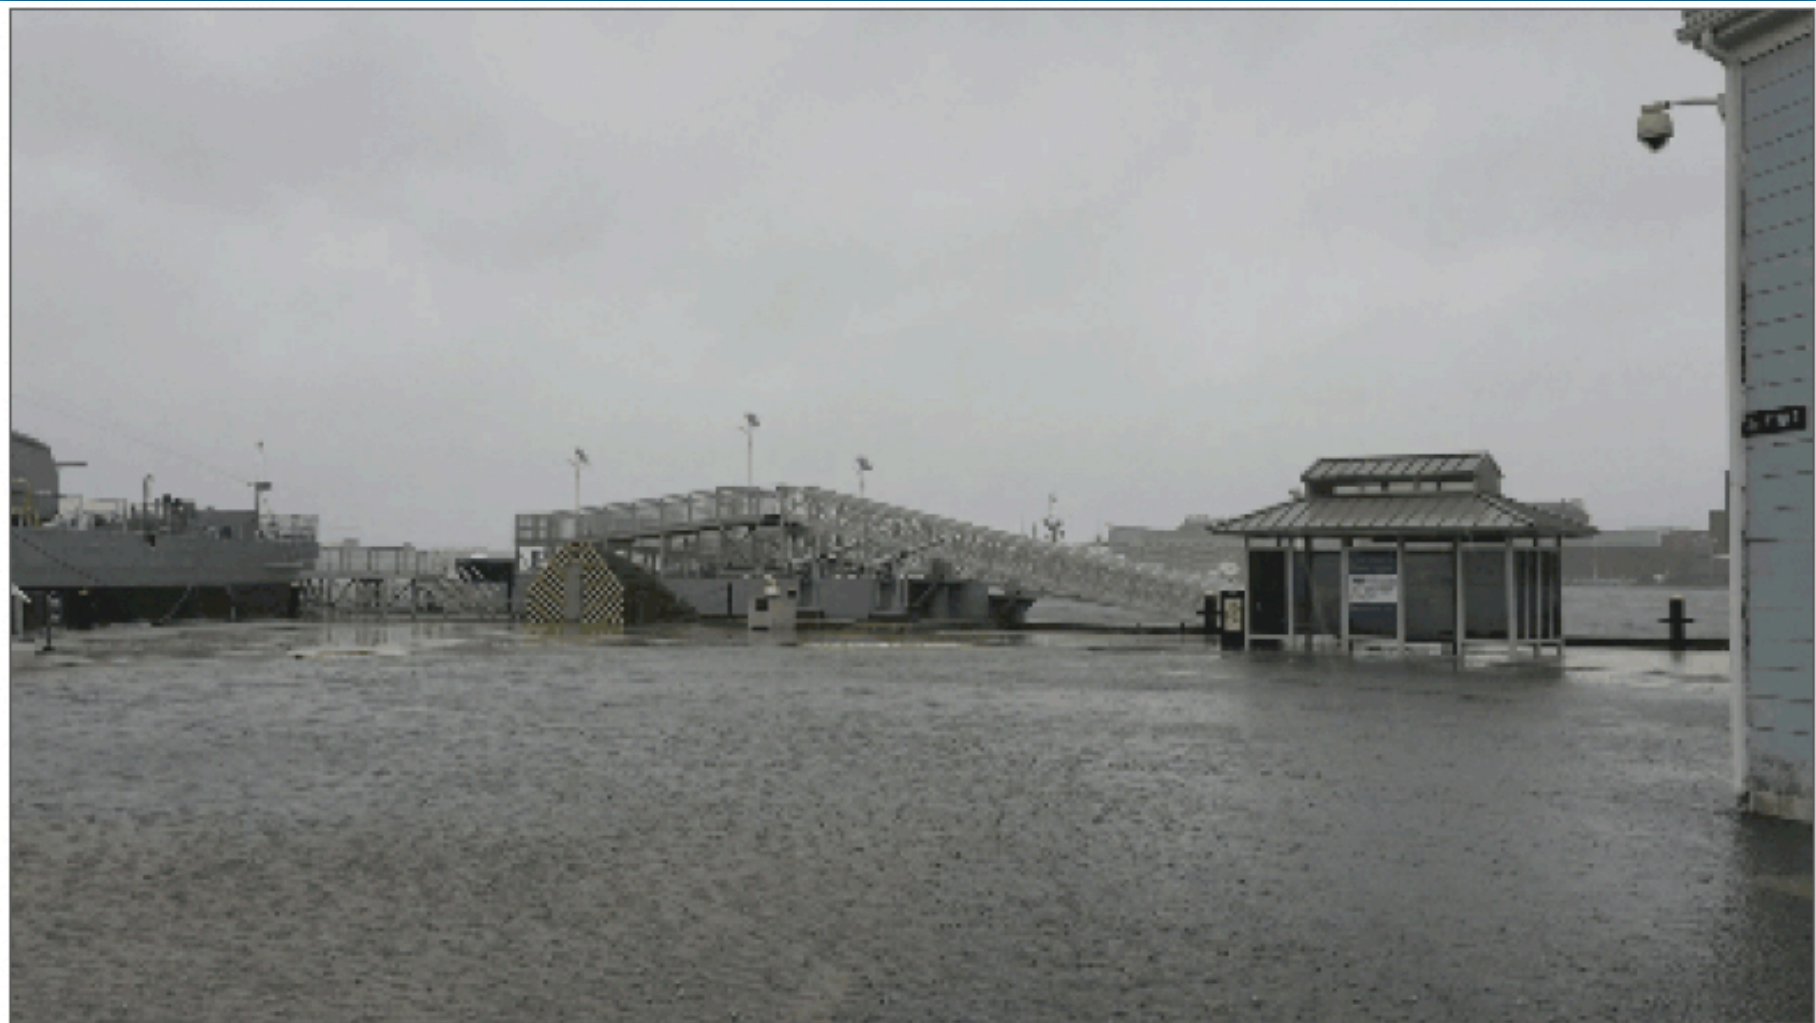
Charlestown Navy Yard

Pier One was flooded from overtopping of seawall

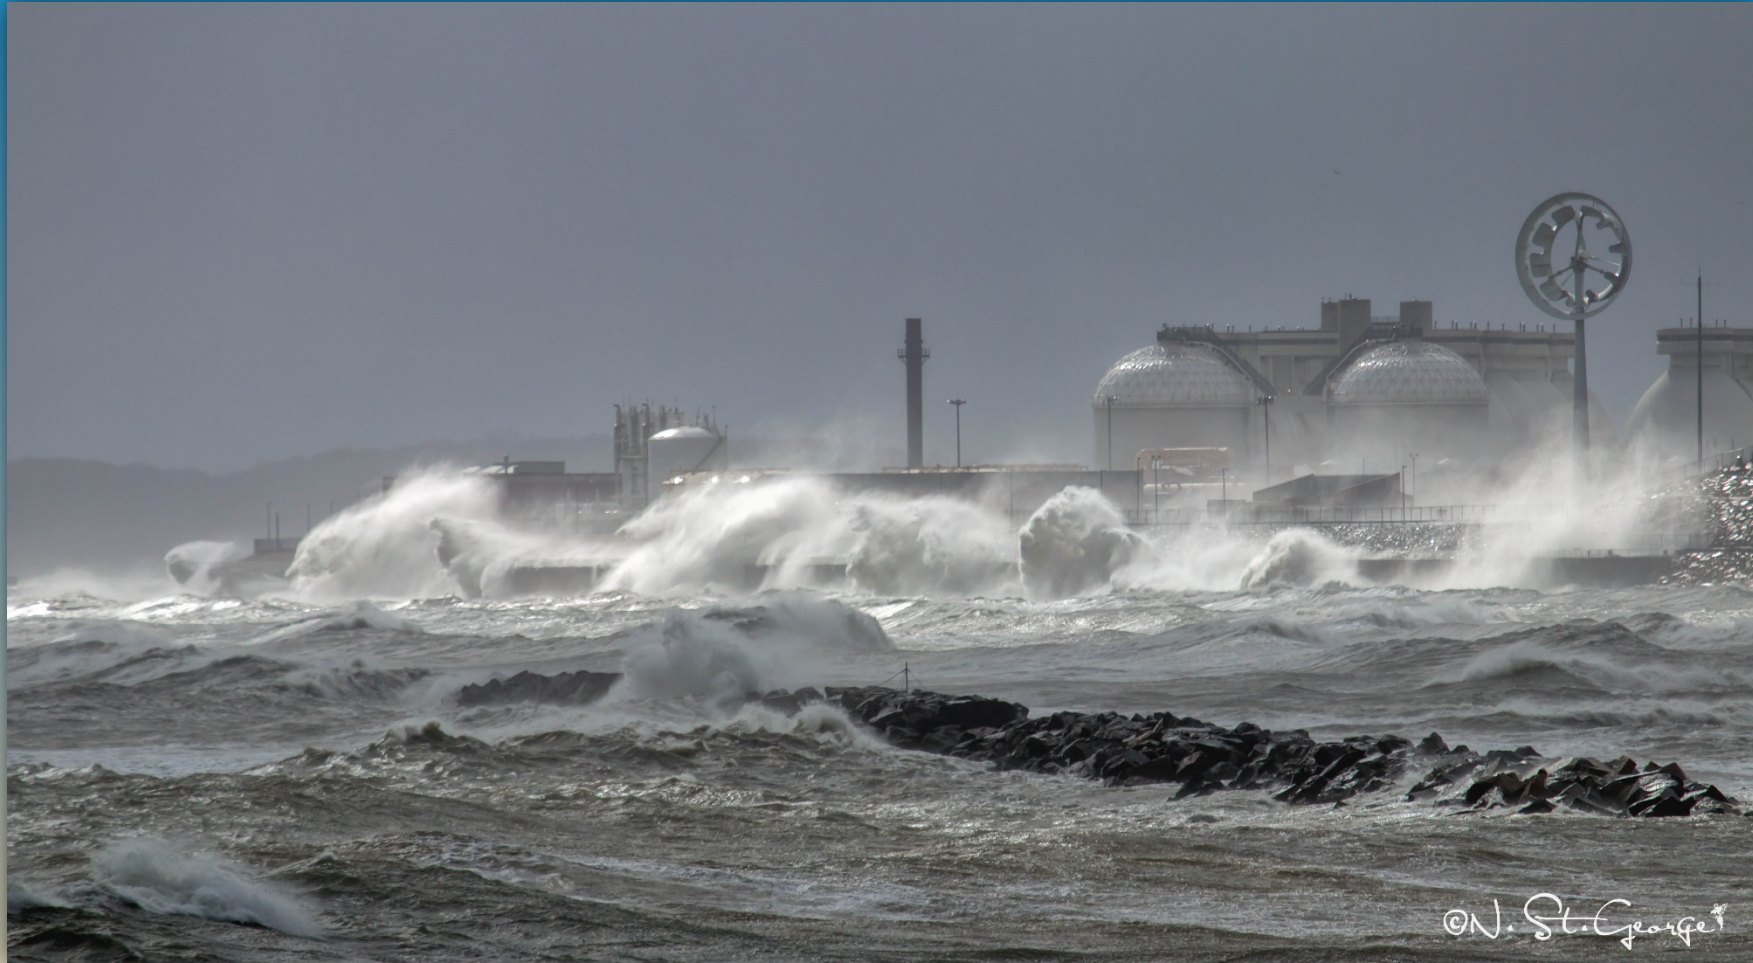
MWRA: Deer Island

The seawall protects the island from storm surges
