***Thunderstorm Impacts on
Wastewater System Operations***

***Deer Island Treatment Plant
Maintenance Coating Contract***

Piping Relocation at the Pelletizing Plant

***Bellevue 2 and Turkey Hill
Steel Tank Painting***

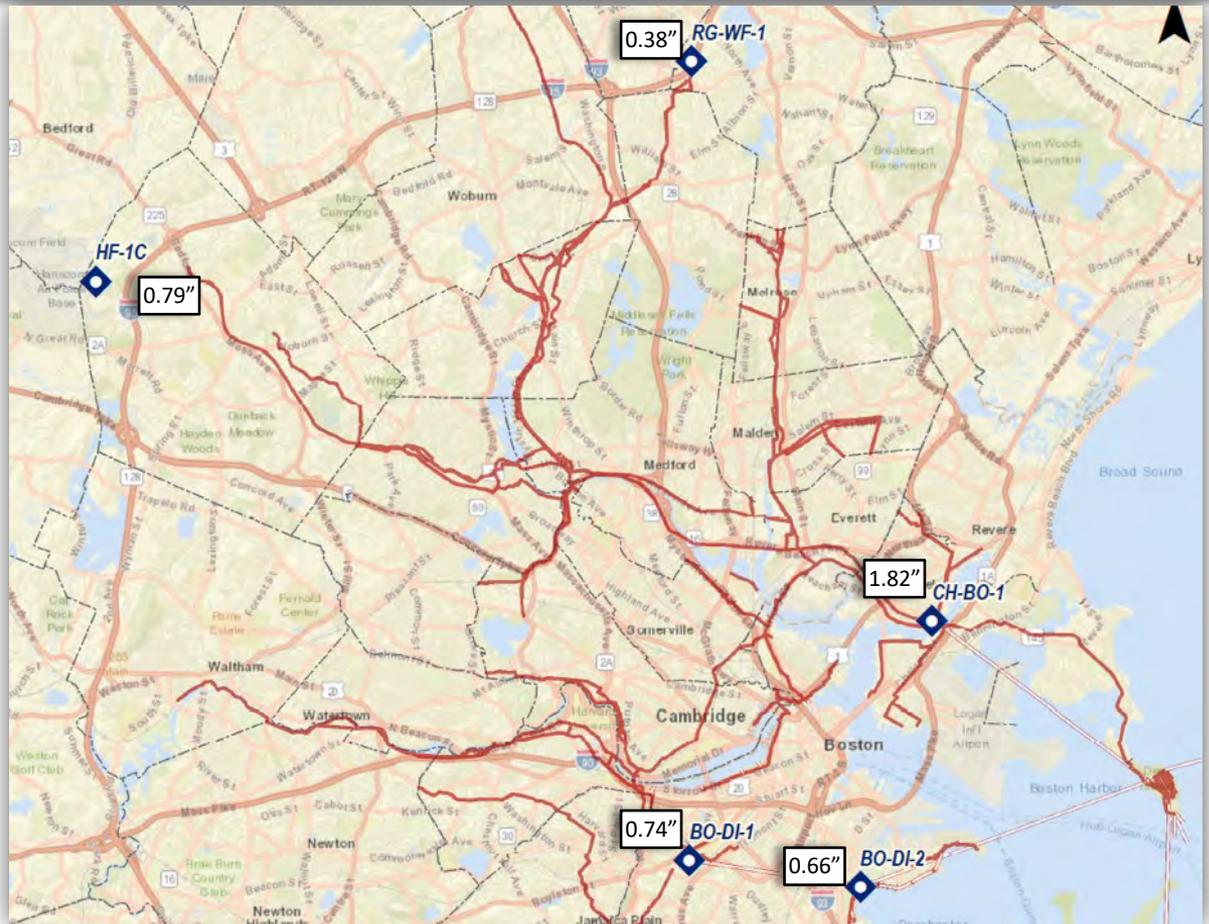
Rainfall Totals for June 29, 2019

Measured Area Rainfall:

Hayes PS:	0.38 inches
Columbus Pk HW:	0.66 inches
Ward Street HW:	0.74 inches
Hanscom:	0.79 inches
Chelsea Creek HW:	1.82 inches

❖ Chelsea Admin Building Rain Gauge registered an instantaneous rainfall rate of 12.26 in/hr at 4:30 pm

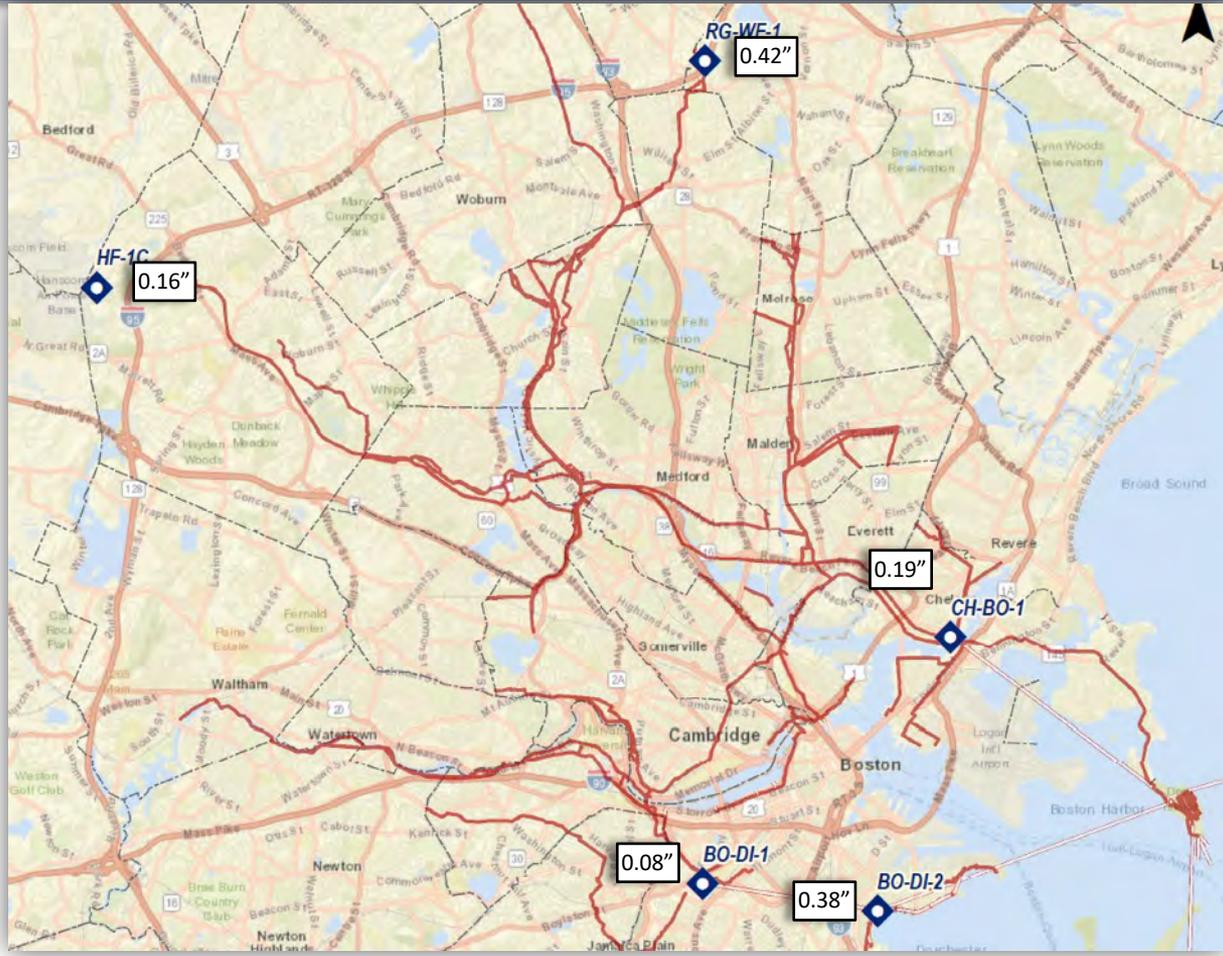
Rainfall Totals for Sunday, June 30, 2019

Measured Area Rainfall:

Hayes PS:	0.42 inches
Columbus Pk HW:	0.38 inches
Ward Street HW:	0.08 inches
Hanscom:	0.16 inches
Chelsea Creek HW:	0.19 inches

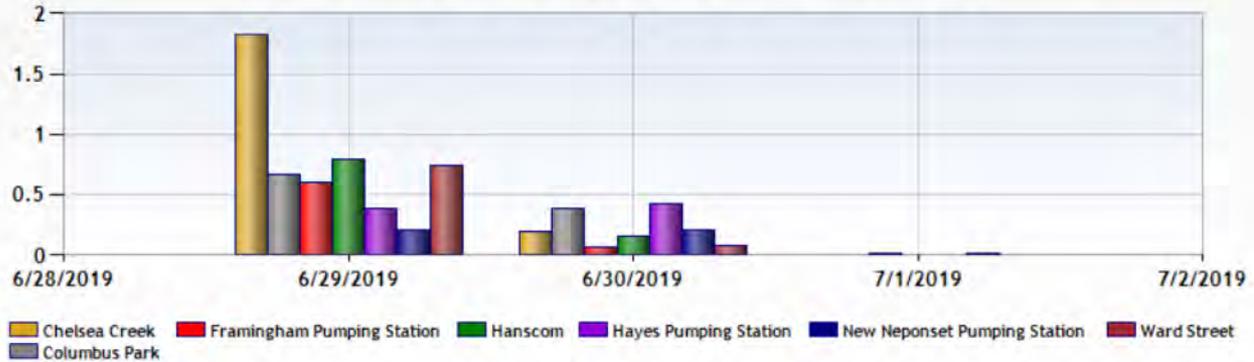
Rainfall Totals From June 29th to July 1st

Daily Rainfall Total in Inches from 6/29/2019 to 7/1/2019
 Collected by Chelsea Creek, Columbus Park, Framingham Pumping Station, Hanscom, Hayes Pumping Station, New Neponset Pumping Station, Ward Street Rain Gauges

Date	Chelsea Creek	Columbus Park	Framingham Pumping Station	Hanscom	Hayes Pumping Station	New Neponset Pumping Station	Ward Street
6/29/2019	1.82	0.66	0.60	0.79	0.38	0.21	0.74
6/30/2019	0.19	0.38	0.07	0.16	0.42	0.21	0.08
7/1/2019	0.00	0.00	0.01	0.00	0.00	0.01	0.00
Total	2.01	1.04	0.68	0.94	0.80	0.43	0.82

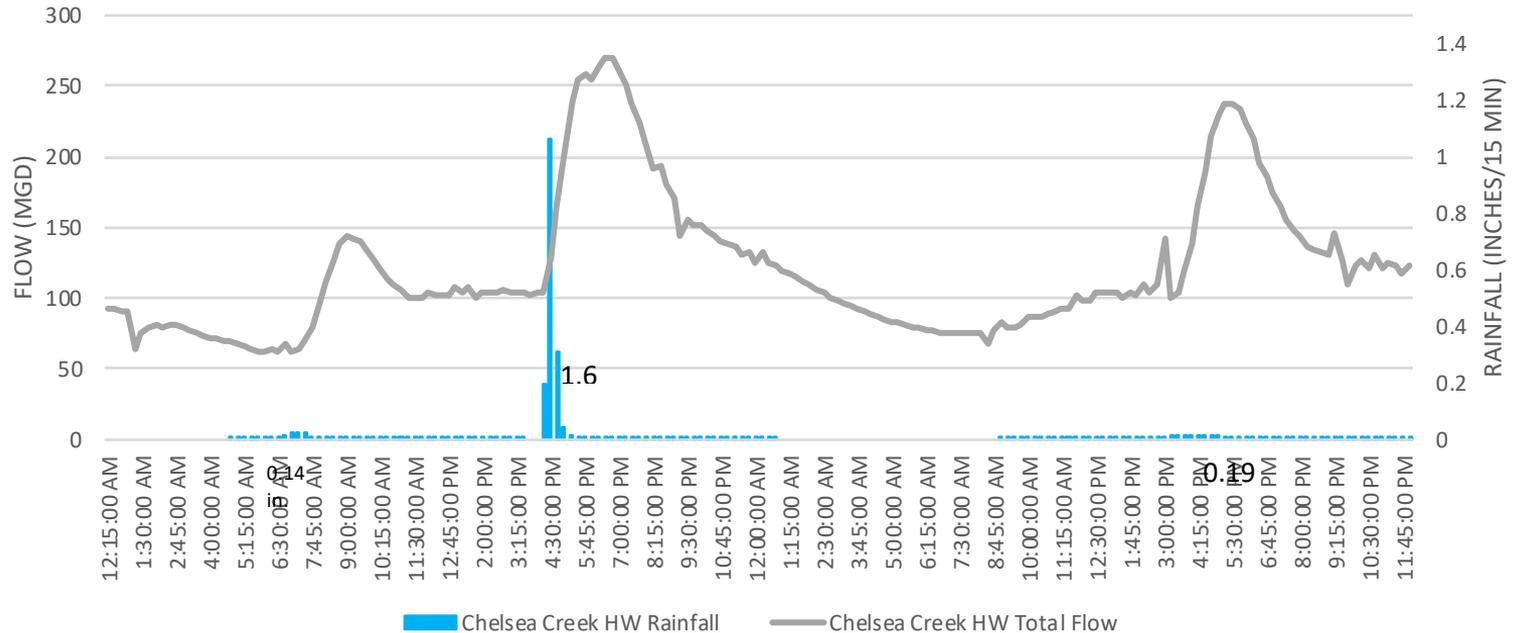
Chelsea Creek Headworks Flow

CHELSEA CREEK HEADWORKS FLOWS
JUNE 29-30 2019

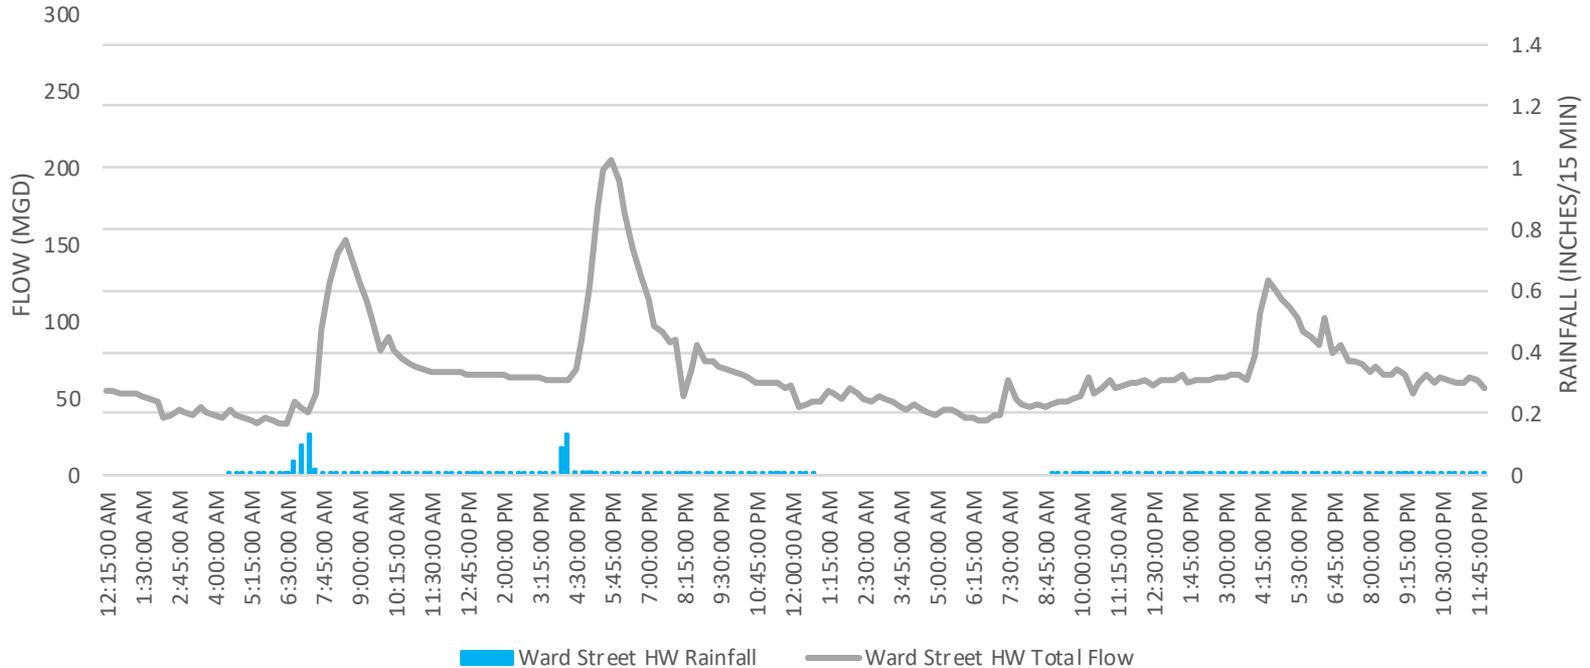
Ward Street Headworks Flow

WARD STREET HEADWORKS FLOW
JUNE 29-30 2019

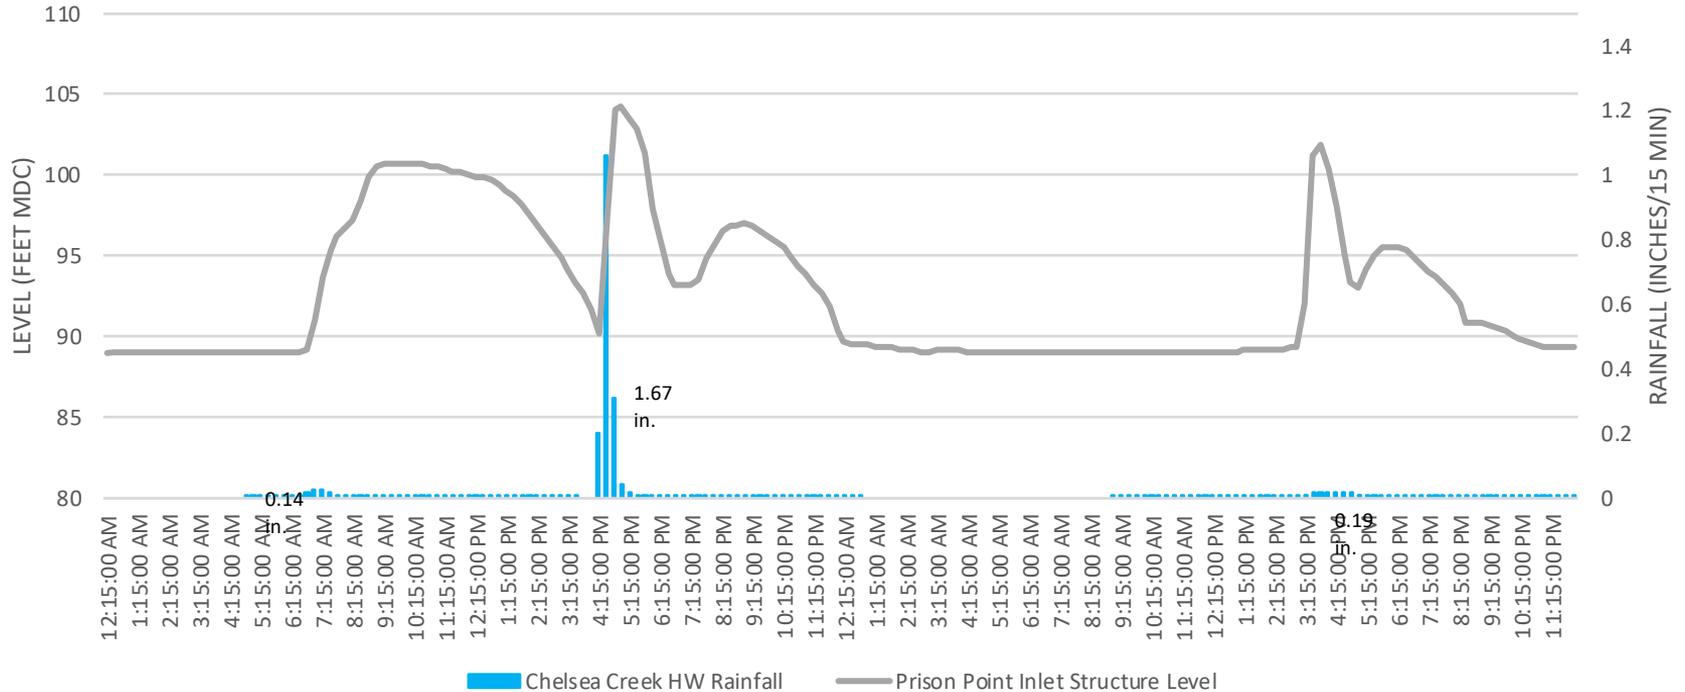
Prison Point CSO Inlet Elevation

PRISON POINT CSO INLET LEVEL
JUNE 29-30 2019

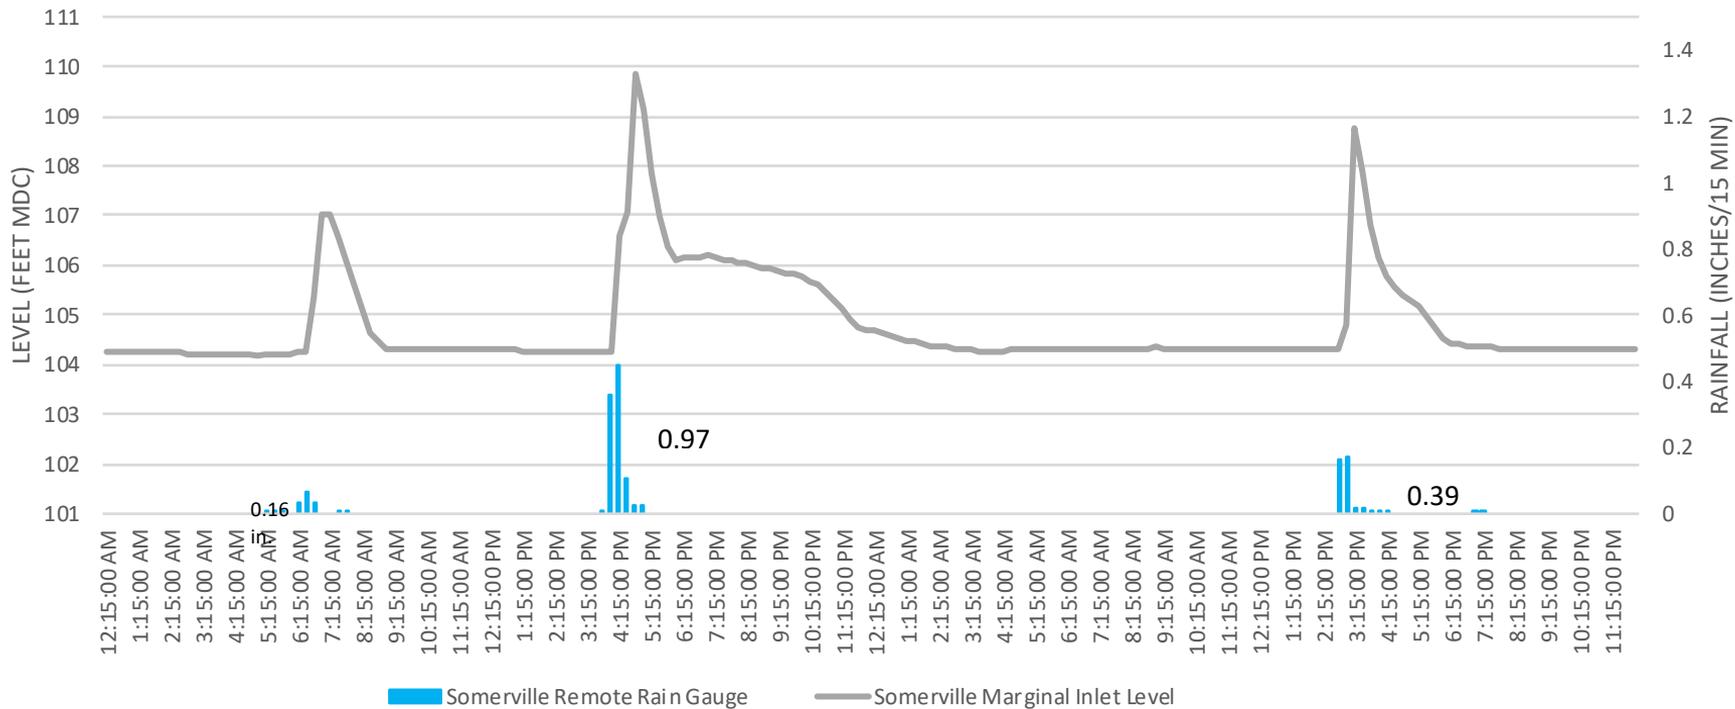
Somerville Marginal CSO Inlet Elevation

SOMERVILLE MARGINAL CSO INLET LEVEL JUNE 29-30 2019

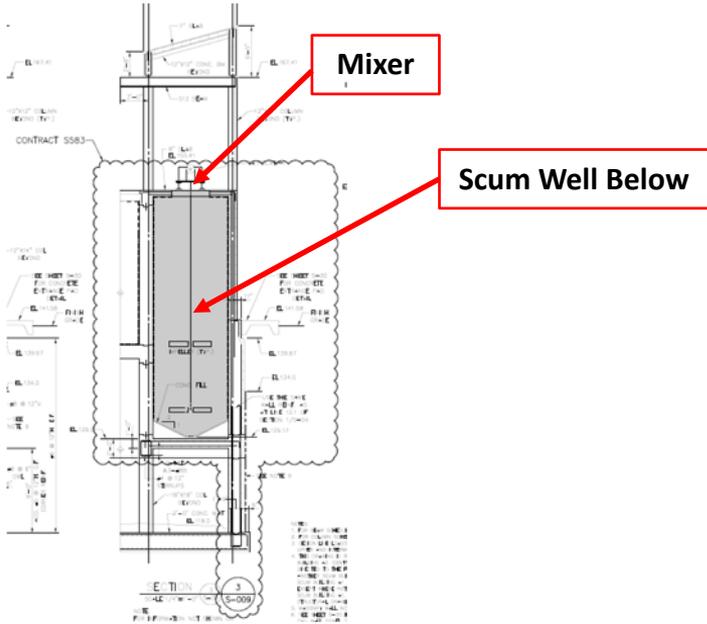
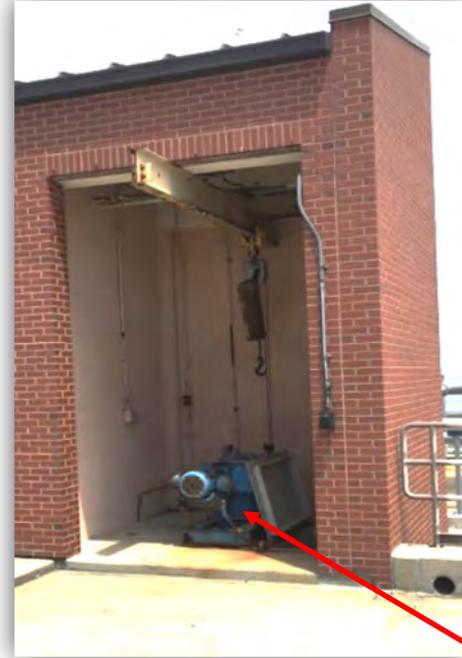
Contract S583 Scum Well Scope

Mixer

- 4 Primary Batteries each with 2 Scum Wells for a total of 8 Scum Wells

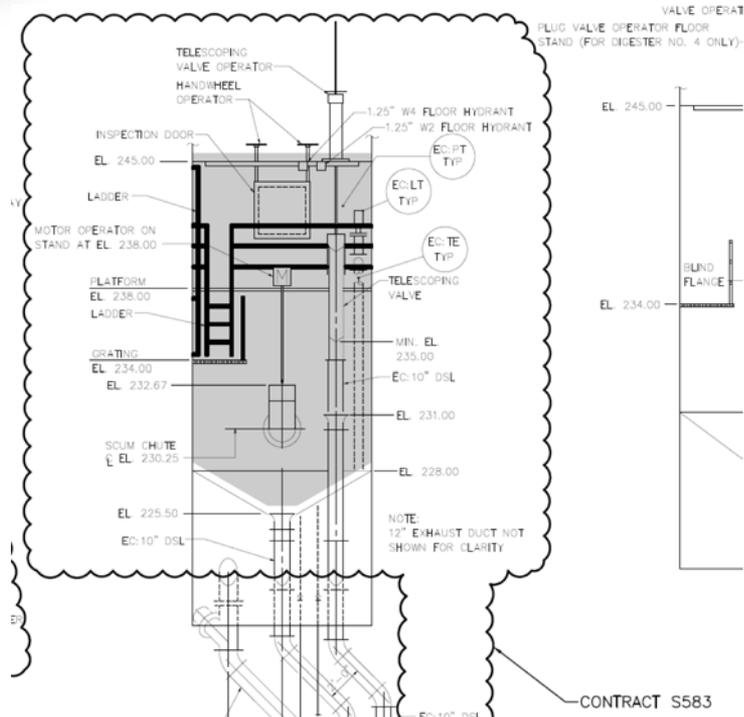
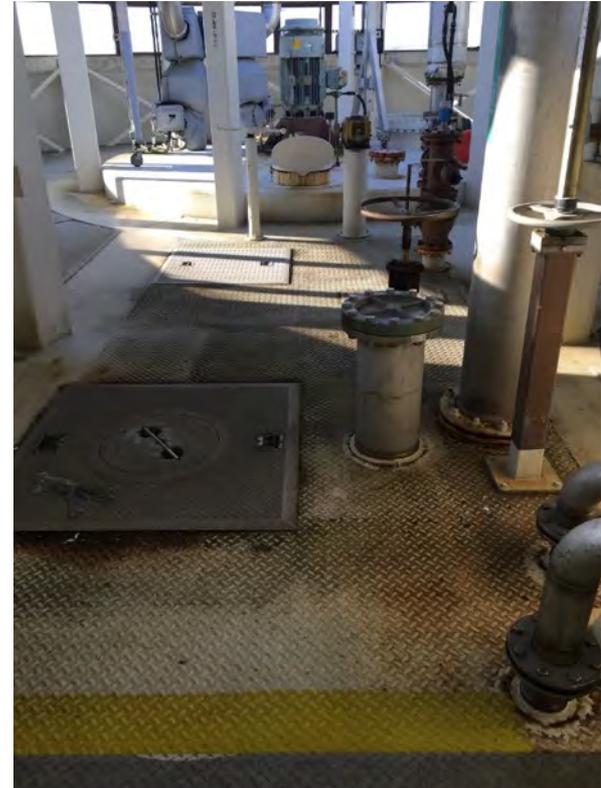
S583 Module 3 Digester Overflow Box Scope

Four (4) Overflow Boxes Total

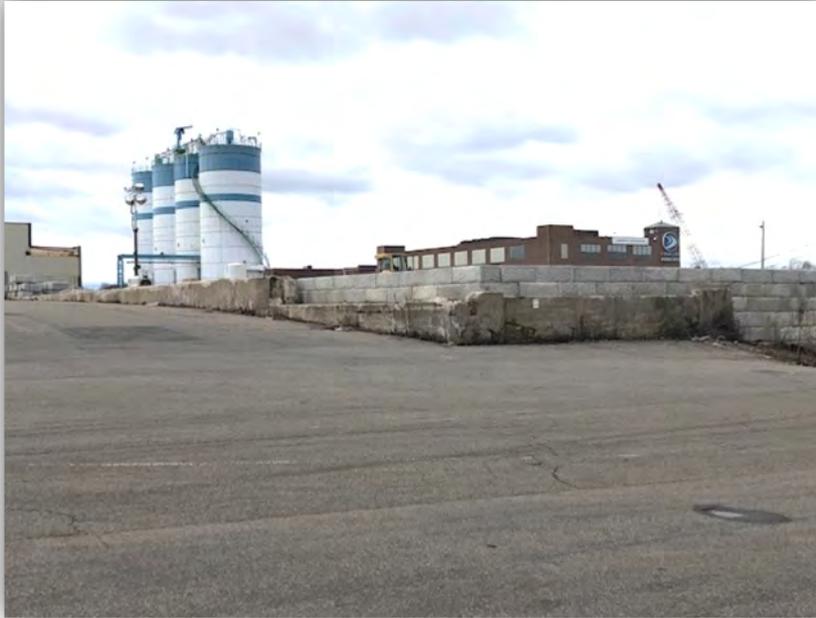
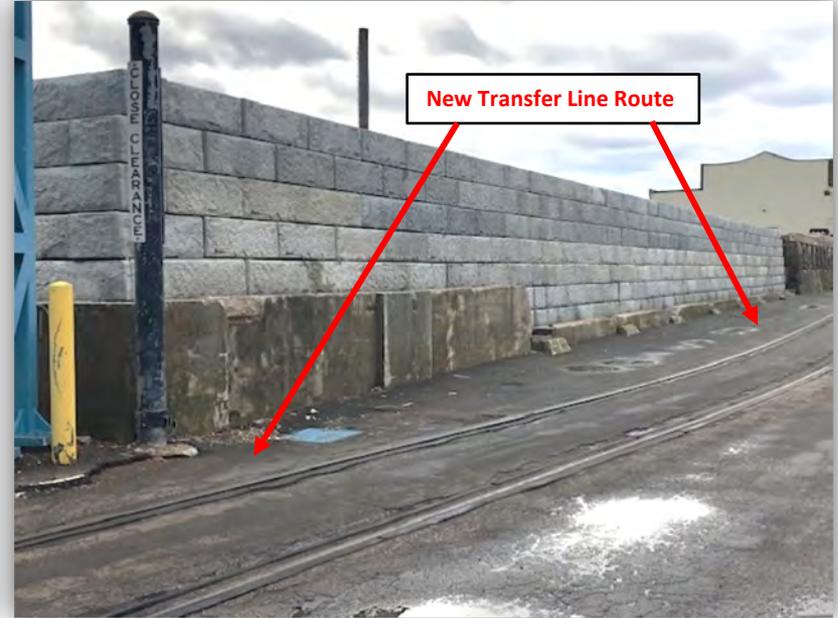
Post Demolition – Building 11

- Loss of access to remote silos reduces on-site storage by 45%
- Board approved Amendment 2 to NEFCO Contract for increased expenses-January 2019
- This Contract will install a new pellet conveyance piping system on dedicated supports

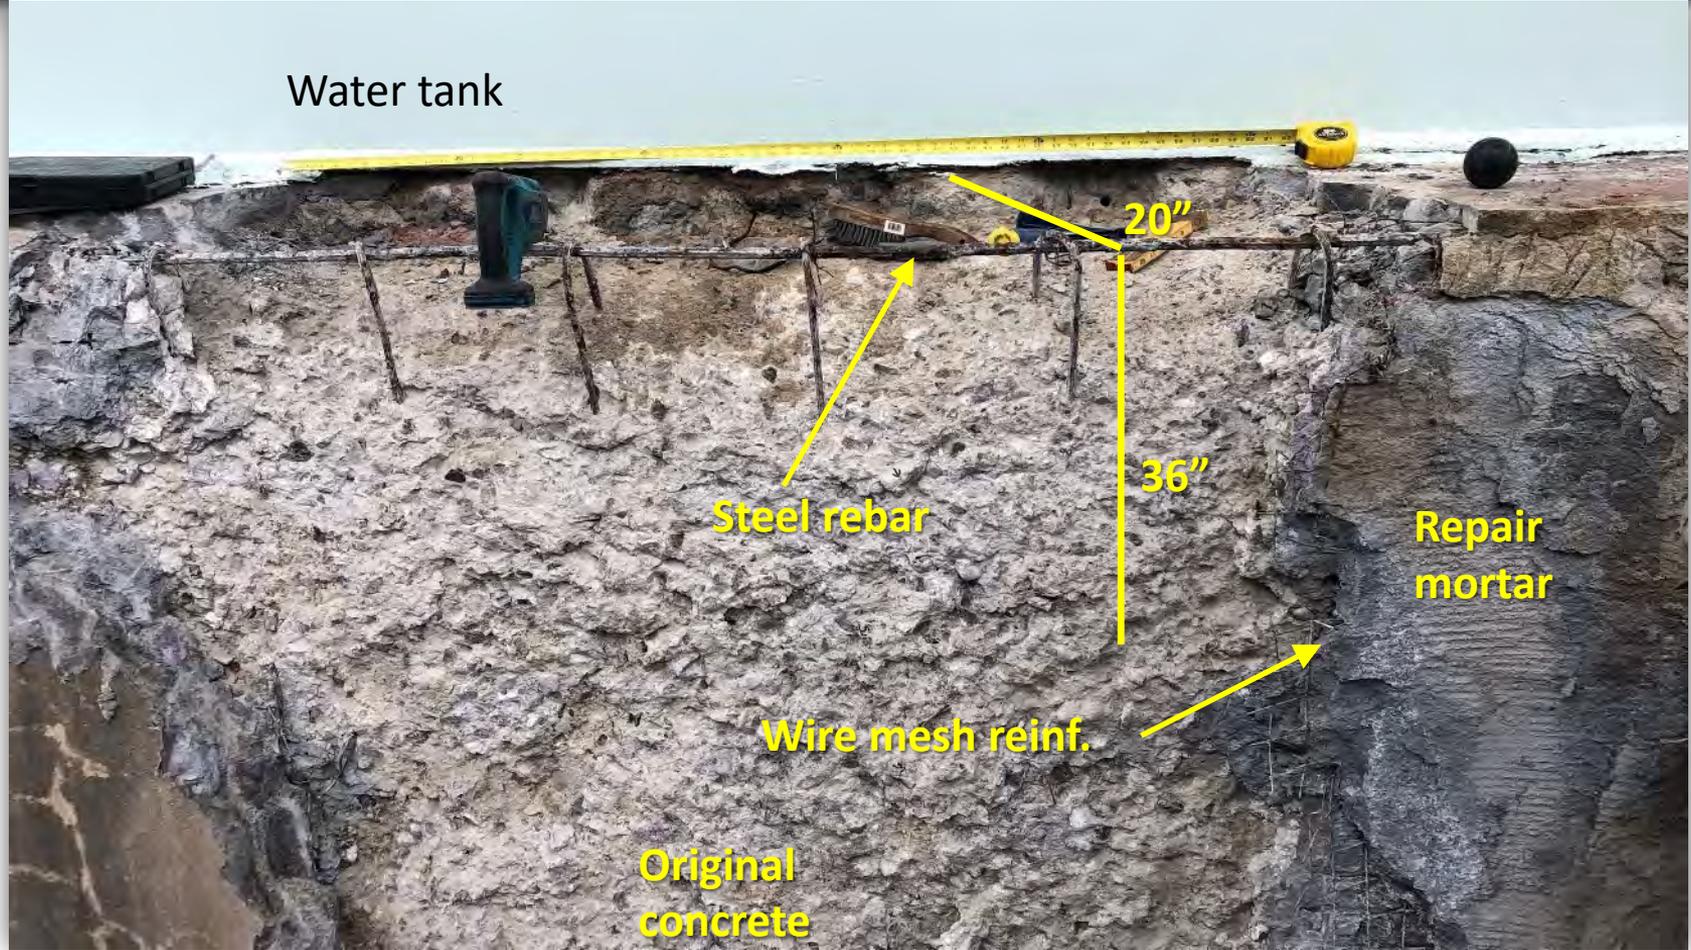
"Test" section to determine extent of demo required

Water tank

20"

36"

Steel rebar

Wire mesh reinf.

Repair mortar

Original concrete

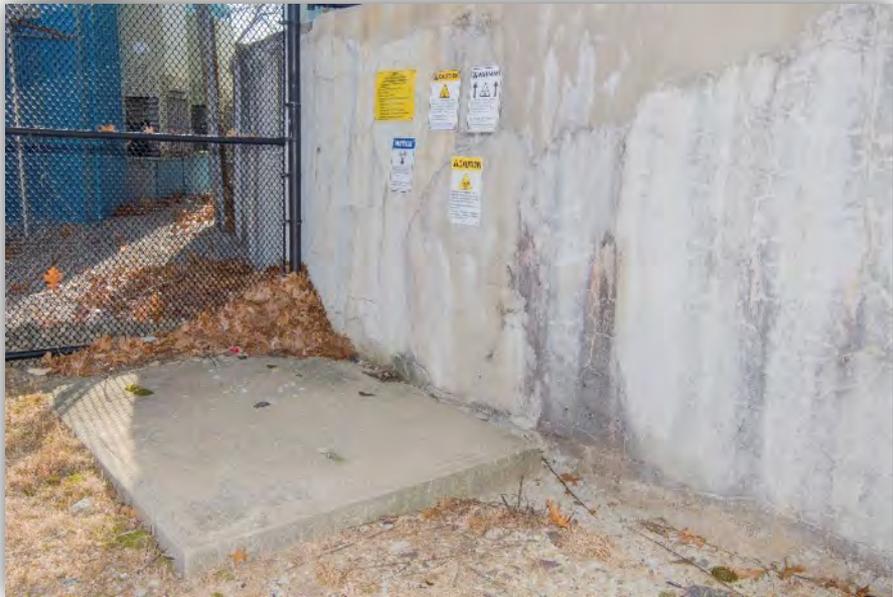
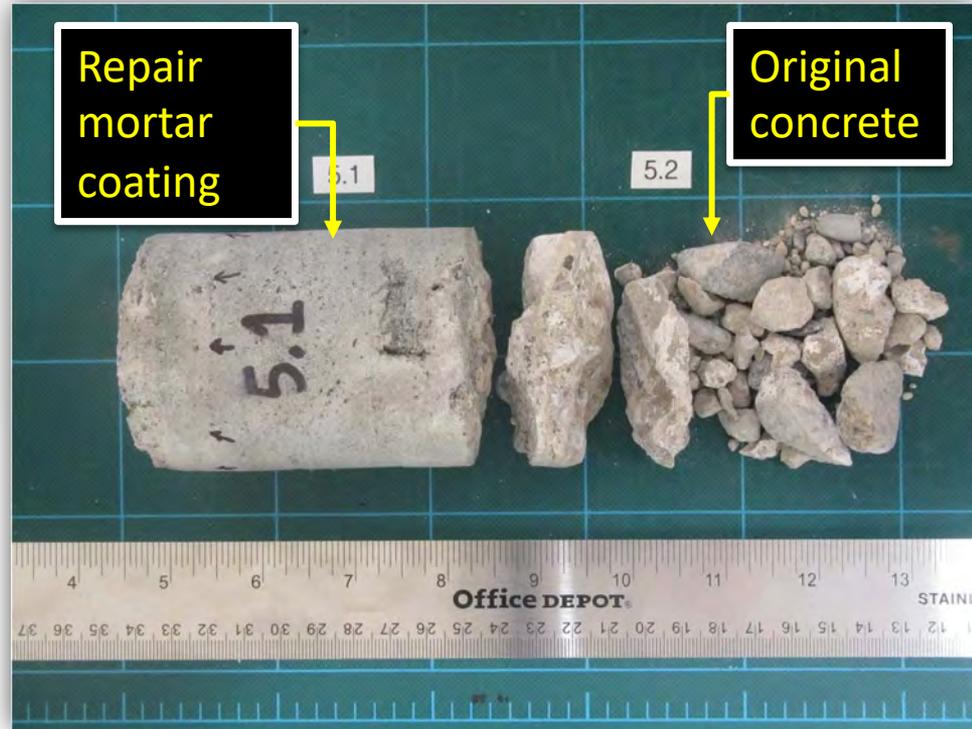
Foundation Core Samples

Six concrete core samples taken
2 ¾" diameter, up to 8" depth

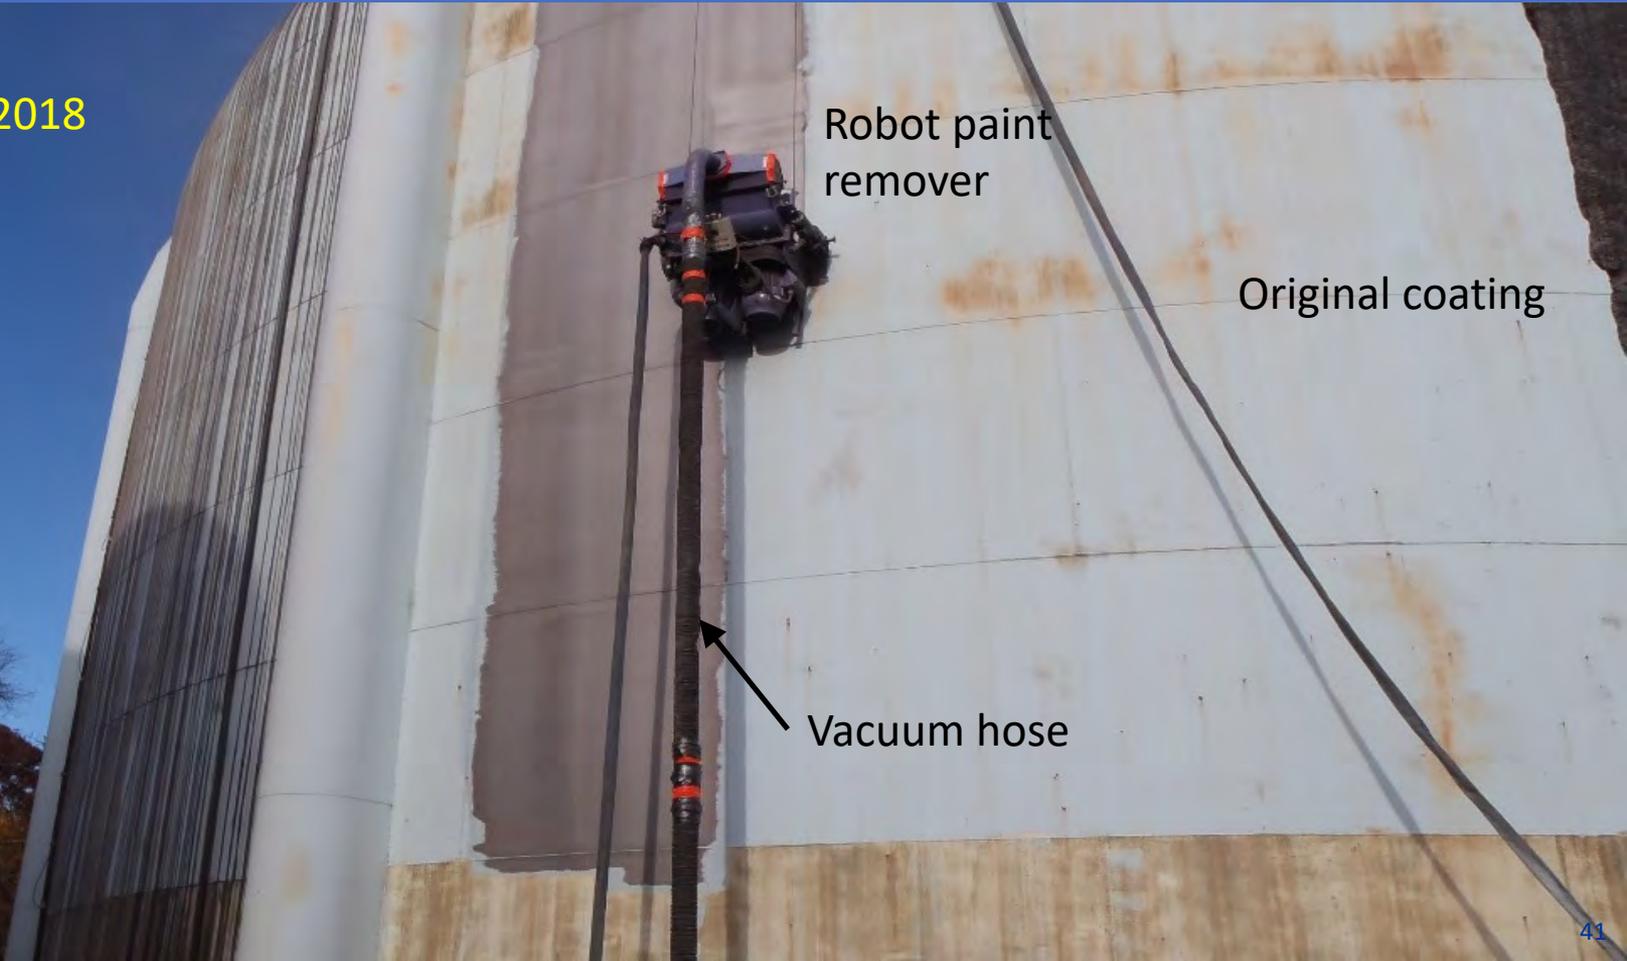
Bellevue 2 "Robot" Paint Removal

Robot paint
remover

Original coating

Vacuum hose

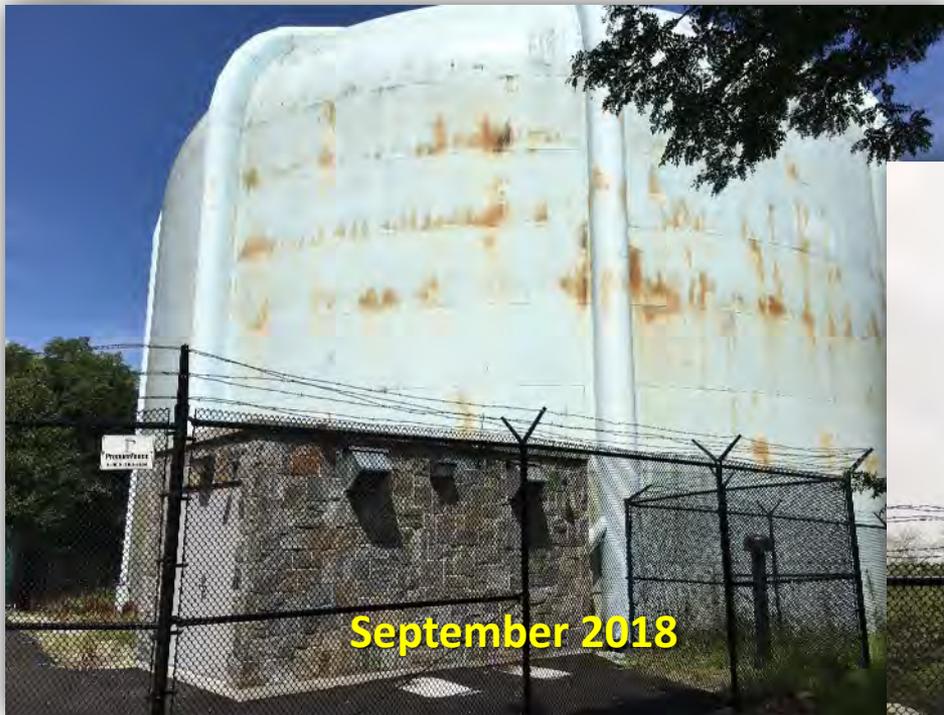
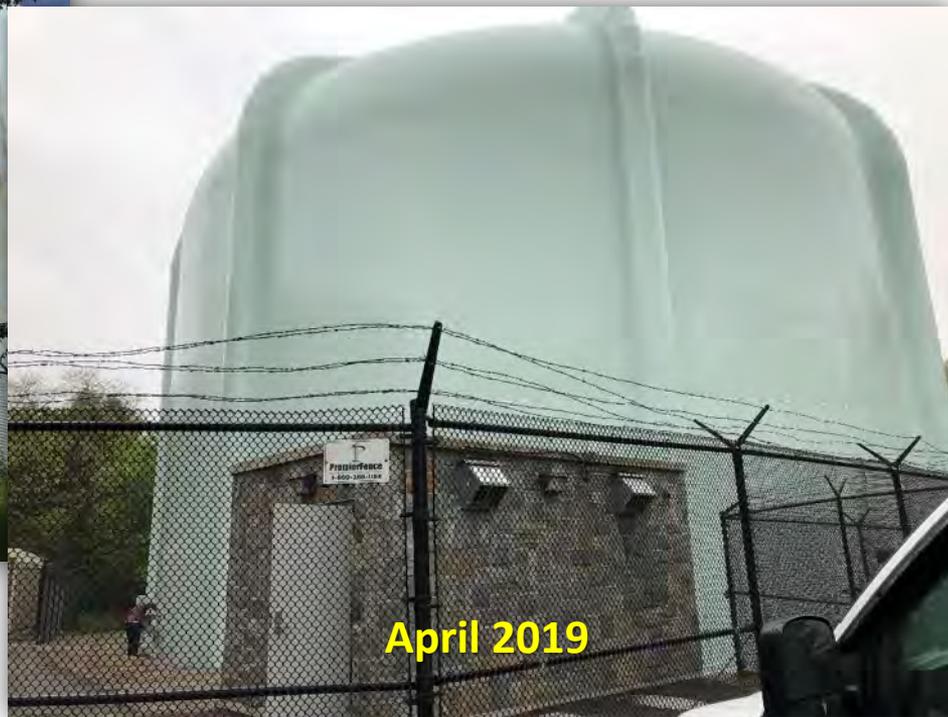
Bellevue 2 Before and After

September 2018

April 2019

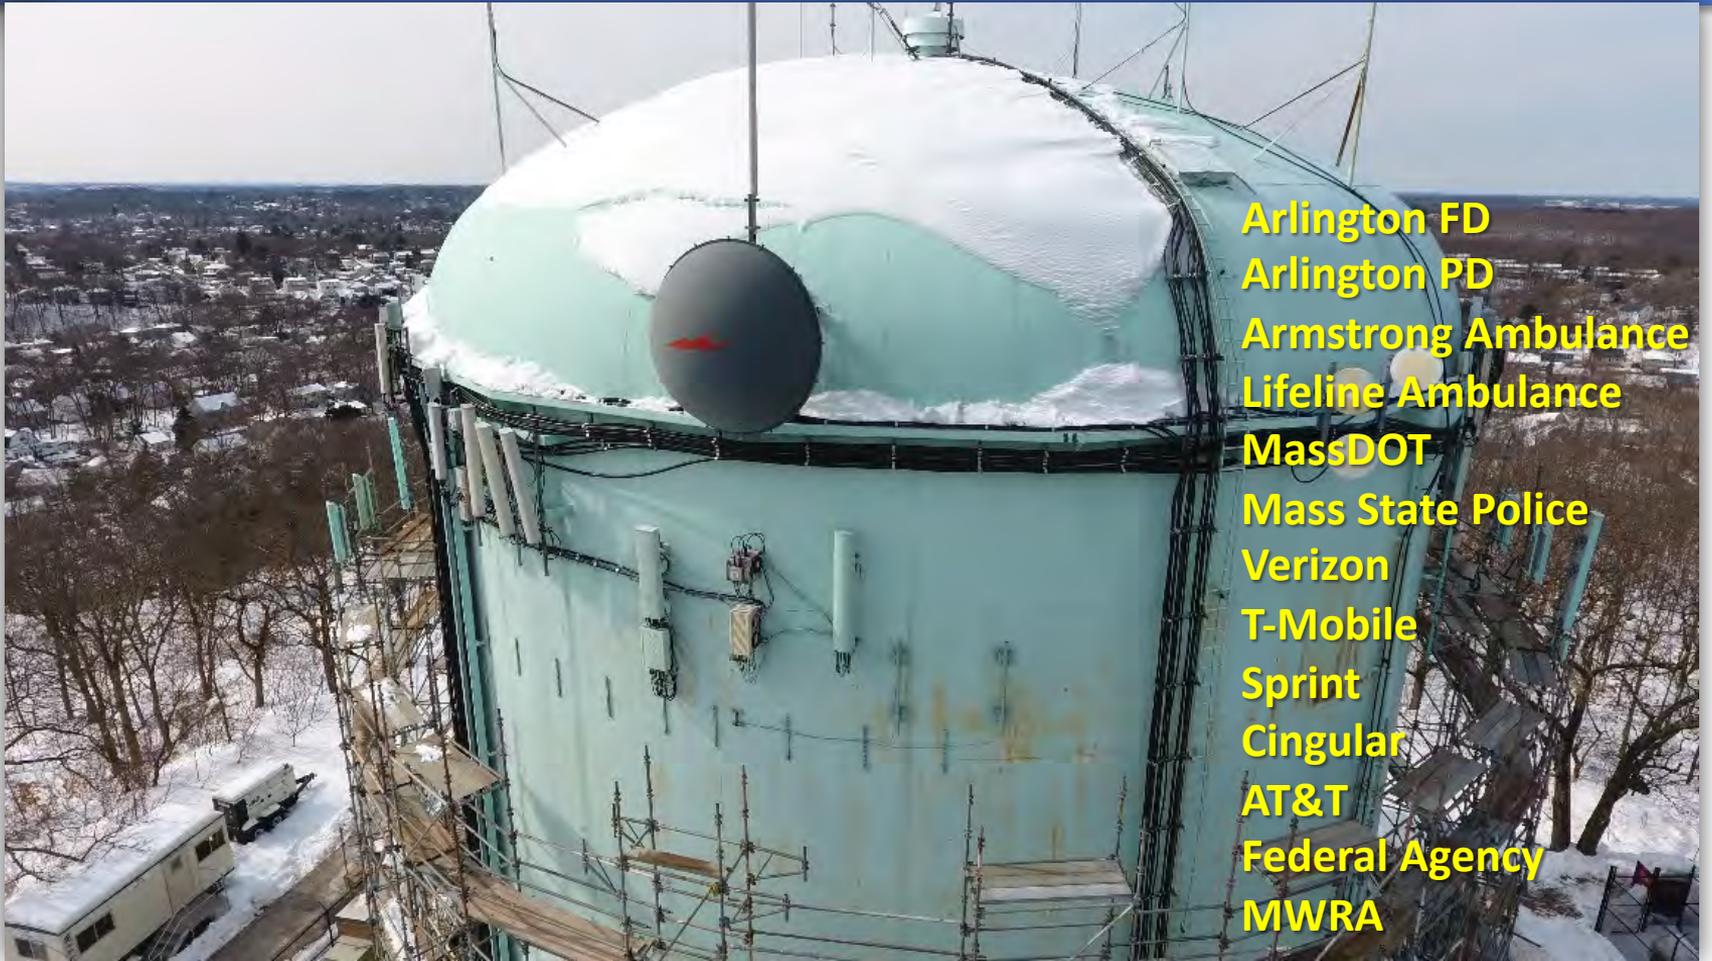
Turkey Hill Tank Antennas, February 2019

Arlington FD
Arlington PD
Armstrong Ambulance
Lifeline Ambulance
MassDOT
Mass State Police
Verizon
T-Mobile
Sprint
Cingular
AT&T
Federal Agency
MWRA

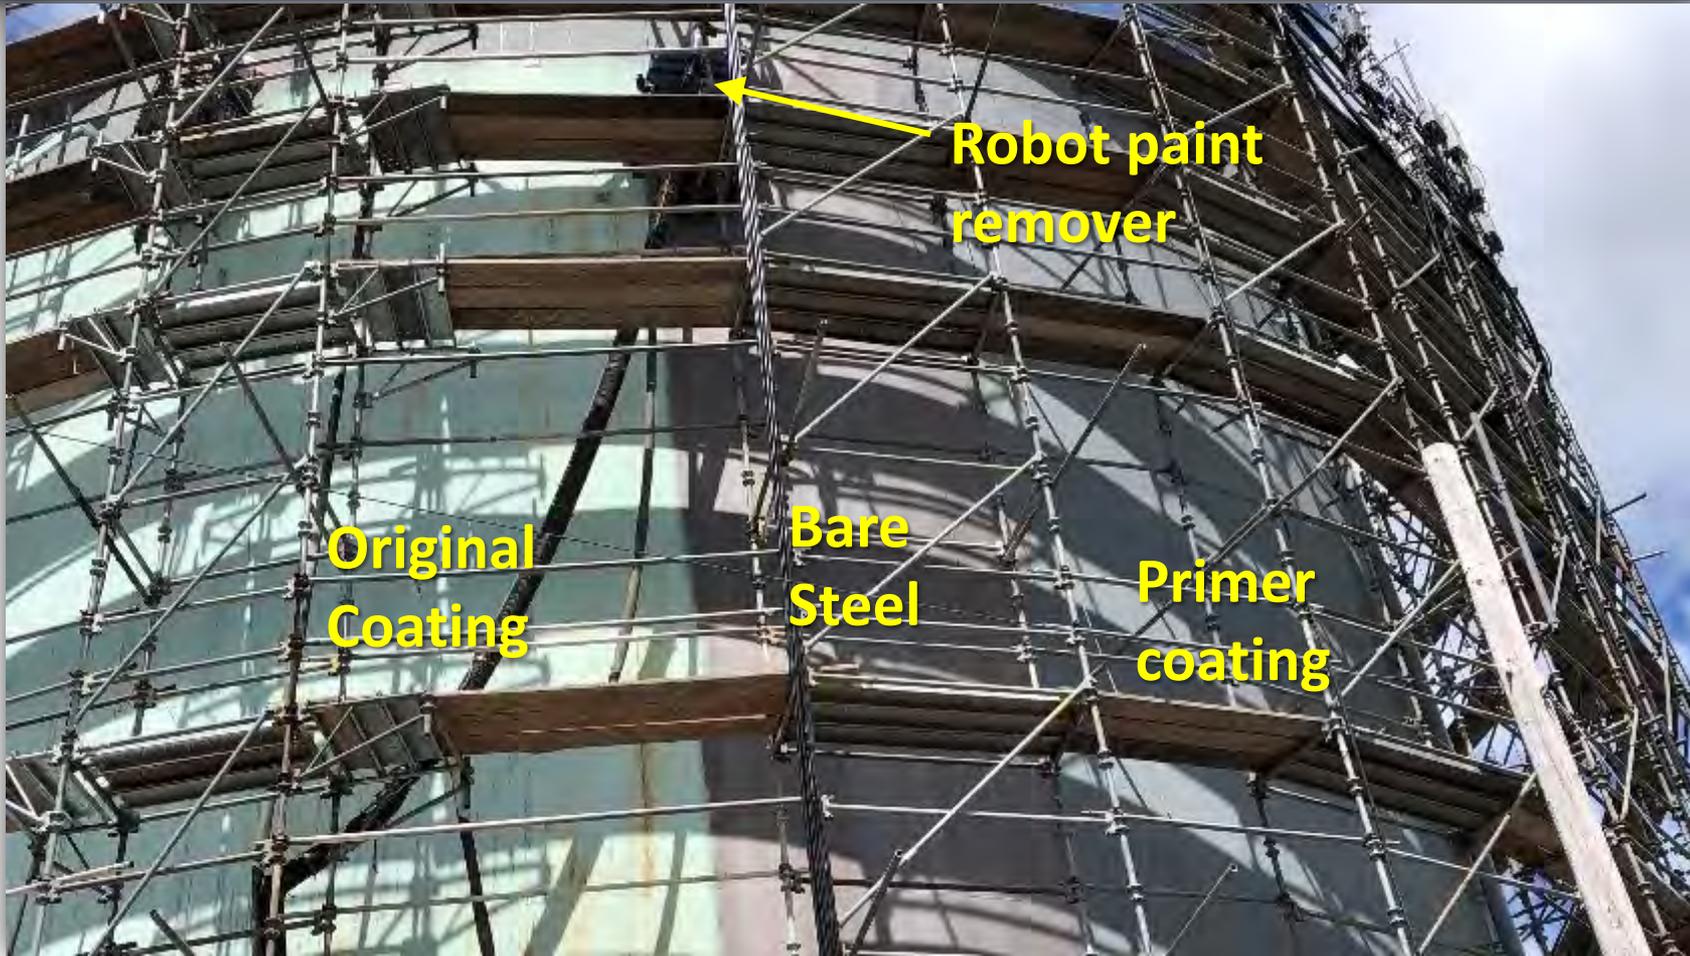
Turkey Hill Water Tank "Robot" Paint Removal

**Robot paint
remover**

**Original
Coating**

**Bare
Steel**

**Primer
coating**
