***Wachusett Dam Lower Gatehouse  
Pipe Break***

November 14, 2018

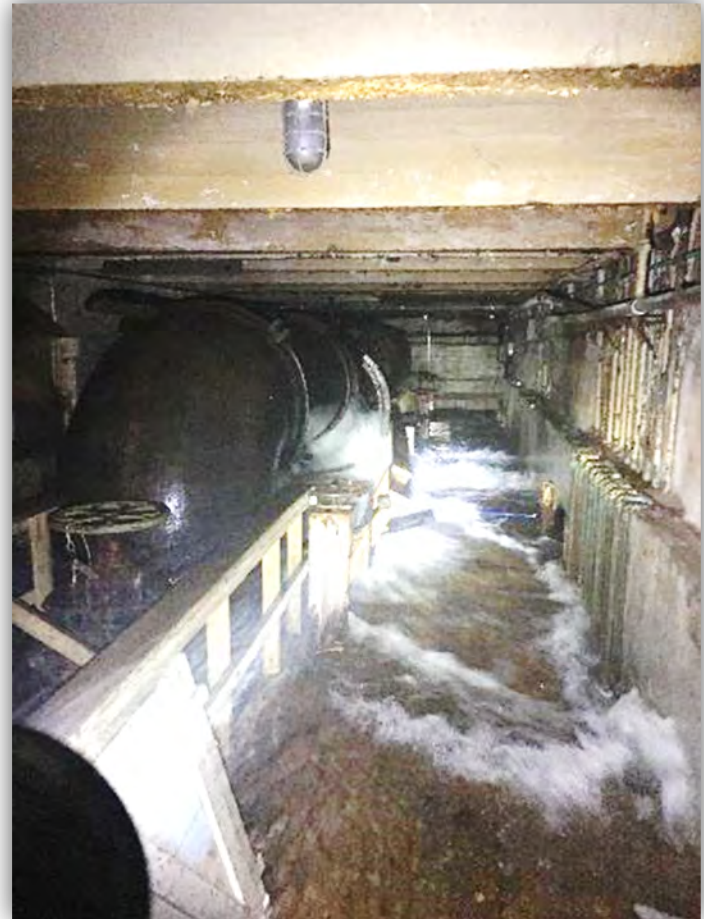
# Wachusett Dam Lower Gatehouse Pipe Break

Break of 1905 Equalizer Pipe during testing of the Wachusett Aqueduct Pumping Station

# Short-Term Action

## Alternatives to Permit Continuation of Wachusett Aqueduct Pumping Station Testing:

1. Close the valves on Lines 1 and 2 to isolate water from the equalizer pipe. Test pipe integrity
2. Install blind flanges on Lines 1, 2 and 3

## Long-Term Plan

- Remove all the old cast-iron piping in Well 4 of the Lower Gatehouse
- Install new pipe and flow control valves for releases to the Nashua River

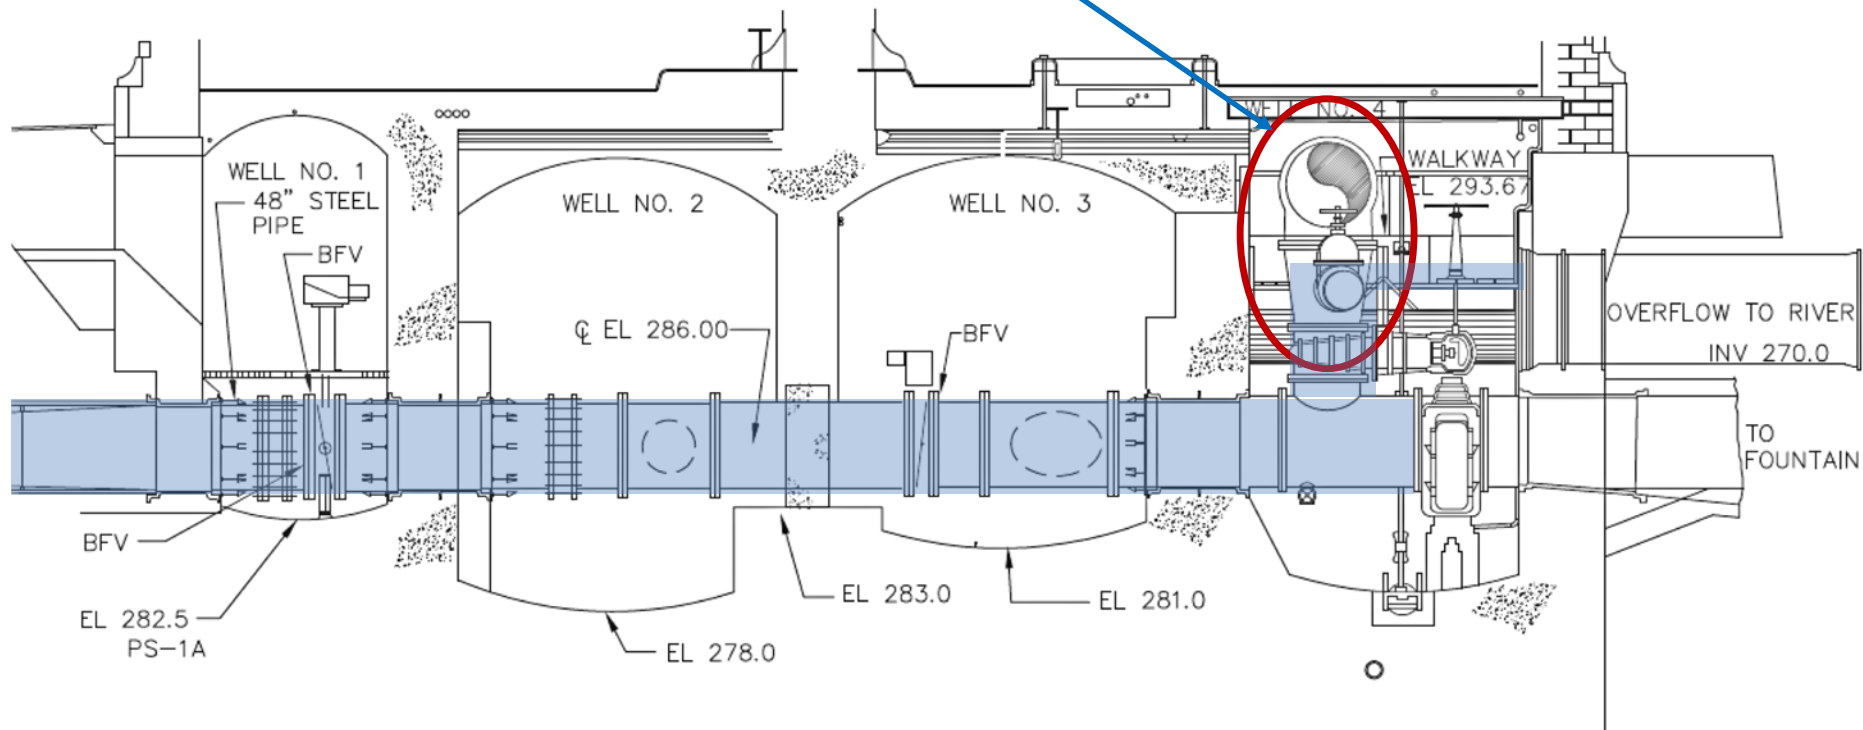
# Wachusett Dam Lower Gatehouse

Tee and Reducer Failed

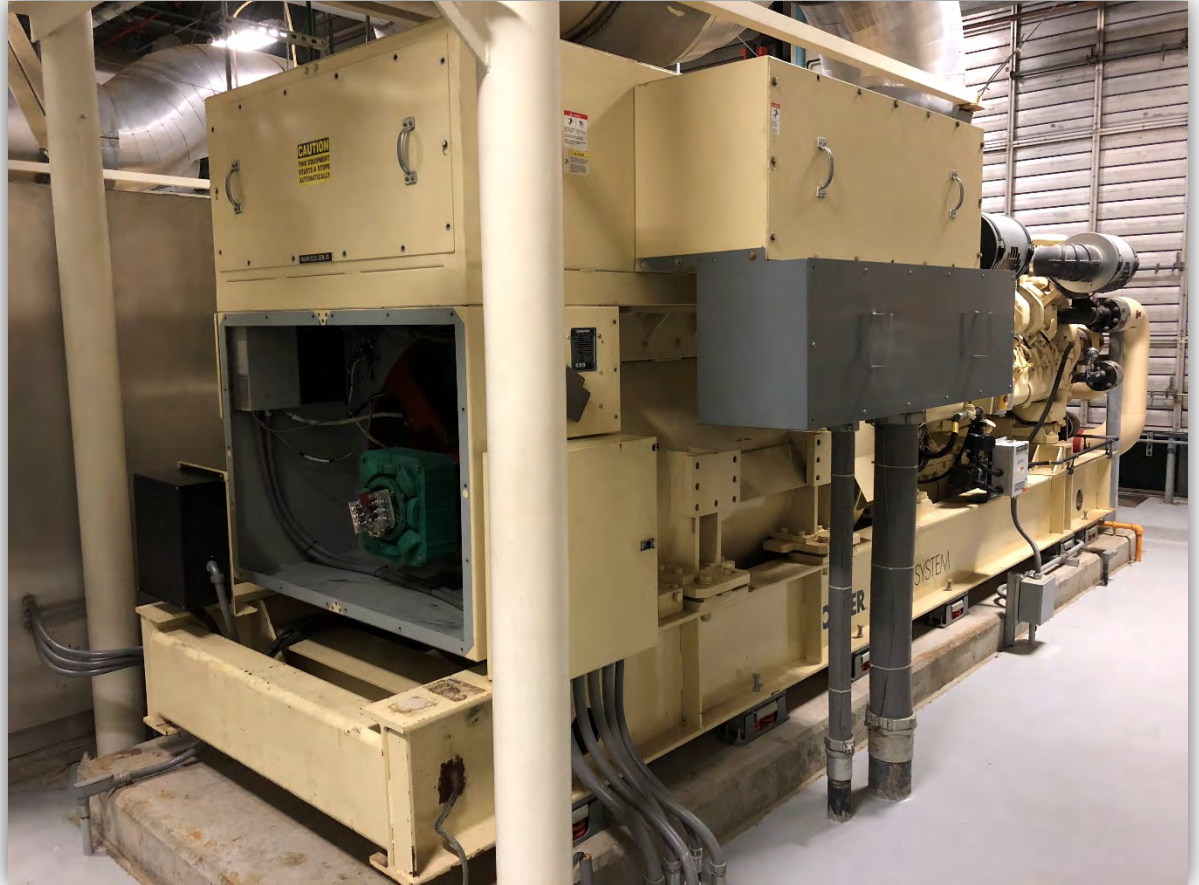
# Carroll Plant Electric Generator No. 1

- Replacement of Generator No. 1 is required following attempts to repair it
- All four generators needed to power Carroll plant and Wachusett Aqueduct Pumping Station at full capacity
- Contract for replacement advertised
