MWRA Pipeline Maintenance

Massachusetts Water Resources Authority
Leakage Control Report
Inspection Branch

Leak No.: FY17-22
 Date: 5/15/2017
 Leak Indication Classification:
 I II **III** (Circle One)
 Service Area: Northern High

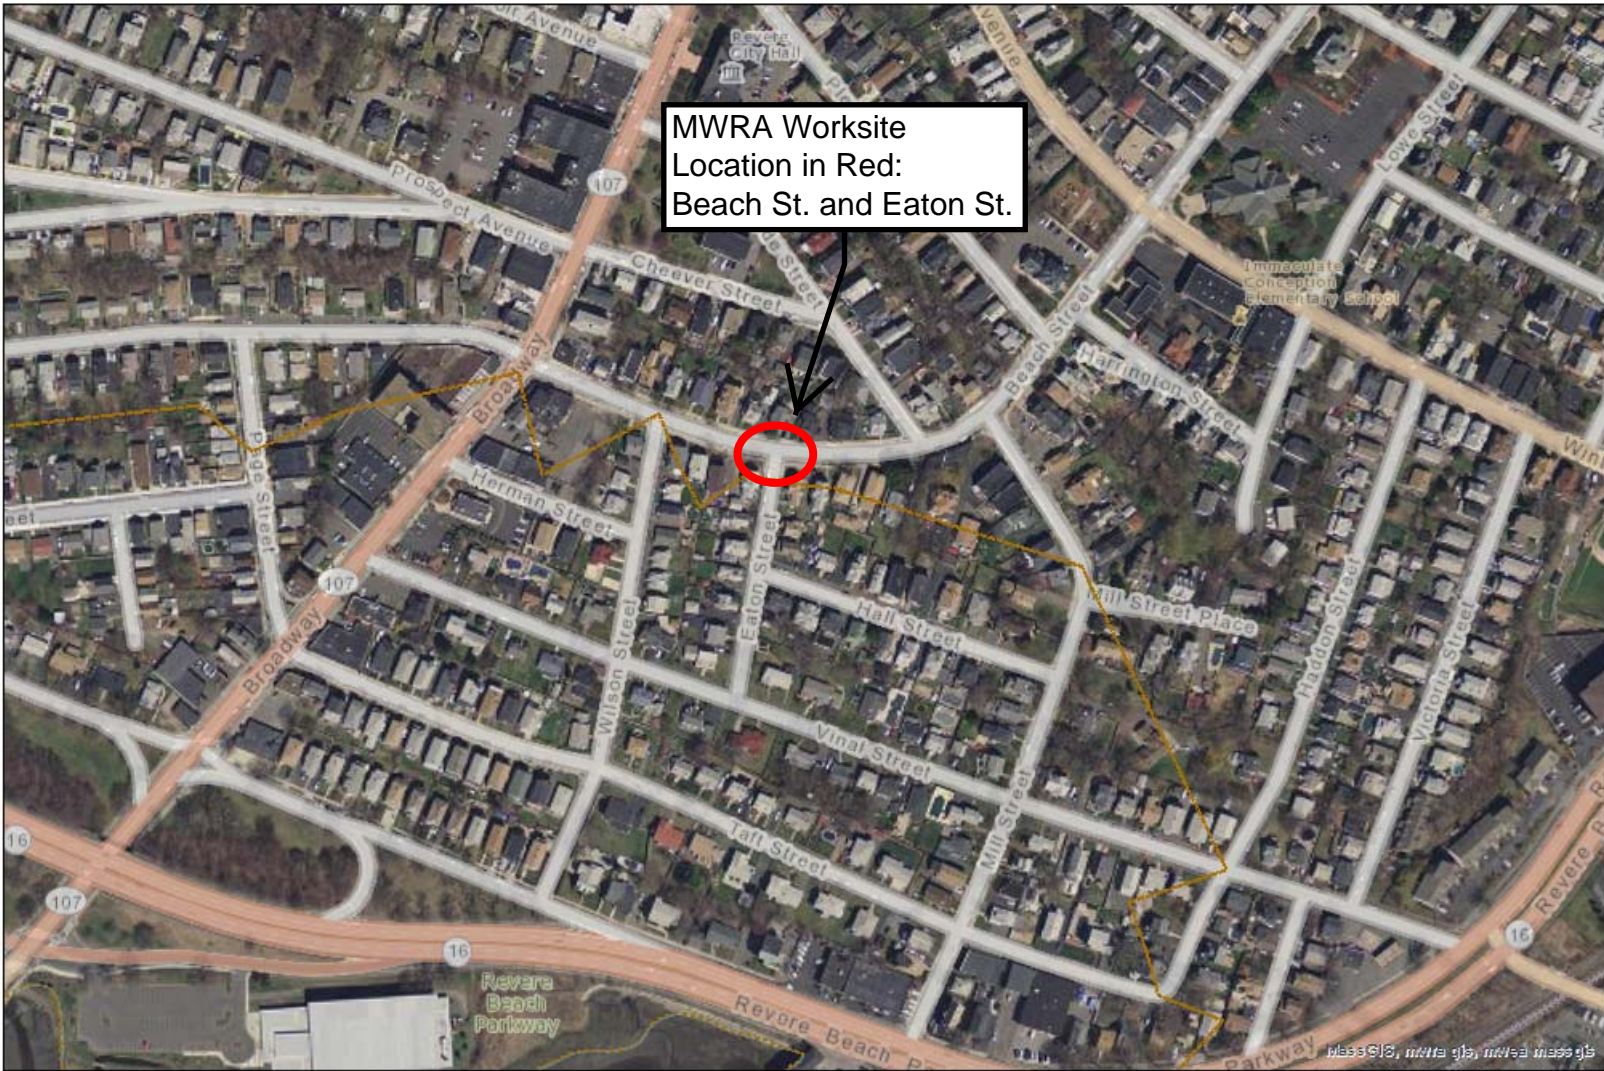
Technician: Pyburn, Smokler Town/City: Revere
 Street Address: Beach Street Cross Street: Eaton Street
 Section #: 69 Detail Record #: - Record Plan #: Sheet 1 Date Installed: 1951

5 GPM

24 Inch

Main	<input checked="" type="checkbox"/>
Joint	<input type="checkbox"/>
Valve	<input type="checkbox"/>
Valve (Packing)	<input type="checkbox"/>
Blow Off	<input type="checkbox"/>
Air Valve	<input type="checkbox"/>
Other	<input type="checkbox"/>

Remarks: Water in road is due to a sump pump which is unrelated to this leak.
