STAFF SUMMARY

TO: Board of Directors
FROM: Frederick A. Laskey, Executive Director
DATE: May 29, 2019
SUBJECT: Update on May 3, 2019 Water Main Break, Section 89, Winchester

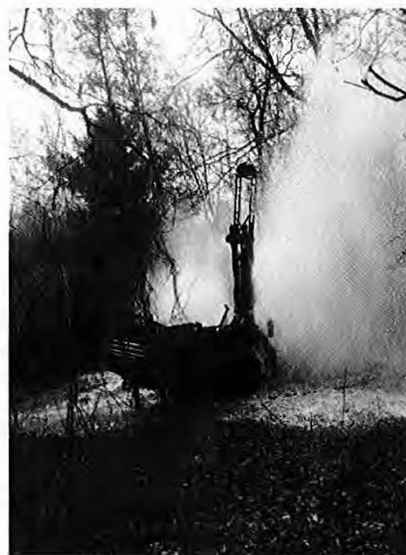
The affected section of pipeline is located in a wooded easement on the Winchester/Woburn town line and caused a geyser of water that ran down the access road along the easement to a nearby wetland without causing significant property damage or creating a public safety concern. This allowed staff to size-up system service options before the pipeline had to be shutdown, thereby preventing loss of service.

MWRA staff immediately mobilized pipeline repair and valve crews and opened the emergency operations center in Chelsea. Notices sent from MWRA caught the attention of media outlets that dispatched video crews to the area. Working closely with the water departments of the impacted communities, staff were able to identify and set up a reconfiguration of the Northern Intermediate High service area.

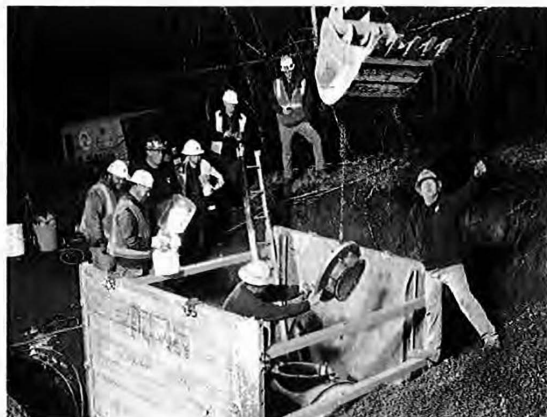
As soon as the flow stopped, MWRA pipeline staff began restoration of the dirt roadway into the damaged pipe section and excavated and prepared the pipeline for repair. This work was completed late Friday night. Meanwhile, staff had located a repair saddle, in Florida, designed especially for this type and size pipeline and made arrangements for its purchase and delivery. In addition, a technician specializing in installation of the repair saddle was located in Ohio. The technician and his tools arrived in his vehicle on Saturday afternoon and the saddle arrived via truck delivery to the site early Saturday evening.

Within two hours the repair was completed, and MWRA valve crews began refilling the line for pressure testing. Reactivation was completed by 1:00 a.m. Sunday, May 5, 2019.
